Exhibit 2: Photographs

Pigeon Point Lighthouse Rehabilitation Plan
Architectural Resources Group

Pescadero, California
December 2008

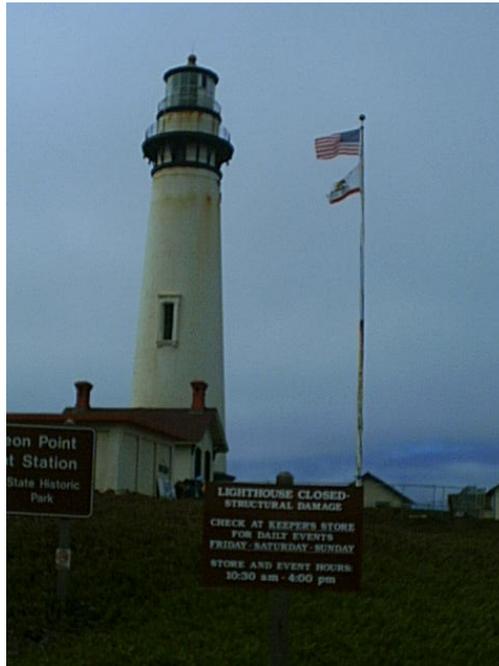
The sign reads: "Lighthouse Closed – Structural Damage."

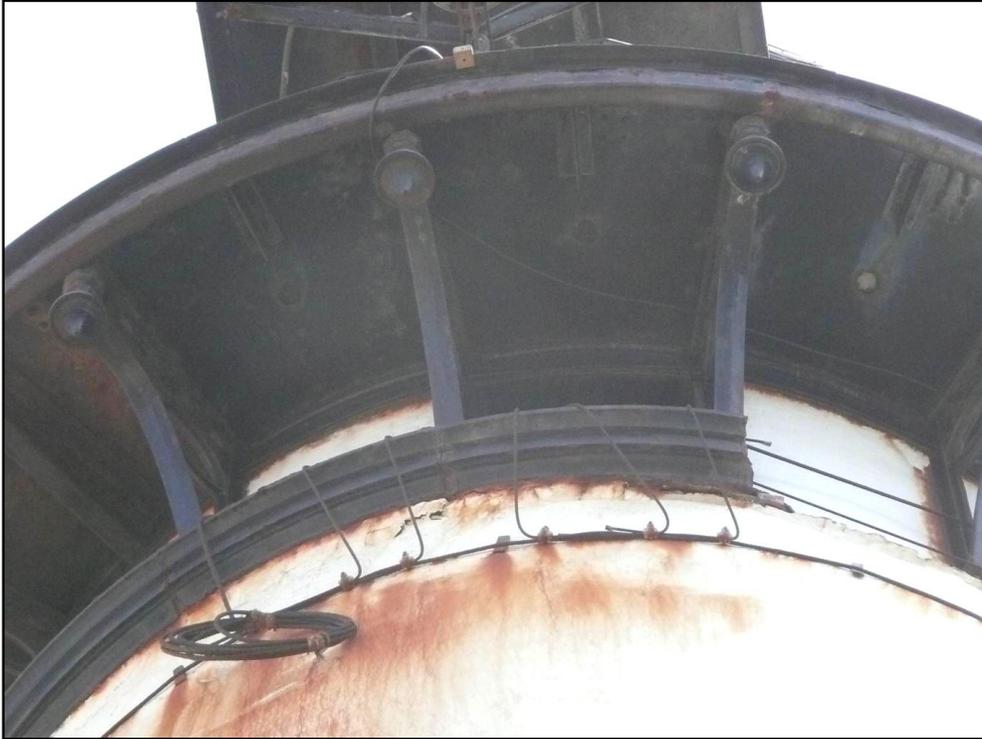
View from the ground of broken belt course and previous temporary cable supports.

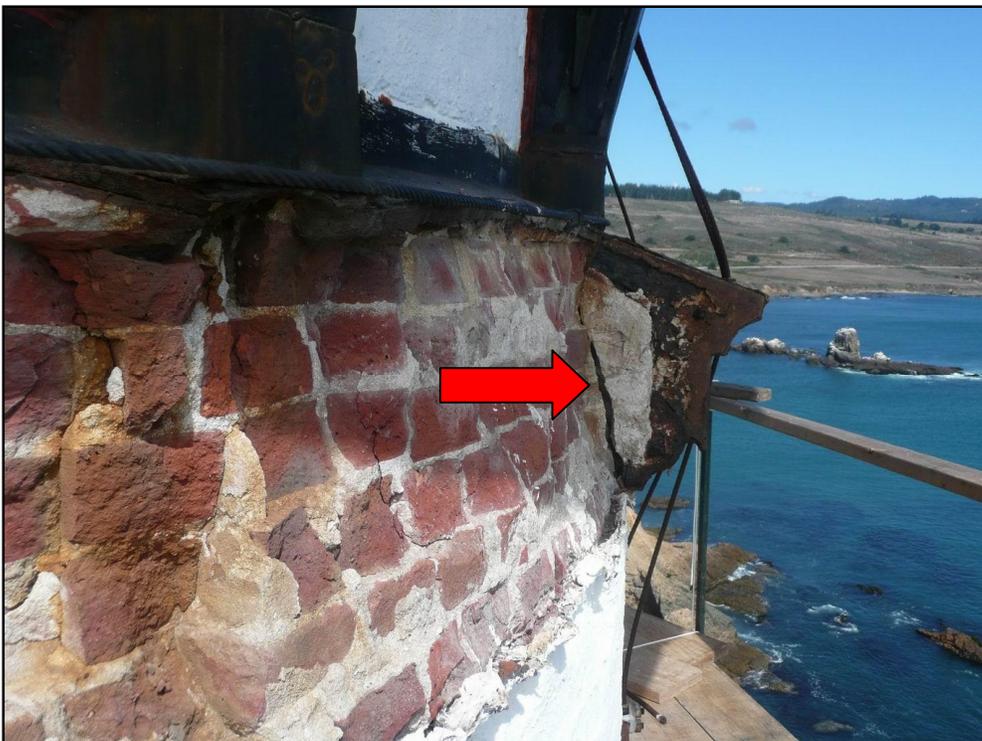
The belt course below bracket #10 is separating from the wall.

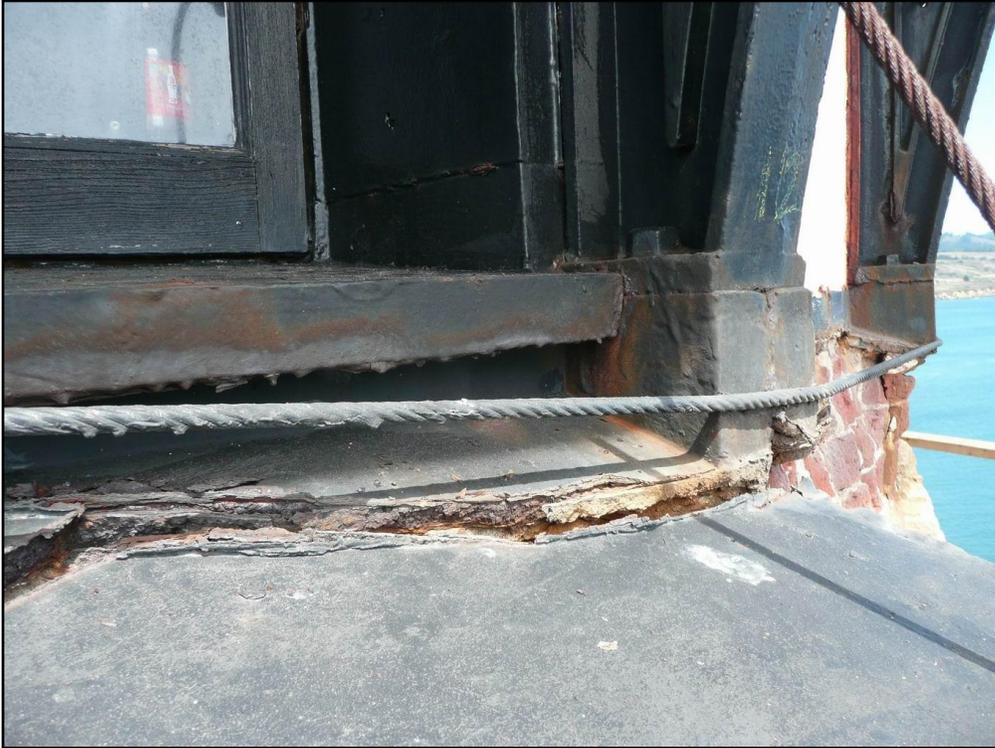
A wide crack in the belt course extends from bracket #12 (pictured) leftward to bracket #14.

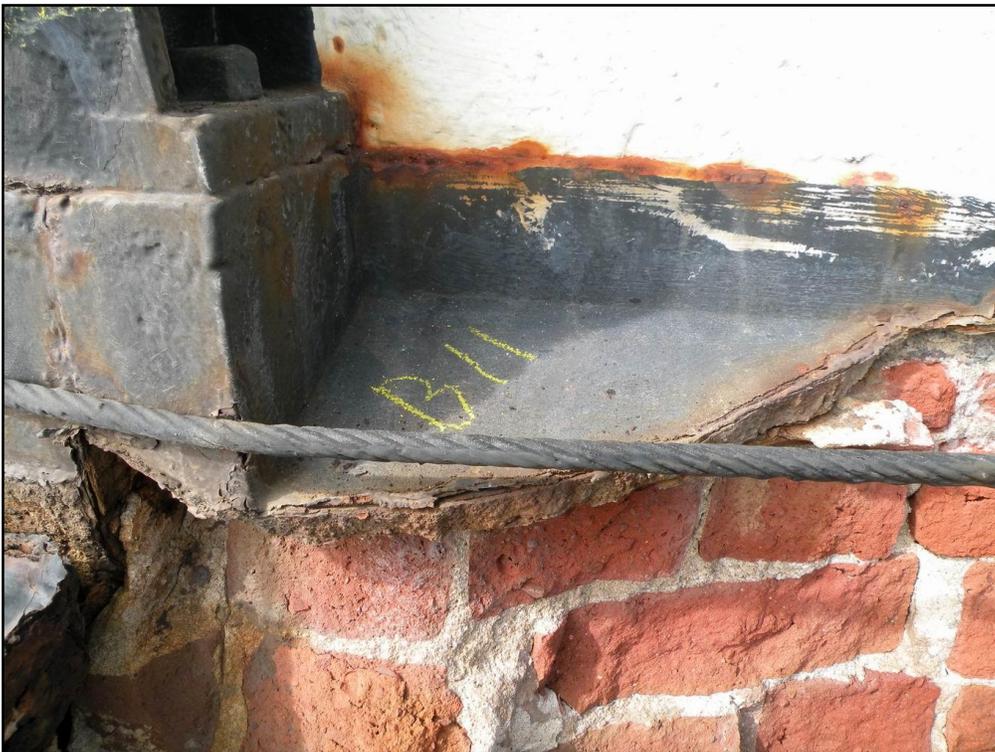
Belt course point of detachment at bracket #12 (mislabeled here as "B11").

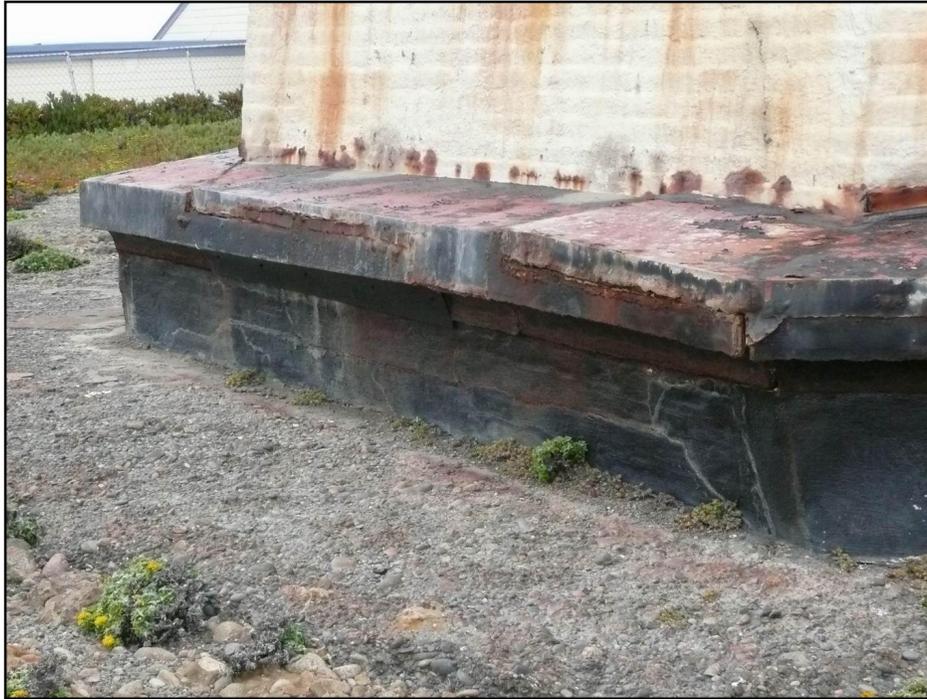
The plinth of the octagonal base is cracked and deformed below the peeling paint.

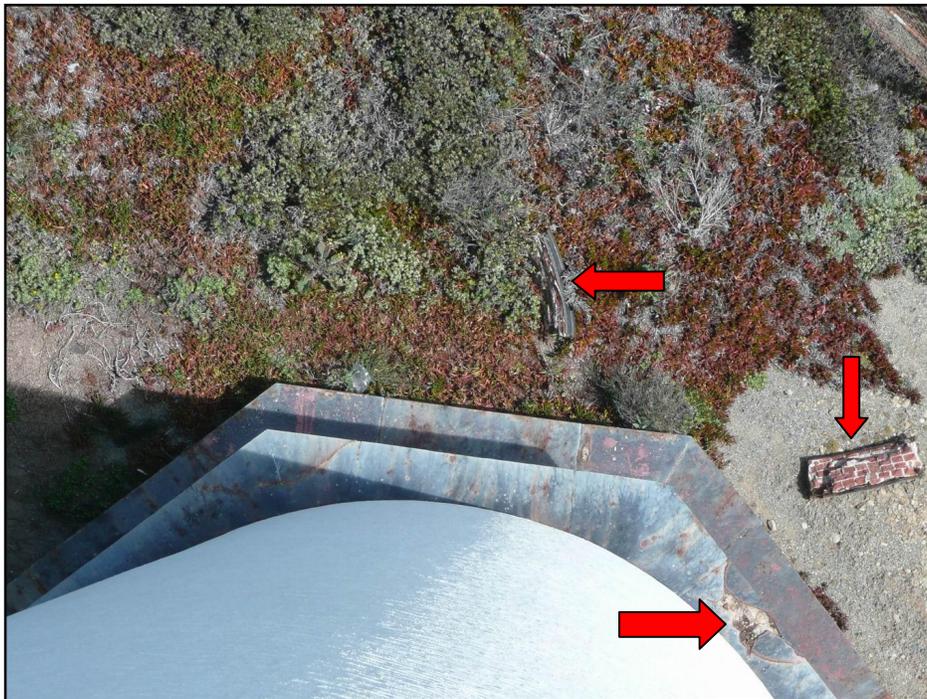
The octagonal base cornice is broken where it was struck by a belt course fragment. The detached belt course sections lie on the ground.

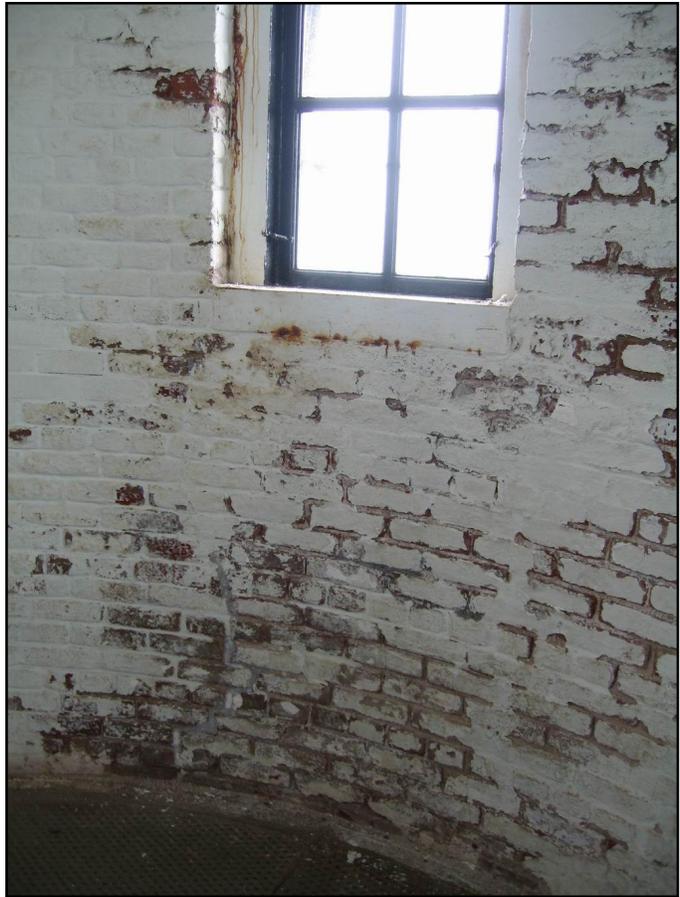
Water intrusion resulting from damaged and missing exterior cast iron features leads to salt crystallization in the masonry pores. The expansion of salt crystals disintegrates mortar and causes surface finishes to spall off the walls.

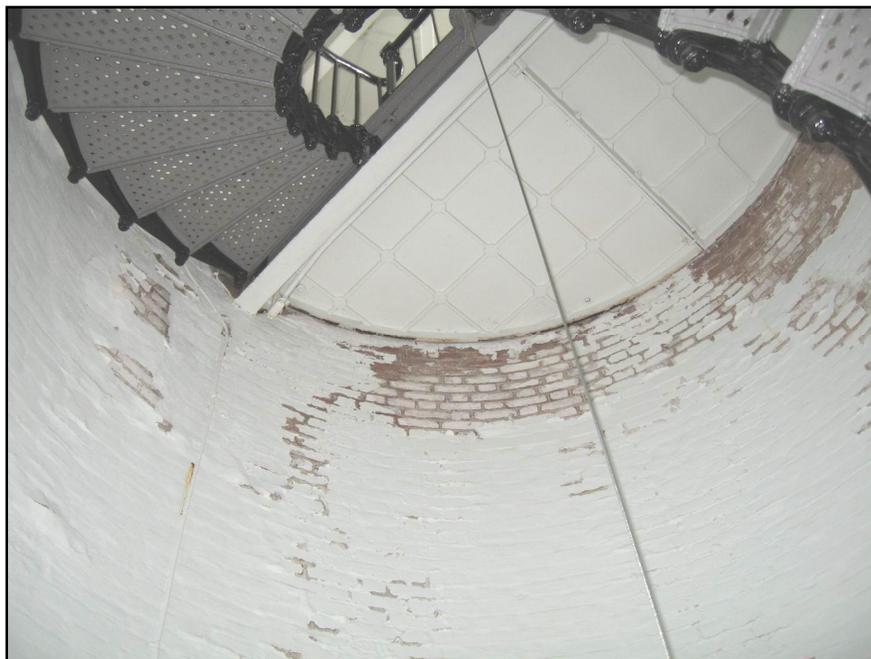
Moisture damage continues down the Lighthouse tower interior, resulting in blistering and peeling paint as well as powdering mortar.
