Exhibit 2: Photos

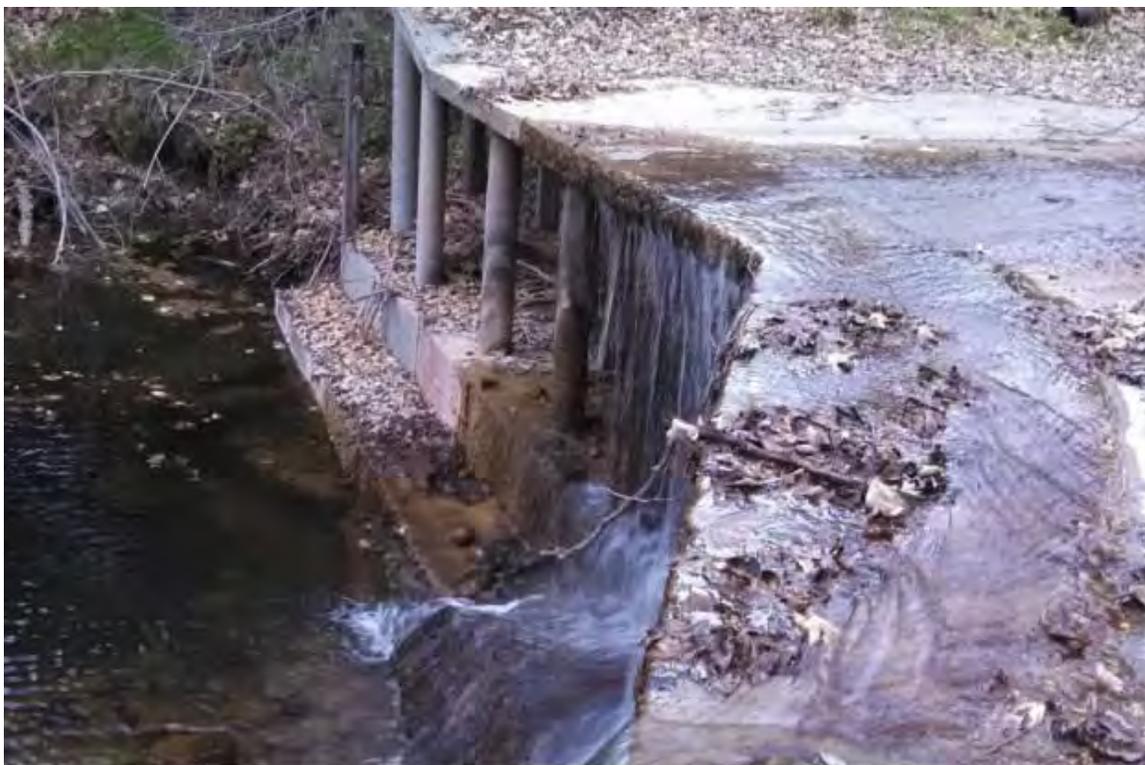
Lower barrier #1: obsolete diversion dam

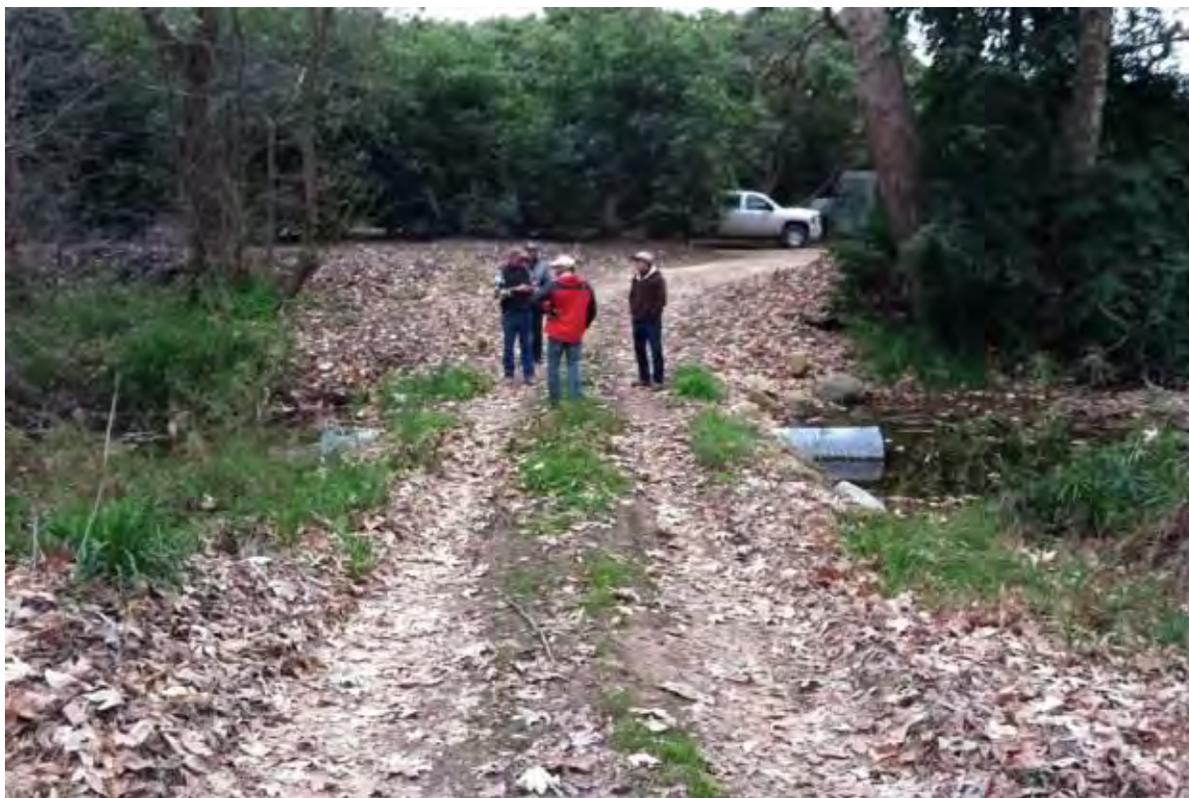
Middle impediment: low-flow road crossing to avocado grove

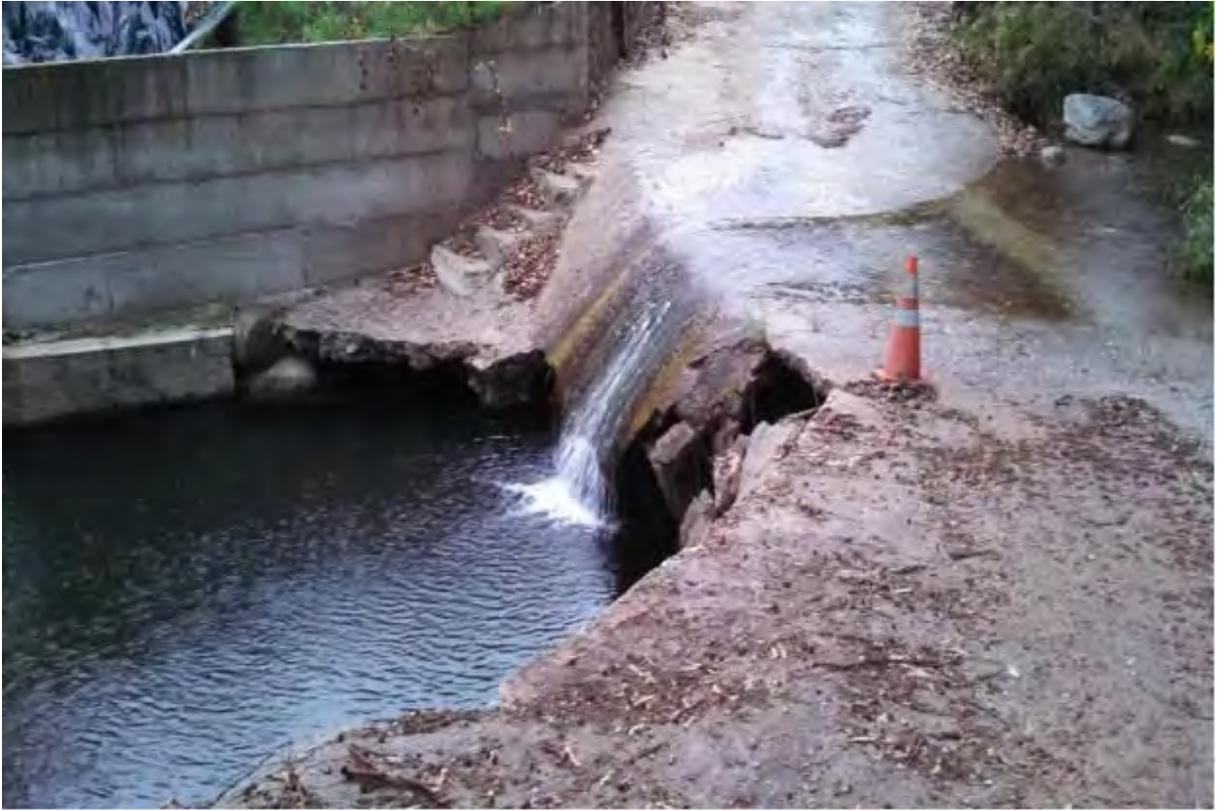
Upper barrier #2: main road crossing
