Exhibit 2: Project Photographs

Bloom Ranch, a

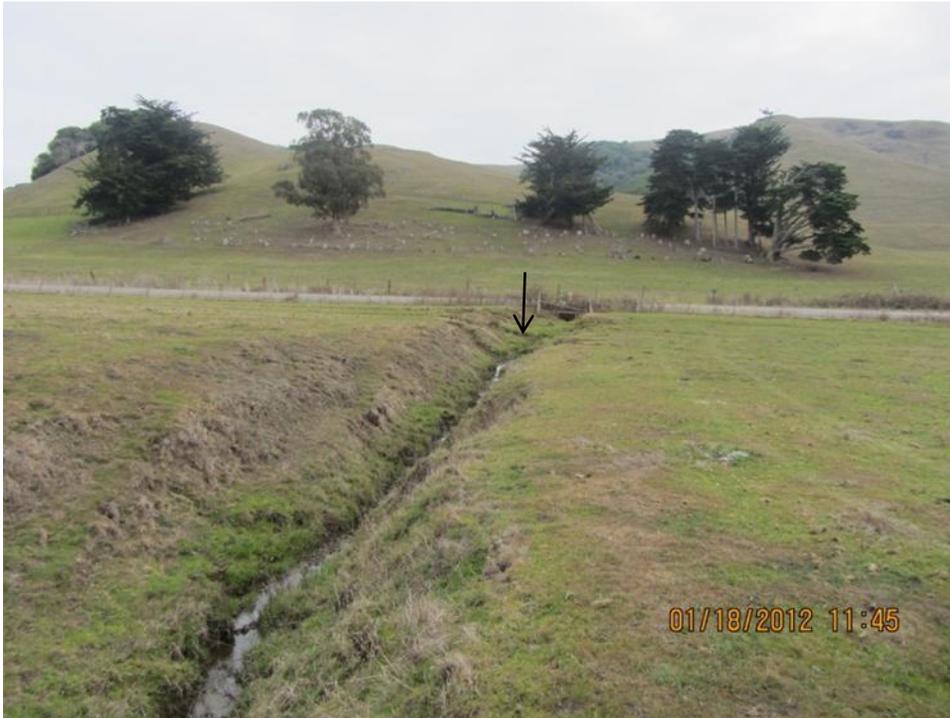
Bloom a, Photo displaying lower section of unnamed intermittent stream. In the proposal the plan includes restoring a cattle crossing (black arrow) and installing a livestock fence exclusion.

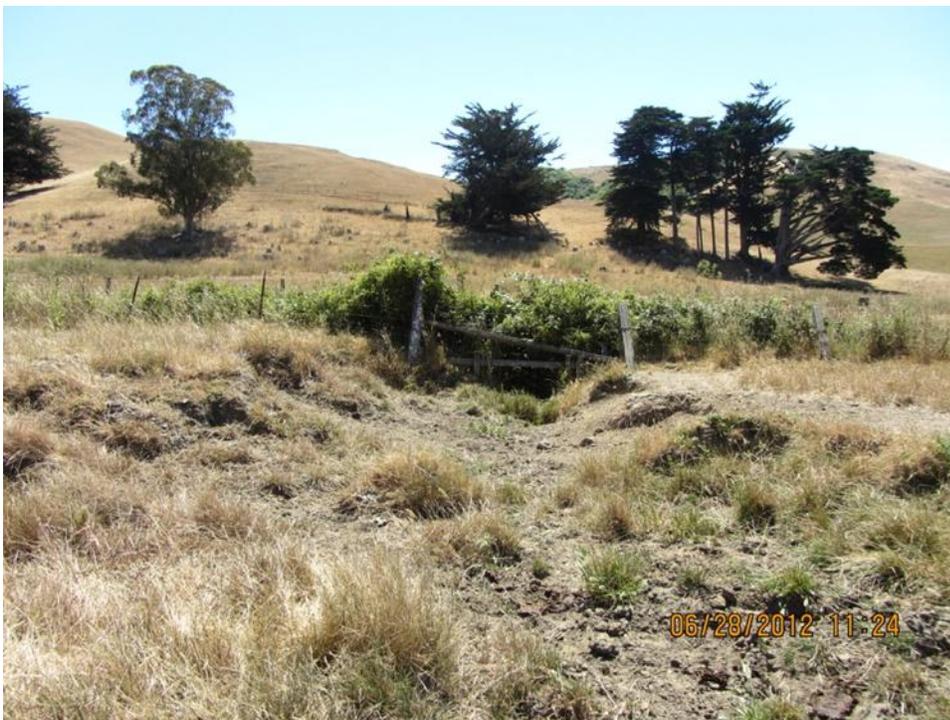
Bloom a, Close up of the planned lower livestock crossing to be repaired.

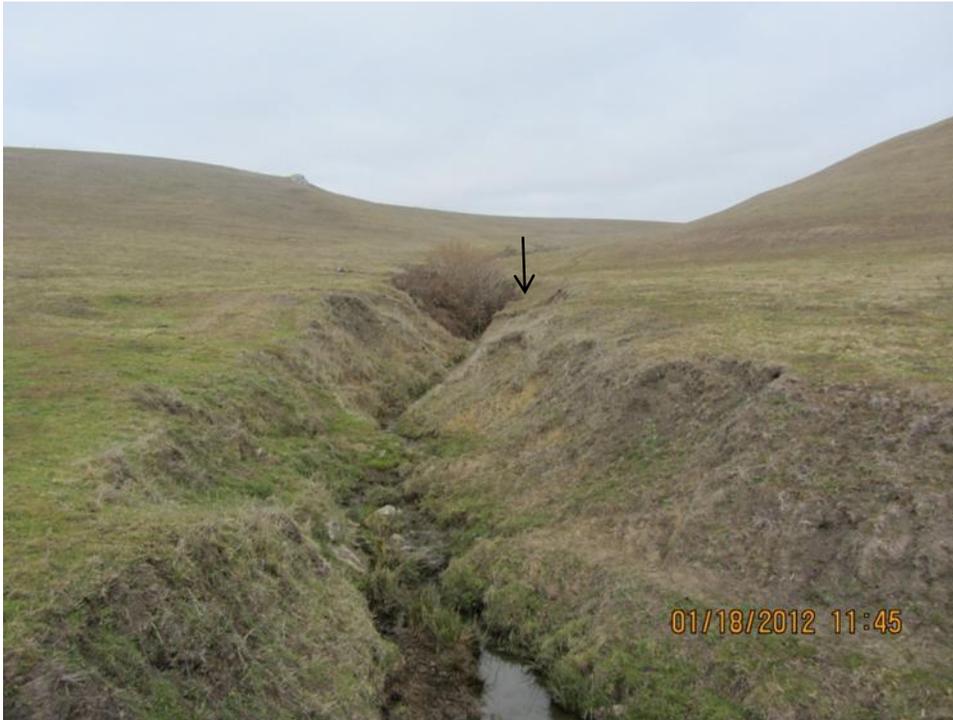
Bloom a, Upstream view of unnamed stream to be fenced for livestock exclusion. The black arrow identifies where streambank grade stabilization repairs will occur.

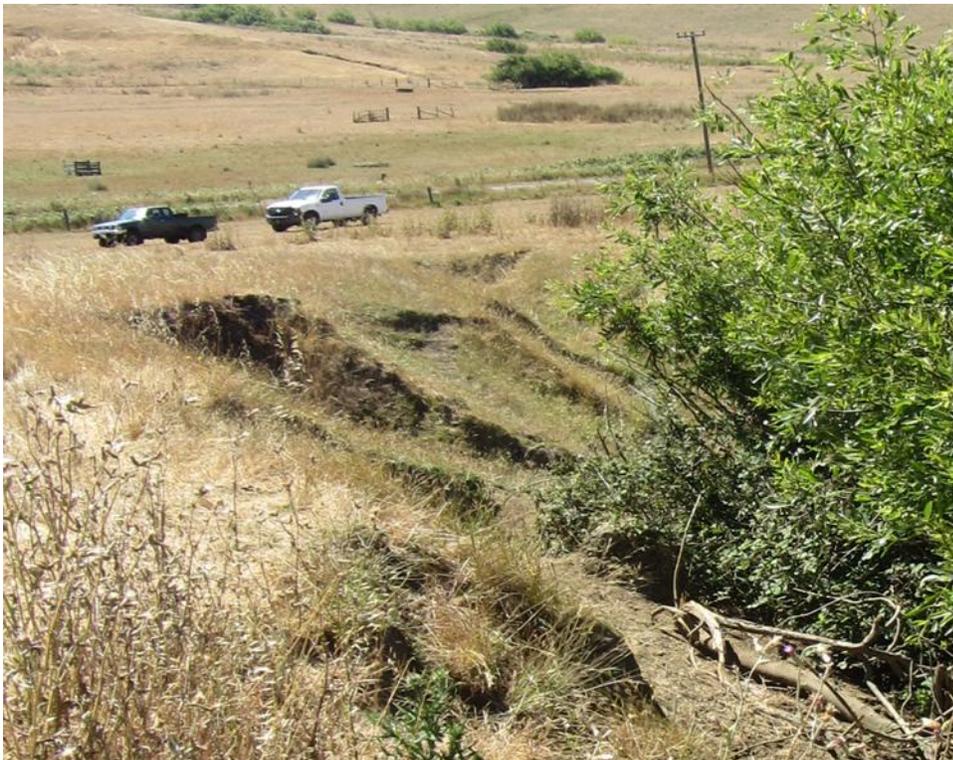
Bloom a, Close up of planned streambank grade stabilization.

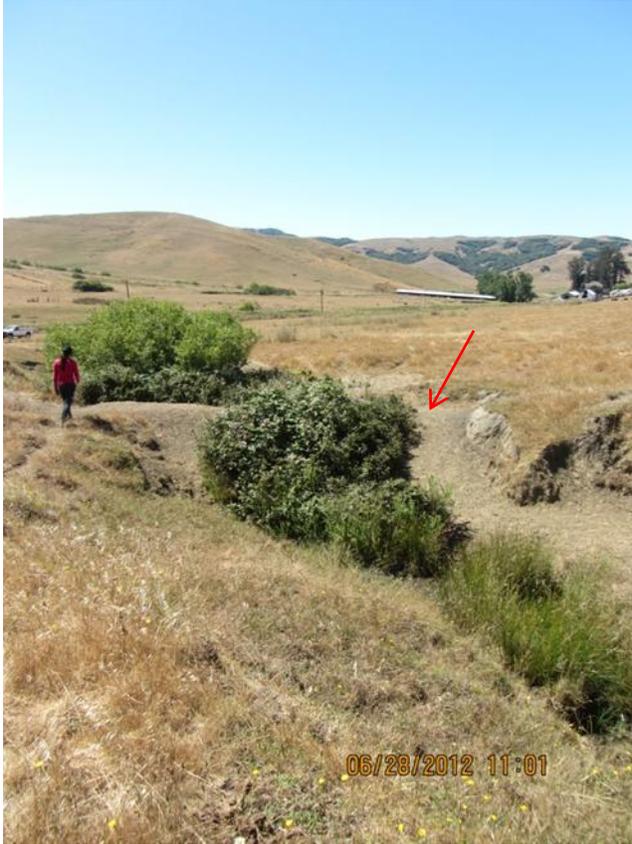
Bloom a, Planned Stream Crossing repair #2.

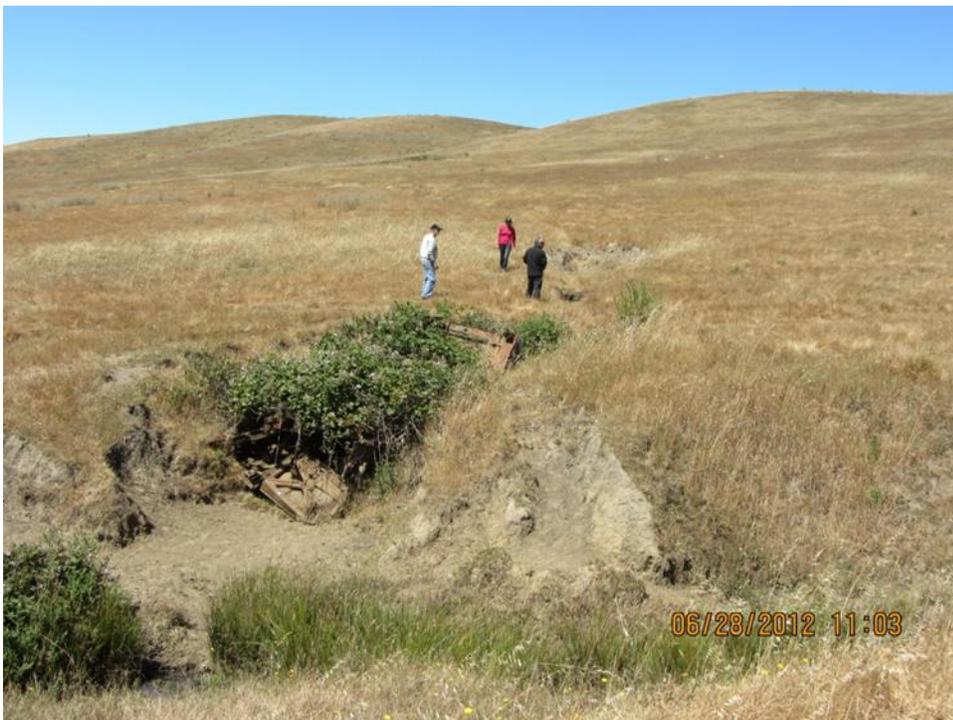
Bloom a, Photo of planned headcut repair.

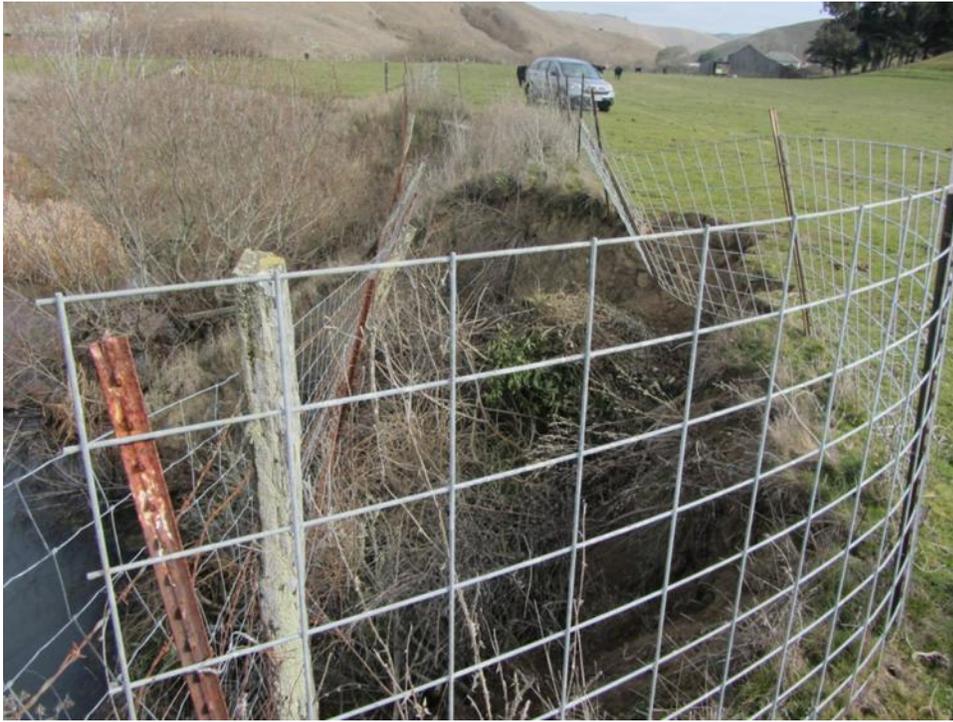
Bloom b, Streambank repair 1

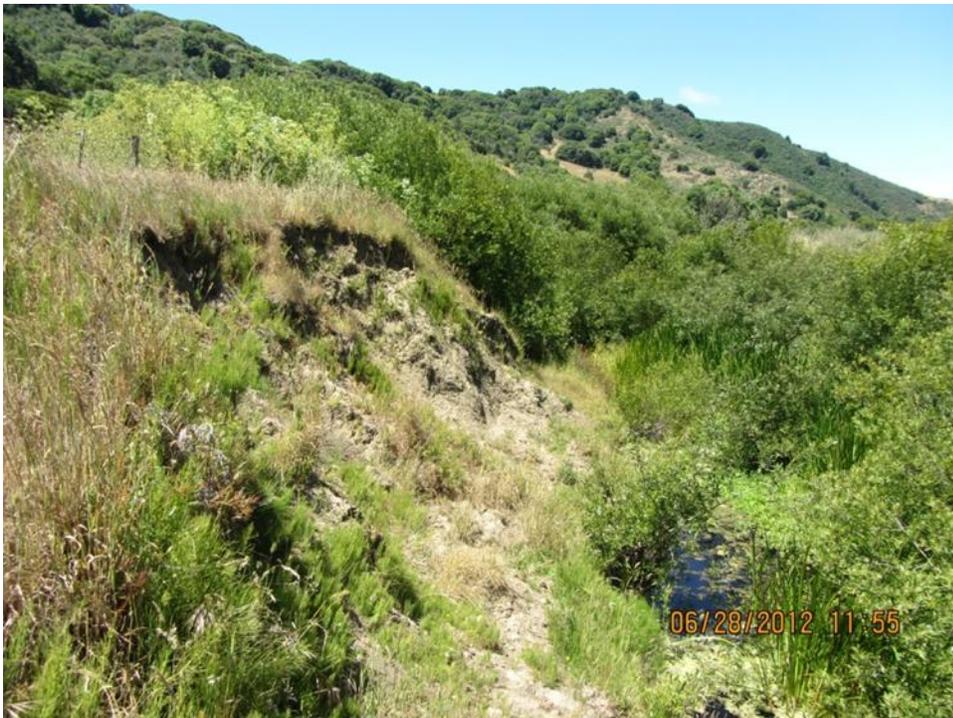
Bloom b, Streambank repair 2.

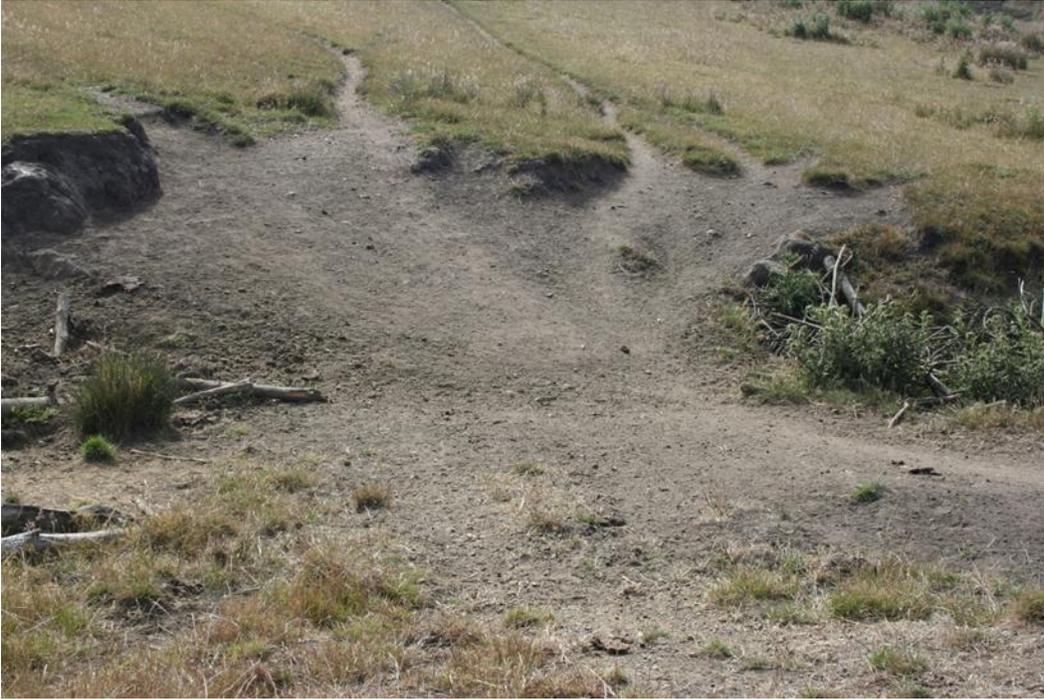
Degraded stream crossing; planning to be repaired with culvert and grade stabilization.

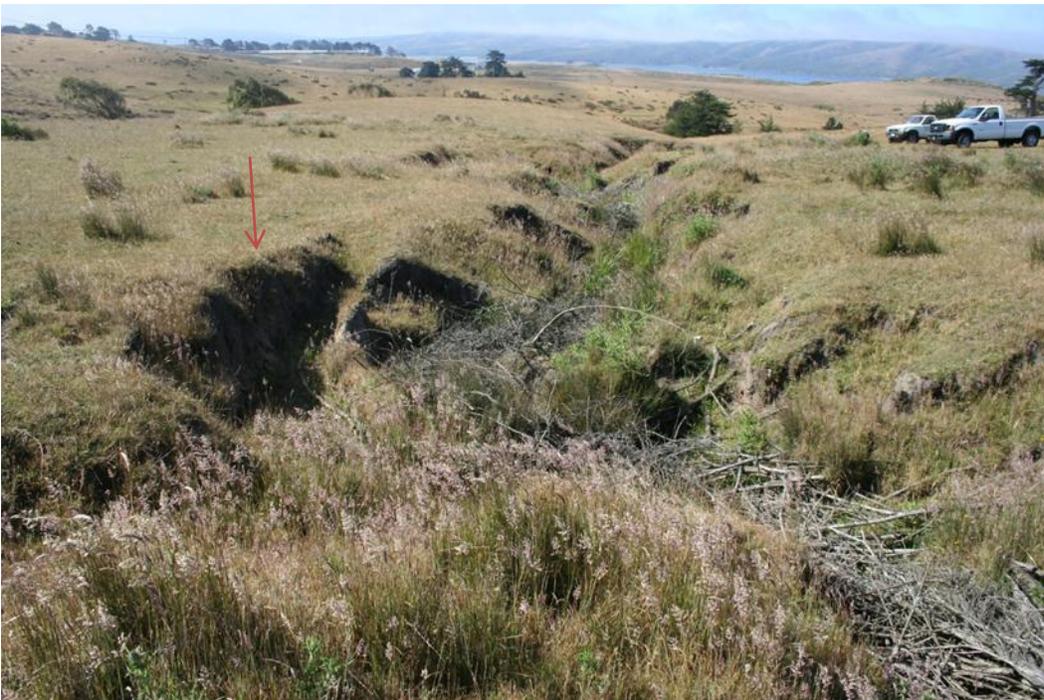
Looking downstream just below the stream crossing, photo capturing the planned streambank and portion of stream to be fenced for livestock exclusion.

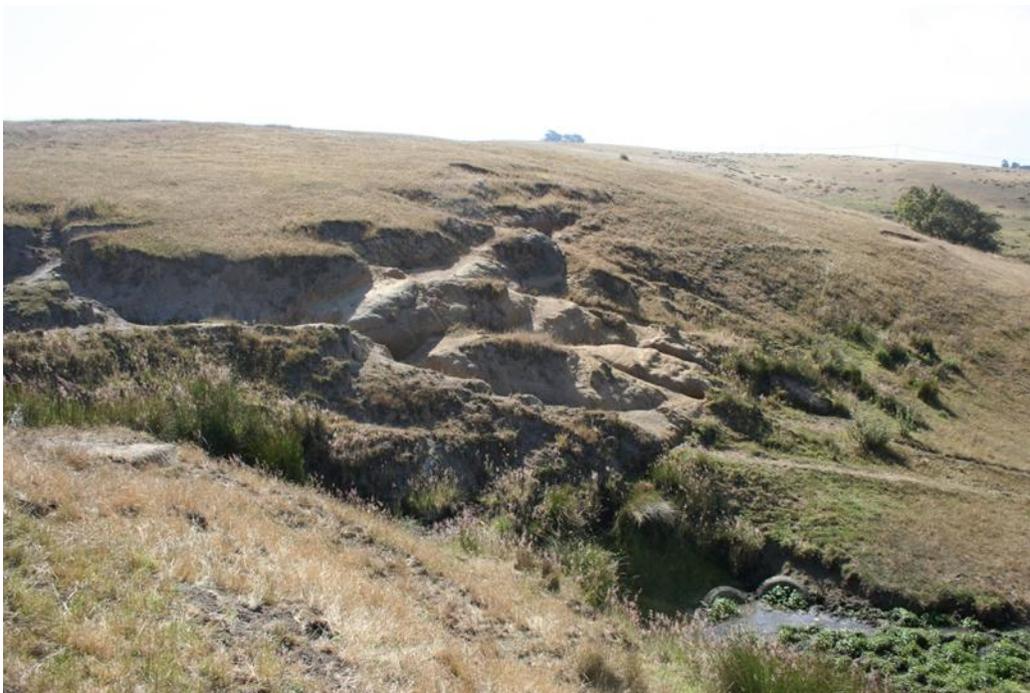
Sandstone outcrop to be fenced for livestock exclusion.

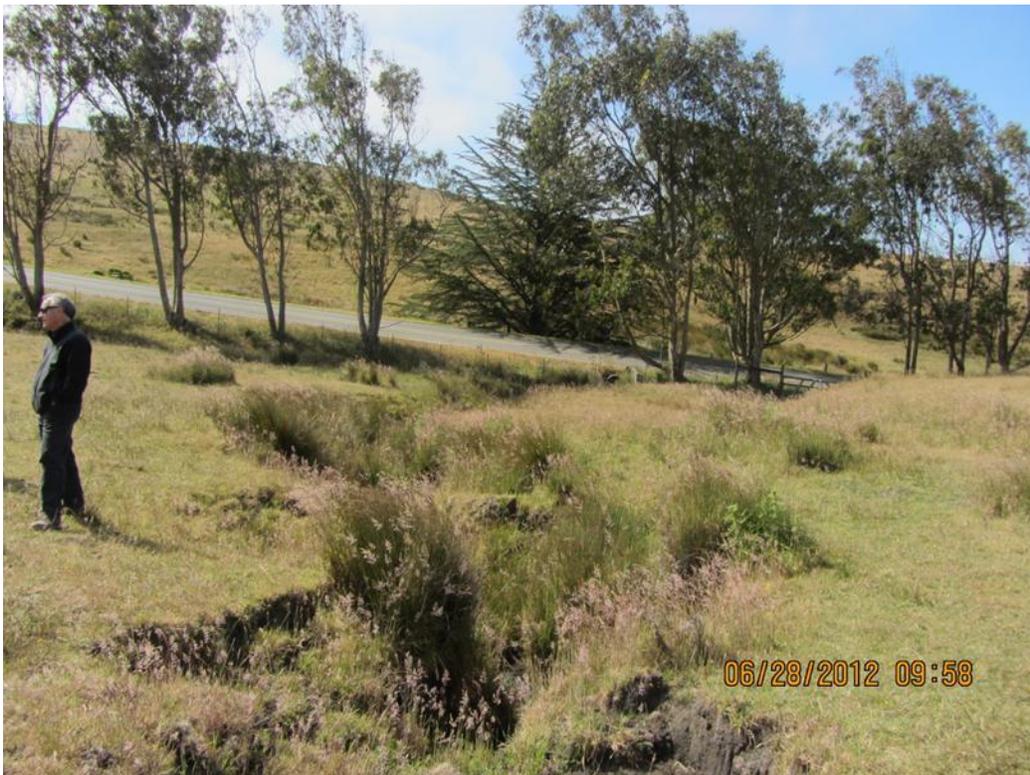
Lower section, downstream of unnamed stream, planned streambank repair and livestock exclusion.
