Exhibit 4: Project Photos

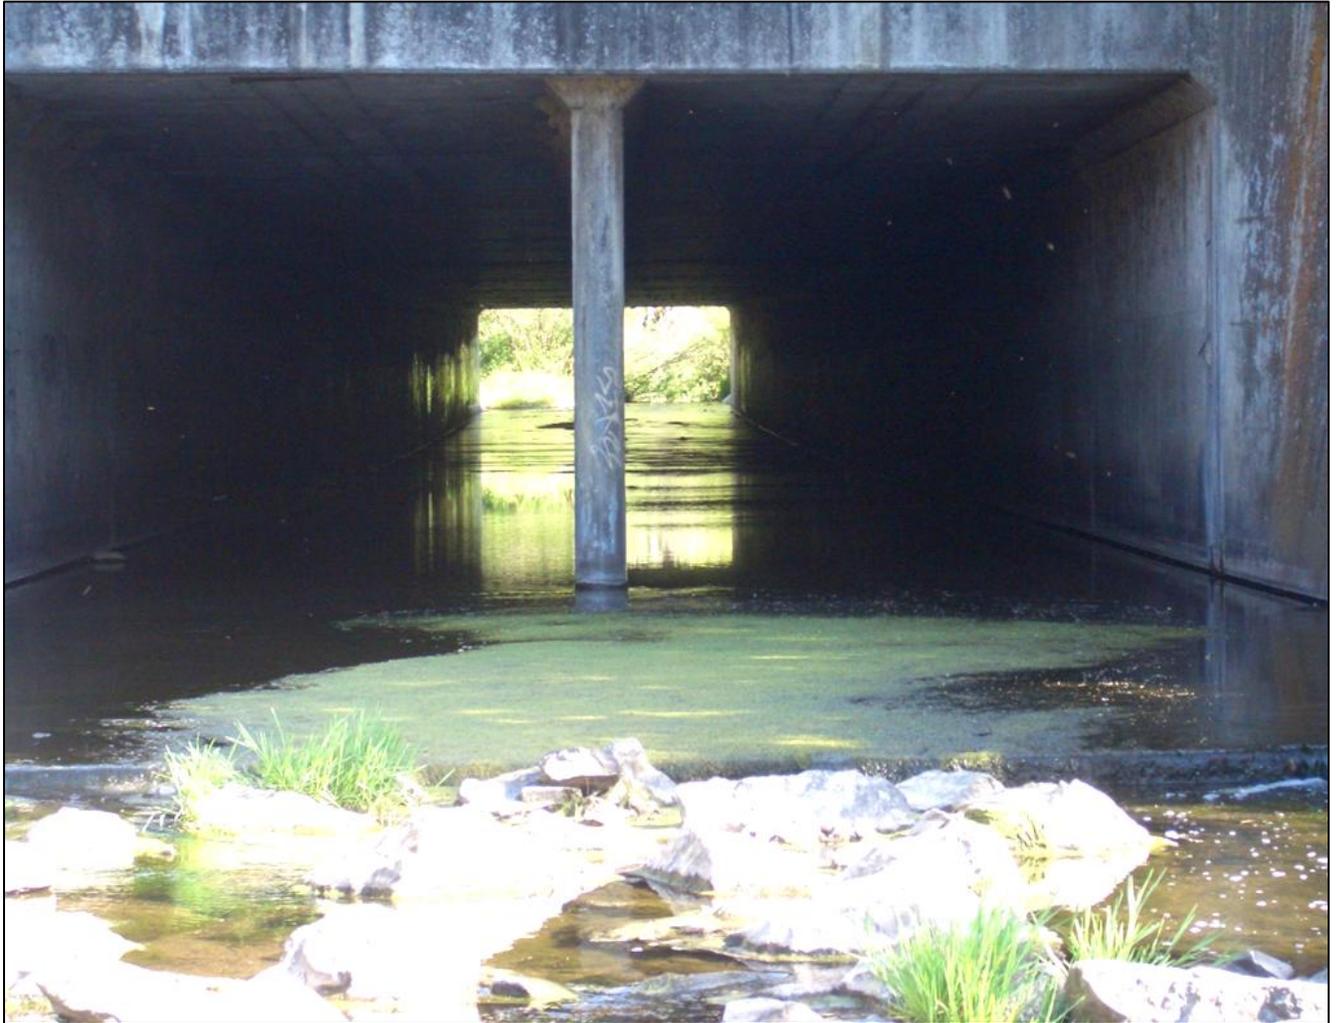
Looking upstream into the twin culverts which currently obstruct passage of anadromous fish.
