**Investigating suitability for eelgrass at Pier 94 (San Francisco) with test plantings**  
Final Report to Golden Gate Audubon Society  
December 2021

Margot Buchbinder, Melissa Patten and Katharyn Boyer  
Estuary & Ocean Science Center, San Francisco State University

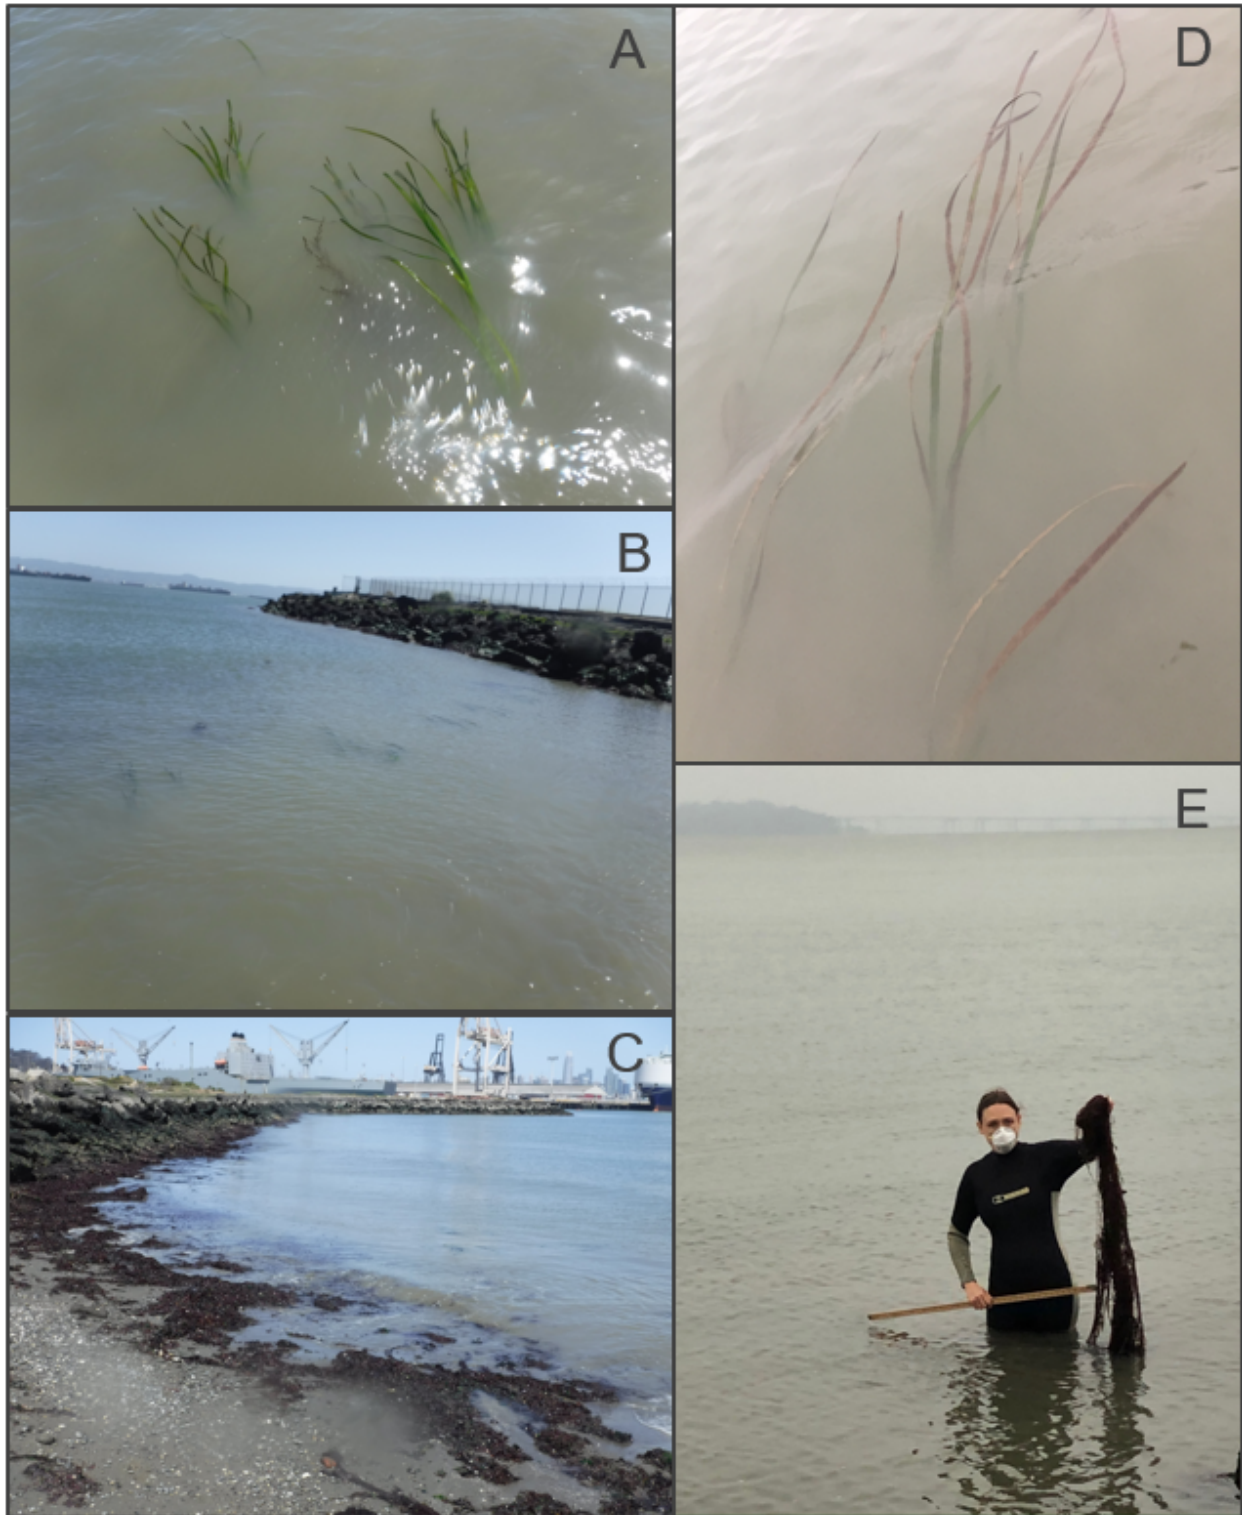
Figure 2. A) Planted plot containing 5 planting units with 2-3 shoots each; B) plots visible from the surface; C) algal wrack on the Pier 94 shoreline; D) plants in September 2020; E) M. Patten with *Gracilaria* algae removed from a plot in September 2020.

In September and November 2020, we monitored the plots for survivorship and possible expansion, finding them again using the GPS unit and by feeling for bamboo stakes. In September, we found shoots in seven of the 10 deep plots, and four of the six shallow plots, with greater survivorship at the southern end of the bands of plots at each depth, which we observed to be somewhat less rocky (see Appendix A). All plots with plants remaining showed significant losses, with a maximum of five shoots remaining of the approximately 12 planted shoots in each plot. The plants that remained looked generally healthy (Fig. 2) with a typical coverage of algal epiphytes on older blades and no signs of amphipod herbivory (which can damage leaves; Lewis and Boyer 2014). They were similar in height to plants we monitor in other beds (e.g., Carr et al. 2011), but were sometimes broken at the tips, which can be a sign of bird herbivory or of physical wear. This level of survivorship from initial plantings made us cautiously optimistic that we would observe spread at the site over time. However, when we returned in November 2020, we found no remaining plants in the shallow plots, and we only found plants in four of the 10 deep plots, for a total of ten shoots remaining at the site. While we searched for plants we found large pieces of thick plastic sheeting (that perhaps once wrapped wharf pilings) over the plots; this sheeting or other debris may have contributed to the loss of plants in the area. When we returned for the final monitoring in April 2021, we found no remaining plants in any of the test plots (Fig. 3).

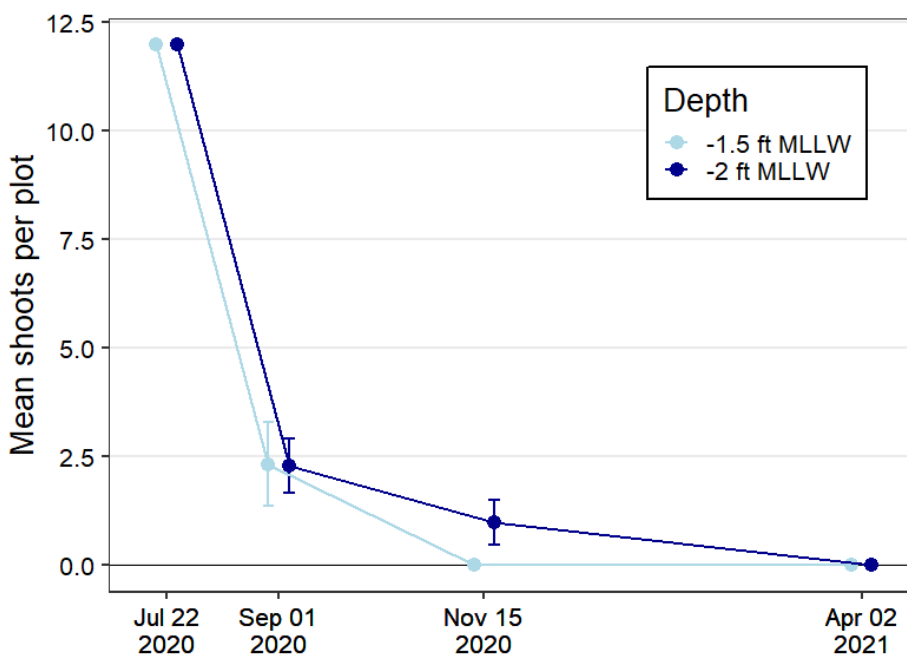
Figure 3. Mean shoot counts for the shallow (-1.5 ft MLLW) and deep (-2 ft MLLW) plots at Pier 94 in Year 1. Error bars indicate  $\pm 1$  standard error.

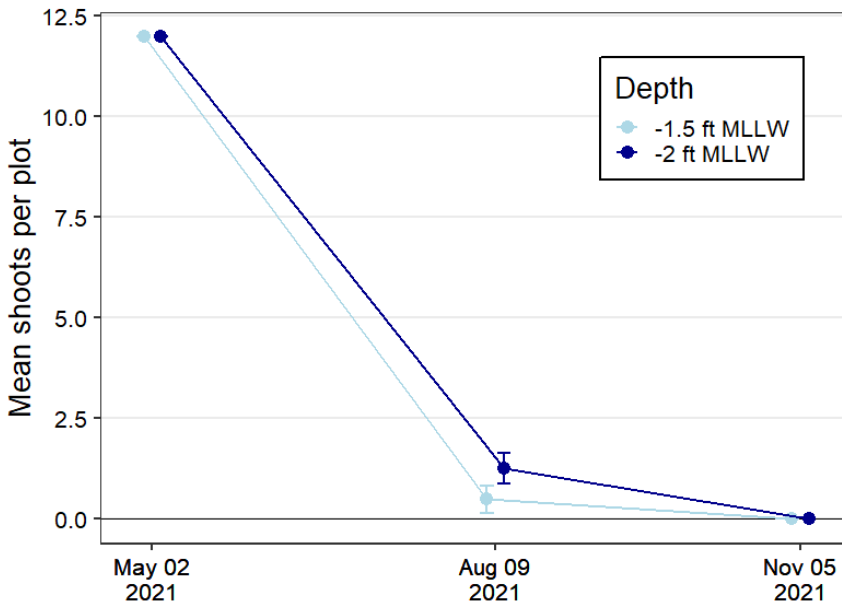
The plots were monitored in August and November of 2021. In August 2021, we found plants in only five of the 11 deep plots, and in two of the six shallow plots. The shoots appeared generally healthy, but some of the shoots seemed delicate and broke apart easily in our hands, suggesting some loss of structural integrity. We did not observe debris on the scale that had been seen in 2020, but we observed high wave action at the site and it is possible that debris that had since washed away could have impacted the plants; we noticed some signs of abrasive mechanical damage to the shoots at the time. We also observed some exposed rhizomes, which could be a sign of erosion on the beach that could have caused plants to wash away. When we completed our final monitoring in November 2021, no plants remained in any of the plots (Fig. 4).

Figure 4. Mean shoot counts for the shallow (-1.5 ft MLLW) and deep (-2 ft MLLW) plots at Pier 94 in Year 2. Error bars indicate  $\pm 1$  standard error.
