MOUNTAINS RECREATION AND CONSERVATION AUTHORITY

Existing Conditions and Opportunities **Lechuza Beach Public Access Improvement Plan**

March 2007

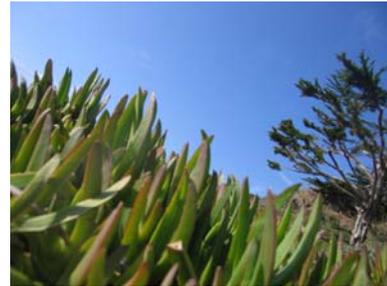
The general area is subject to wildfires, which are an inherent threat in the native chaparral plant community. However, much of the native coastal bluff plant community has been replaced by ornamental plantings. Invasive non-native plants that threaten wildlands in California were observed on both private and public areas on and in the vicinity of Lechuza Beach. For example, iceplant (*Carpobrotus spp.*) was observed at the stairway near the end of East Sea Level Drive.

ICEPLANT AT
EAST SEA LEVEL DRIVE

- Where invasive non-native plant removal and/or habitat restoration are required or appropriate, it is recommended that the planting palette be developed with the guidance of environmental specialists on the Design Team.

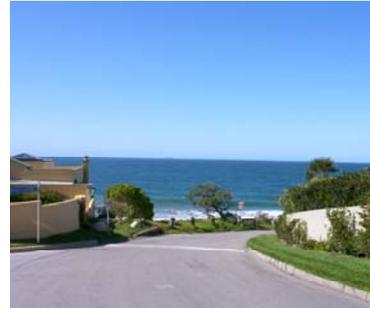
As noted above, neither reach of Sea Level Drive has sidewalks or designated pedestrian routes. Speed bumps in the roadway, combined with generally steep roadbed slopes and cross slopes, contribute to creating routes that are inaccessible and even unsafe for some people with disabilities.

EAST SEA LEVEL DRIVE

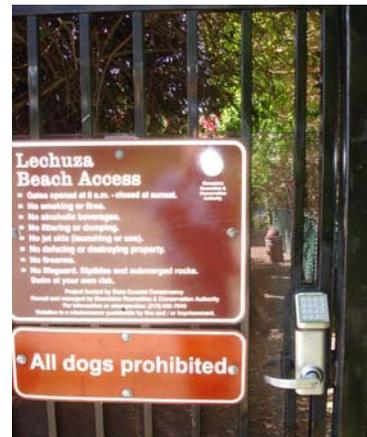
EXISTING GATE AT LOT I

- In order to provide improved access to Lechuza Beach from the intersection of Broad Beach Road and East Sea Level Drive, accessibility improvements to the pedestrian gate are recommended (see the following subsection on *Park Entries*). By removing all architectural barriers to access at this location and providing detailed information about the accessibility and safety of the pedestrian route from the gate to the beach, MRCA will better meet the needs of many park users who are currently unable to approach or operate the pedestrian gate. It should be noted that the California Coastal Commission (CCC) has determined that both the pedestrian and vehicular gates in this location are unpermitted.

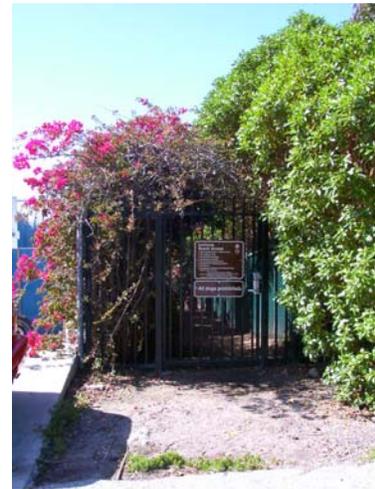
The entry gate is not accessible. The required 60 inches of level space on the push side of the gate is not provided and adequate maneuvering space is not available at either side of the gate. Nearby plantings do not allow the gate to be opened fully and some low-hanging, thorny branches also reduce the vertical clearance to less than the required minimum of 80 inches. A smooth, uninterrupted bottom rail or kick plate that is 10 inches minimum in height is not provided at the push side of the gate. Directional signs to indicate the location of an accessible gate within the project area are not present at this location.

EXISTING GATE AT LOT I
BROAD BEACH ROAD/BUNNIE LANE

- It is recommended that the entry gate be modified or replaced with a gate that meets the accessibility guidelines described in this report.
- There is some latitude in repositioning the gate since the width of the corridor can be increased by five feet in this area as a result of the public access easement to the west. It is recommended, however, that the gate remain near Broad Beach Road rather than further south along the pathway. There are no significant beach

- Plantings in the vicinity of the gate should be maintained so that they do not block the gateway or reduce the vertical clearance to less than 80 inches.
- Obstacles and/or hazards in the access route from parking spaces on Broad Beach Road to the gate should be removed.
- It is recommended that secure bicycle parking be provided at this location.
- Improved opportunities for public parking are described in the following section on ***Parking and Transportation***.

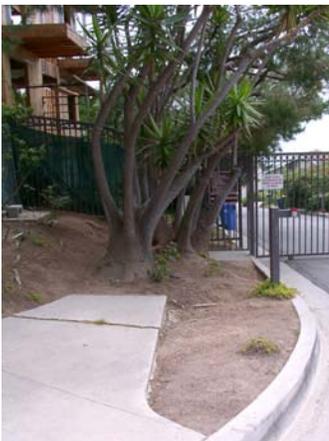
The entry gate is not accessible. Trees obstruct the access route from parking along the north side of Broad Beach Road to the gate. The required 60 inches of level space in front of the gate is not provided and adequate maneuvering space is not available at either side of the gate. There is no curb cut on either side of the gate. The gate requires more than 5 lbs of pressure to open. A smooth, uninterrupted bottom rail or kick plate that is 10 inches minimum in height is not provided at the push side of the gate. Directional signs to indicate the location of an accessible gate within the project area are not present at this location.

APPROACH TO ENTRY GATE AT
EAST SEA LEVEL DRIVE

- Even though it is unlikely that the pedestrian routes from available public parking on Broad Beach Road to the gate and from the gate to the end of East Sea Level Drive can be improved so that they are fully accessible, it is recommended that the entry gate be modified or replaced with a gate that meets the accessibility design guidelines described in this report.

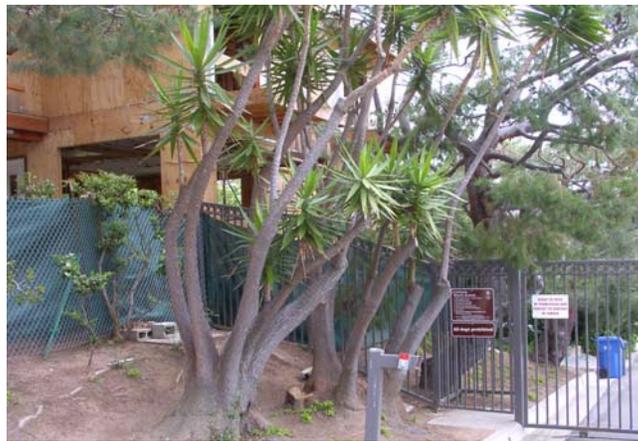
ENTRY GATE AT
EAST SEA LEVEL DRIVE

- Relocating the pedestrian gate into the roadway would appear to require modifications to the existing vehicular gate as well. If it is not possible to remove the obstacles in the access route on either side of the pedestrian gate, it may be necessary to replace the entire gate structure.

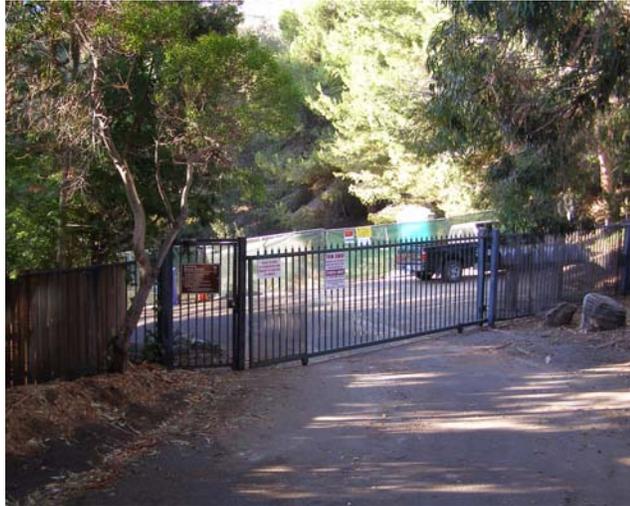
GATED ENTRY AT WEST SEA LEVEL DRIVE

- Although there is no buffer or setback between the roadway and the residence at the intersection of West Sea Level Drive and Broad Beach Road, it is recommended that, if possible, an accessible pedestrian entry remain in this location to provide access for visitors and residents to West Sea Level Drive.

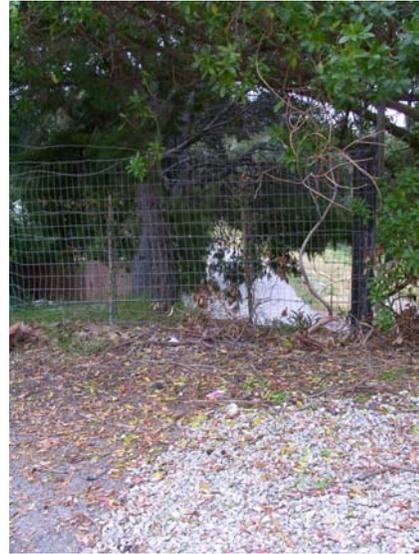
VIEW FROM PACIFIC COAST HWY

- It is recommended that the feasibility of constructing an accessible pedestrian route (such as a ramp or series of ramps) directly from Pacific Coast Highway to West Sea Level Drive be investigated. A stairway, however, may be the more feasible option due to the width of the easement and the steepness of the slope in this location.
- It is recommended that secure bicycle parking be provided at this location.

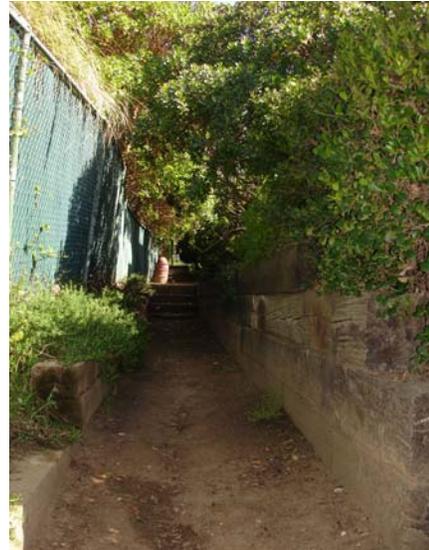
A short wooden stairway with four (4) risers occurs just a few feet from the entry gate. There are no handrails at this set of stairs. The path between this set of stairs and the next has a slope that varies between 7 and 9 percent. The existing path is very narrow in this location (10 feet) with no setback from adjoining properties (with a chain link fence on the west side and a low timber retaining wall on the east side). Planting reduces the vertical clearance to less than the required minimum of 80 inches along portions of the pathway.

UPPER PATH AND STAIRS NEAR THE ENTRY GATE

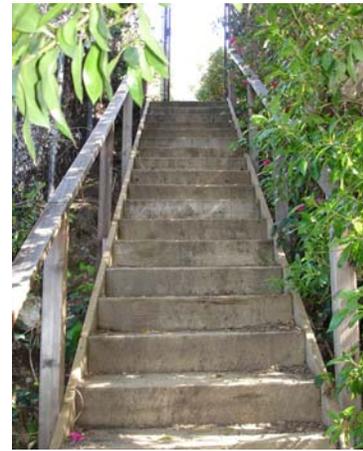
The timber risers on the bottom set of stairs are not uniform (varying between 5 and 7 inches high). Stair nosings do not have a two-inch strip of contrasting color. The stairs are steep and worn. There is a handrail on the east side of the stairs, which meets the requirements for height and width, but handrails are not present on both sides of all stair runs as required by code. The lower set of stairs and a discontinuous security fence are located about 5 feet from the western property line of Lot 84. The residence on this lot is located close to its western property line, at the approximate elevation of East Sea Level Drive. The stairs are closest to Lot 83, although the residence on this lot is located upslope in the vicinity of Broad Beach Road and more than 100 feet from the Lot I corridor.

UPPER SECTION:
THIRD SET OF STAIRS

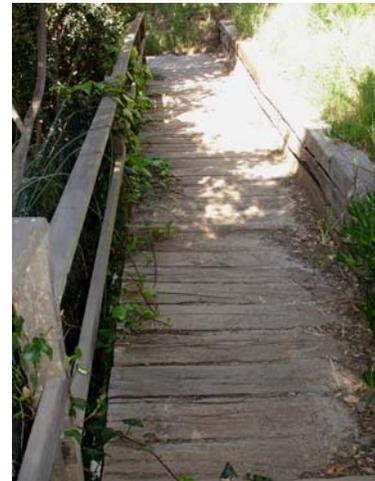
MIDSECTION BOARDWALK

- The slope above the midsection boardwalk should be stabilized before replacing or repairing the boardwalk. It is recommended that seating opportunities be investigated in this location (a widened seating surface at the retaining wall or an alcove with a bench).

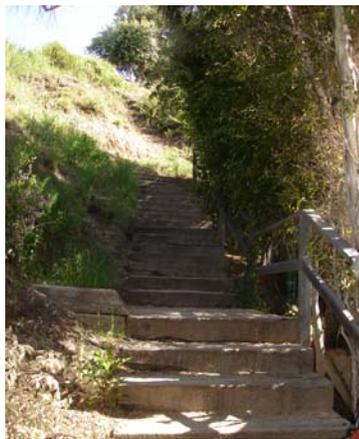
HANDRAILS ARE REQUIRED
ON BOTH SIDES OF STAIRWAY

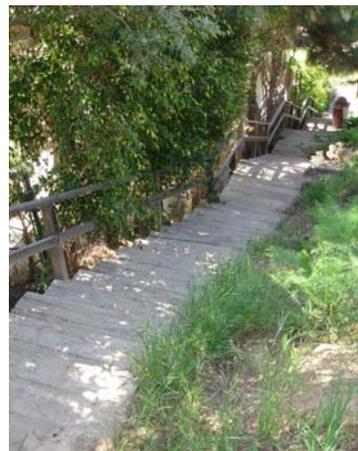
STAIRWAY IN LOWER SECTION

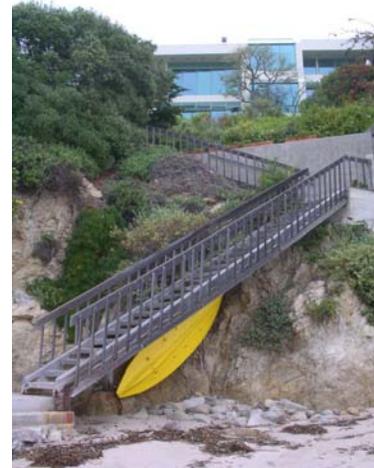
STAIRS FROM OVERLOOK
TO LECHUZA BEACH

- It is recommended that the stairs at the end of West Sea Level Drive be replaced with stairs that meet current safety and accessibility codes.
- Further study is recommended to determine if there are opportunities for relocating the stairs (within the general vicinity of their current location) in order to provide a landing that is less likely to be damaged by high tides during storms.

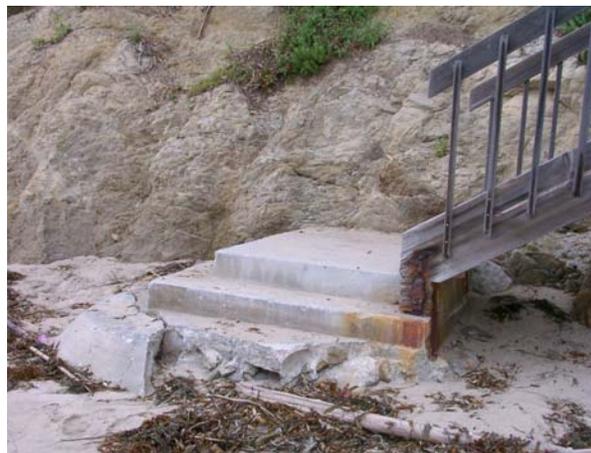
DAMAGED LANDING
AT BASE OF STAIRS

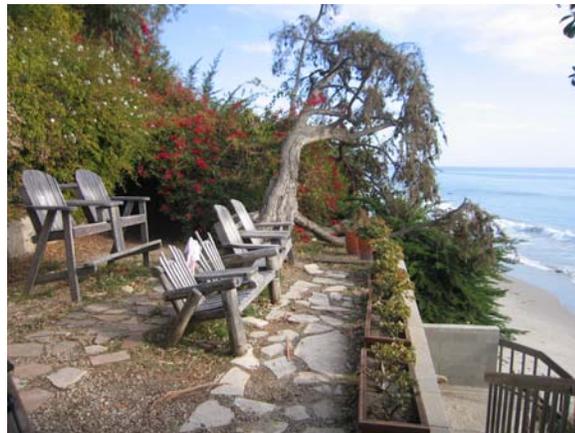
An accessible route is potentially available from the end of West Sea Level Drive to the overlook. The overlook itself is relatively level and approximately 28 feet long by 13 feet wide. One length of the overlook is contained by a fence/wall. However, there are no guardrails at the drop-off above the stairs on the south side of the overlook or at the steep drop-off at the east end of the overlook, which is obscured by dense planting. Some of the wooden site furnishings (chairs and tables) have been damaged by vandalism.

OVERLOOK AT
WEST SEA LEVEL DRIVE

- Furnishings should reflect the site's natural setting, blending in with and complementing the wild beach landscape.
- It is recommended that any invasive exotics planted in this area be removed and replaced with California native plants suitable for coastal habitats.

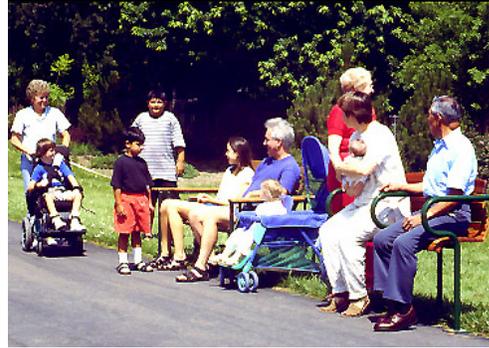
A VARIETY OF SEATING CHOICES
ACCESSIBLE BENCHES & THE REST SEAT

- In addition to providing accessible benches with backs, armrests and companion seating areas as described in the guidelines and technical requirements for accessibility, a range of seating opportunities should be provided (similar to the current seating which varies in height) to allow for a flexible, functional and enjoyable experience by all users, young and old, with and without disabilities, and a clear line of sight to important elements for any seated or standing user. An example is the Rest Seat (designed by Brian F. Donnelly, Donnelly Design, of Davis, California), which has a higher seating surface that is pitched forward more than conventional bench seating. This results in a minimum of fatigue, and the additional clearance beneath the seat also allows the user to push up to a standing position more easily.

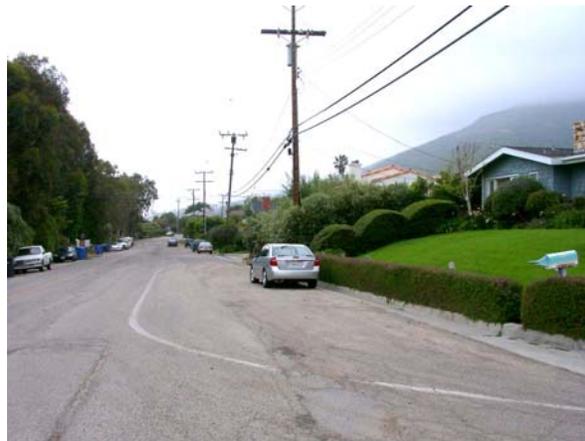
BROAD BEACH ROAD
(VIEW TO THE WEST)

- Grades along Broad Beach Road between East and West Sea Level Drive are relatively level, although roadway crowning produces cross slopes that exceed 2 percent.
- There are limited opportunities for providing a fully accessible route (particularly for people with mobility disabilities) from existing parking opportunities to any of the park entrances at Broad Beach Road.

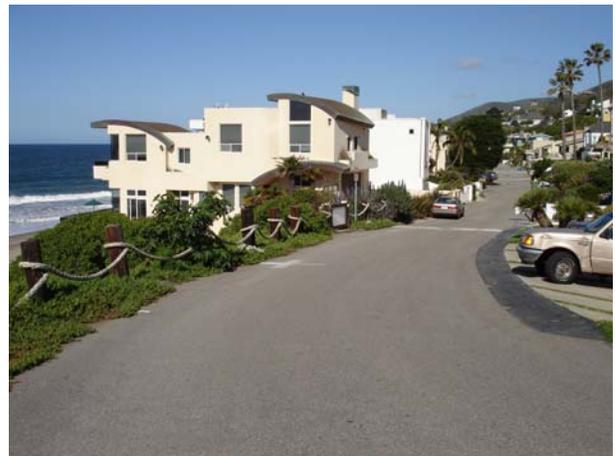
EAST SEA LEVEL DRIVE
AT LECHUZA BEACH

- Currently the potential exists for establishing accessible on-street parking spaces along both reaches of Sea Level Drive.
- Grades at East Sea Level Drive vary. The roadway slope exceeds 5 percent from the intersection with Broad Beach Road south until the road turns west. The roadway slope becomes fairly level as it parallels the beach.

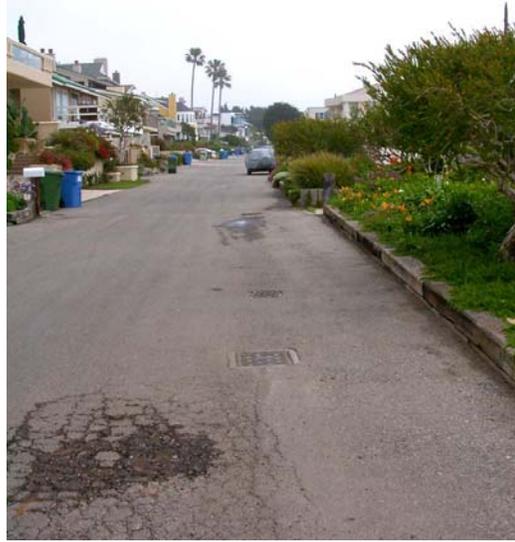
EXISTING PARKING ON EAST SEA LEVEL DRIVE

- Another recommendation for further study is the establishment of a passenger loading zone (potentially in the location of the current fire turnaround at the end of East Sea Level Drive), which would provide the opportunity for increased access for persons with disabilities who are traveling with others in private or public vehicles. For those using private vehicles, the use of a reservation system for accessing the passenger loading zone would also be required. Further study is recommended to explore opportunities for providing public transportation for park visitors with disabilities, either with scheduled or on-demand service. Potential transportation providers include ParkLINK Shuttle (with service from the Zuma Beach parking lot) or local paratransit providers.

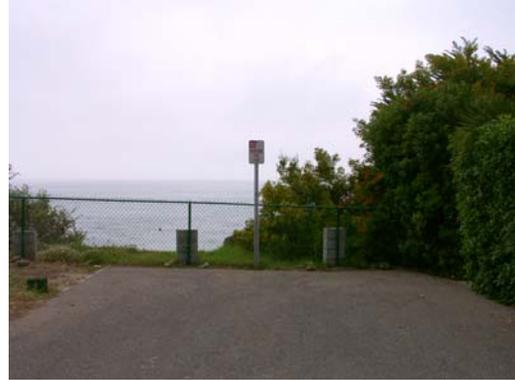
FIRE TURNAROUND AT WEST SEA LEVEL DRIVE

- Further study is recommended to determine areas that have the potential for becoming on-street accessible parking space(s).
- Another recommendation for further study is the establishment of a passenger loading zone (potentially in the location of the current fire turnaround at the end of West Sea Level Drive), which would provide the opportunity for increased access for persons with disabilities who are traveling with others in private or public vehicles (as described above).

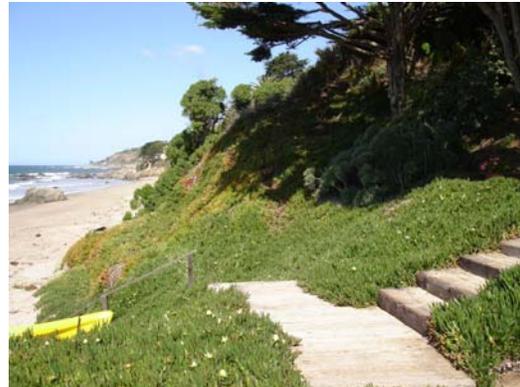
Lechuza Beach experiences high tides during storms, some of which have been responsible for damage to roads and access structures constructed within the ocean's reach. For example, the southern connecting portion of Sea Level Drive was washed out by storm action. The stair landing at West Sea Level Drive also has evidence of storm damage. Existing beach-level access within Lechuza Beach itself is exclusively provided by stairways, including at the end of East Sea Level Drive. However, there are several at-grade access points to private beach lots on East Sea Level Drive to the east of the potential location for an improved beach access route.

LECHUZA BEACH ACCESS
AT THE END OF EAST SEA LEVEL DRIVE

- Further study is recommended to review the mean high tide within the project area at Lechuza Beach. This information can help guide the Design Team in determining the feasibility of providing either a permanent beach access route or a temporary surface.
- It is likely that even if the option were chosen of providing a portion of the beach access route using a temporary surface, it would still be necessary to replace the decking, walkway and stairway at the end of East Sea Level Drive with a permanent accessible route such as a sloping walkway or ramp. It is recommended that geotechnical studies be performed to determine the feasibility of constructing this portion of the accessible route in the approximate location of the current construction.

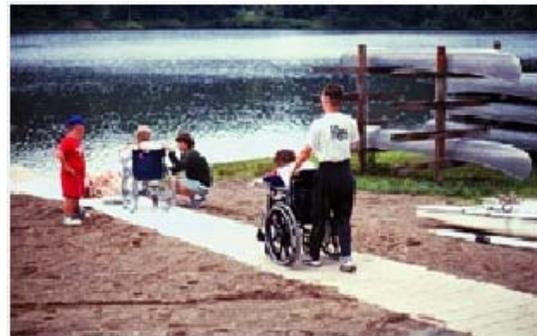
TYPICAL BEACH ACCESS ROUTE

Currently, there are no means for people with disabilities to travel across the sandy upper beach to reach the water so that they can play, swim or participate in other shoreline activities. According to new proposed guidelines for outdoor developed areas, the provision of a beach access route (a pathway—either permanent or temporary—over the surface of the beach itself that leads to the high tide level) is required at each linear half mile of new beach. The proposed accessibility guidelines for beach access routes require the provision of a firm and stable pathway across the beach surface. Because beaches are subject to erosion, a permanently installed beach route, such as decking, may not be suitable for some environments. For this reason, beach access routes can use temporary surfaces, such as rubber mats, recycled plastic decking, plastic mesh, lattice and other materials, so long as these surfaces are available at all times while the beach is open for public use.

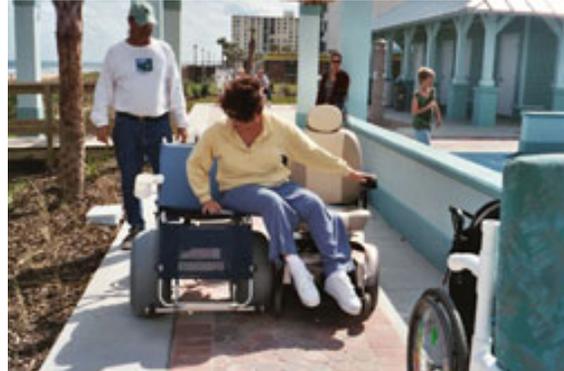
TRANSFERRING FROM A PERSONAL WHEELCHAIR TO A BEACH WHEELCHAIR

Another option for improving beach access is the provision of beach devices or beach chairs, which are mobility aids that enable a person with a mobility impairment to travel anywhere on the beach instead of being limited to a point at the end of a beach access route. For example, as part of a recent court settlement, the State of California Department of Parks and Recreation will provide—in addition to beach access routes—at least two beach wheelchairs at state beaches (unless there are no staff or facilities at the park reasonably available to store and supervise the use

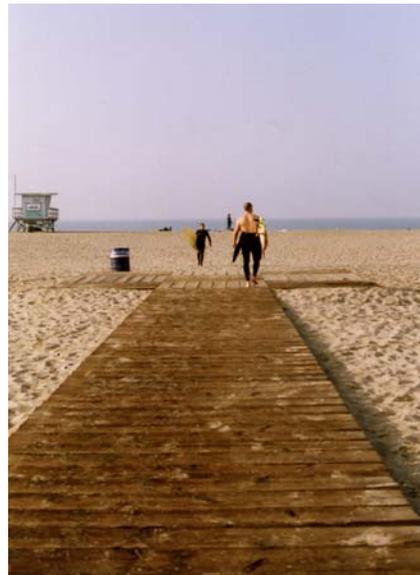
PERMANENT BEACH ACCESS ROUTE AT SANTA MONICA BEACH

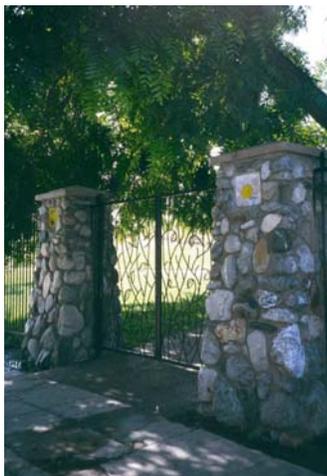
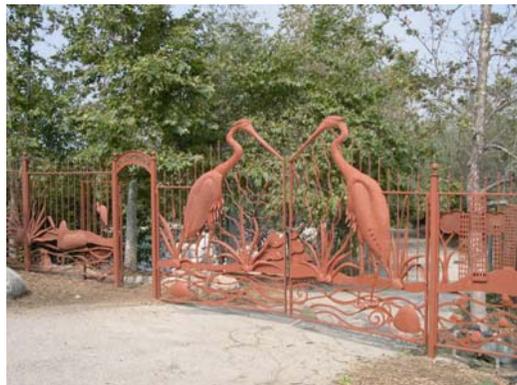
EXAMPLES OF LOCAL PUBLIC
PEDESTRIAN AND VEHICULAR GATES
