FINAL REPORT

Ormond Beach Wetland Restoration Site-Wide Soil/Surface Water Investigation

**FINAL REPORT
ORMOND BEACH WETLAND RESTORATION
GENERAL SITE-WIDE INVESTIGATION
FOR SOIL REUSE OPTIONS**

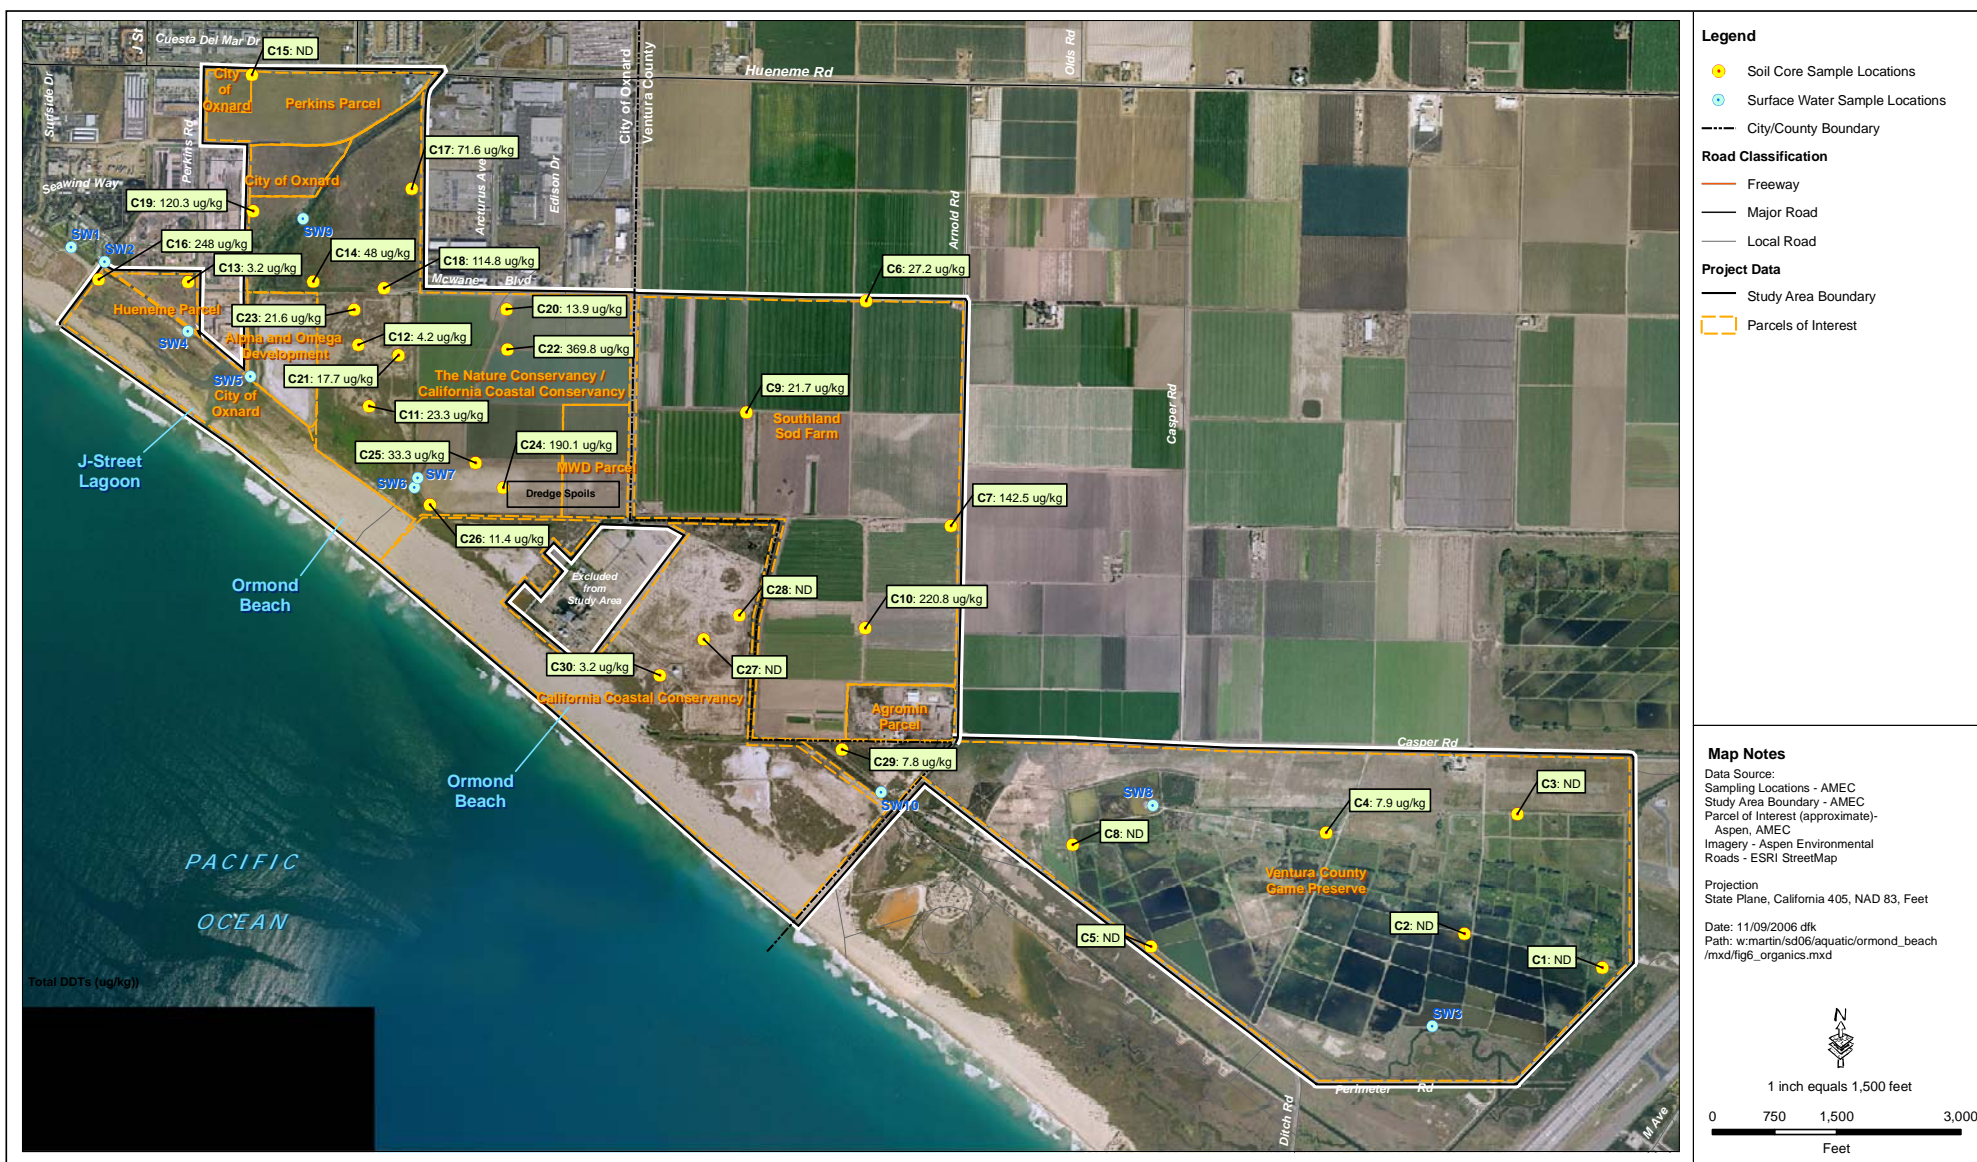
Measured concentrations of total DDT and derivatives (sum of DDT + DDE [dichloro-diphenyl-dichloroethylene] + DDD [dichloro-diphenyl-dichloroethane]) ranged from ND to 370 µg/kg. Elevated levels (above both marine ERMs and freshwater PELs) of total DDT and derivatives were found at Sites C-7, C-10, C-14, C-16, C-17, C-18, C-19, C-22, and C-24 (Table 6). These sites are, for most part, spread out over the entire study area (with the exception of the Ventura County Game Preserve).

The soil chemical analyses indicate that the study area is essentially free of metal and organic (e.g., petroleum hydrocarbons, PCB) chemical contamination, with the exception of the total DDT. Detectable levels of the pesticides total DDT and toxaphene were found throughout the study site. A geographical depiction of the total DDT results is presented in Figure 6. The total organochlorine pesticide levels observed in the study area may affect the reuse options that are pursued. Soils with the highest concentrations of pesticides may be precluded from disposal in areas that are in contact with the aquatic environment and sensitive aquatic receptors. In addition, the pesticide results reported in this study report are based upon the testing of core composites. Consequently, the pesticide levels at each site are likely biased low.

1. Based upon the composite organochlorine pesticides results presented in this report, it is recommended that the archive samples be analyzed (top, middle, and bottom core samples) to determine the actual organochlorine pesticide levels closer to the ground surface, as well as with depth in the sediment column. It should be determined at what depth soil pesticide levels reach or approach non-detect. This information will be invaluable in determining the volume of pesticide-containing soils that will need to be removed from the project area with possible agricultural reuse.
