Exhibit 3: Site Photos

Santa Rosa Creek - Pierson Reach 2003

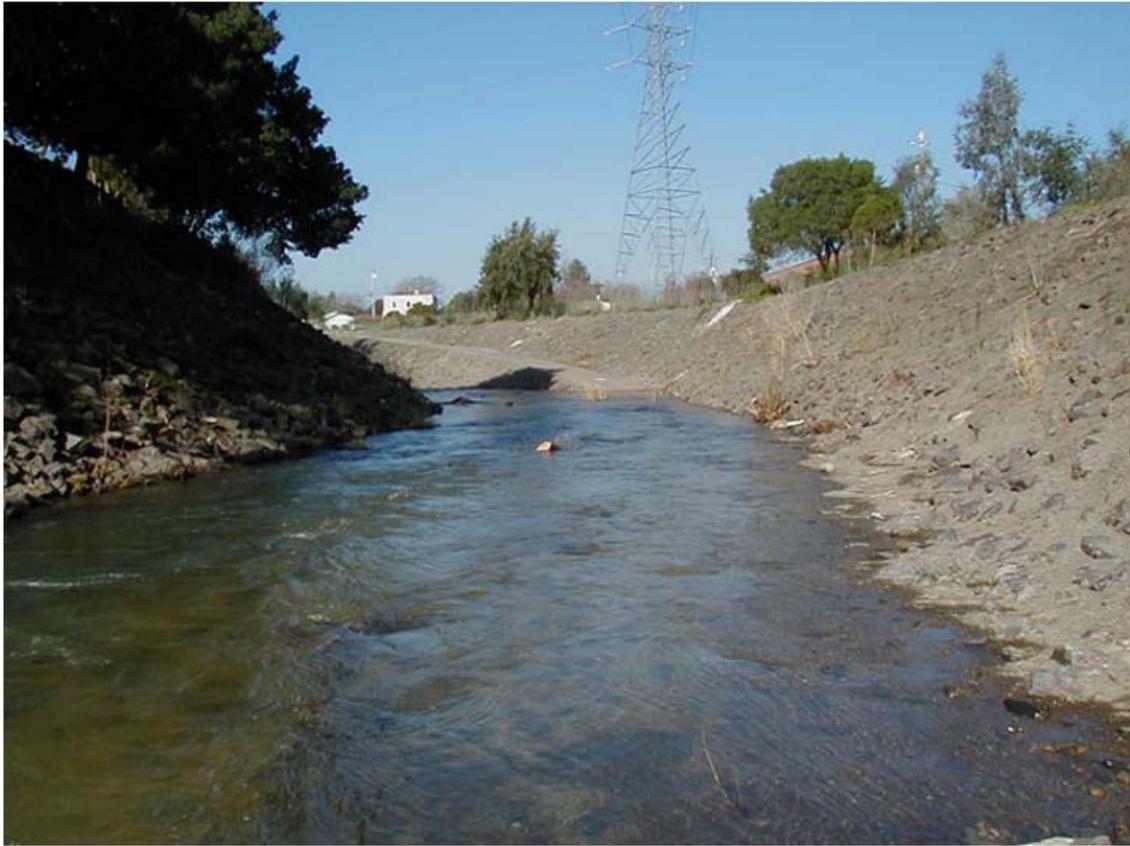
Photo 1

The picture above shows the existing conditions along the Pierson Reach. In response to severe flooding during the 1950s and 1960s, approximately 35 miles of creeks within the Santa Rosa area were channelized. Various creek channels were straightened, widened, denuded, and cemented. These actions resulted in decreased flooding within the urban area, but also caused degraded water quality conditions, negatively affecting steelhead trout, chinook salmon, other native fishes, and a variety of other wildlife dependent upon the creek corridors. Restoration efforts have been successful up and downstream from the project site. The Pierson reach is one of the last remaining stretches of concrete flood channel in the downtown area.

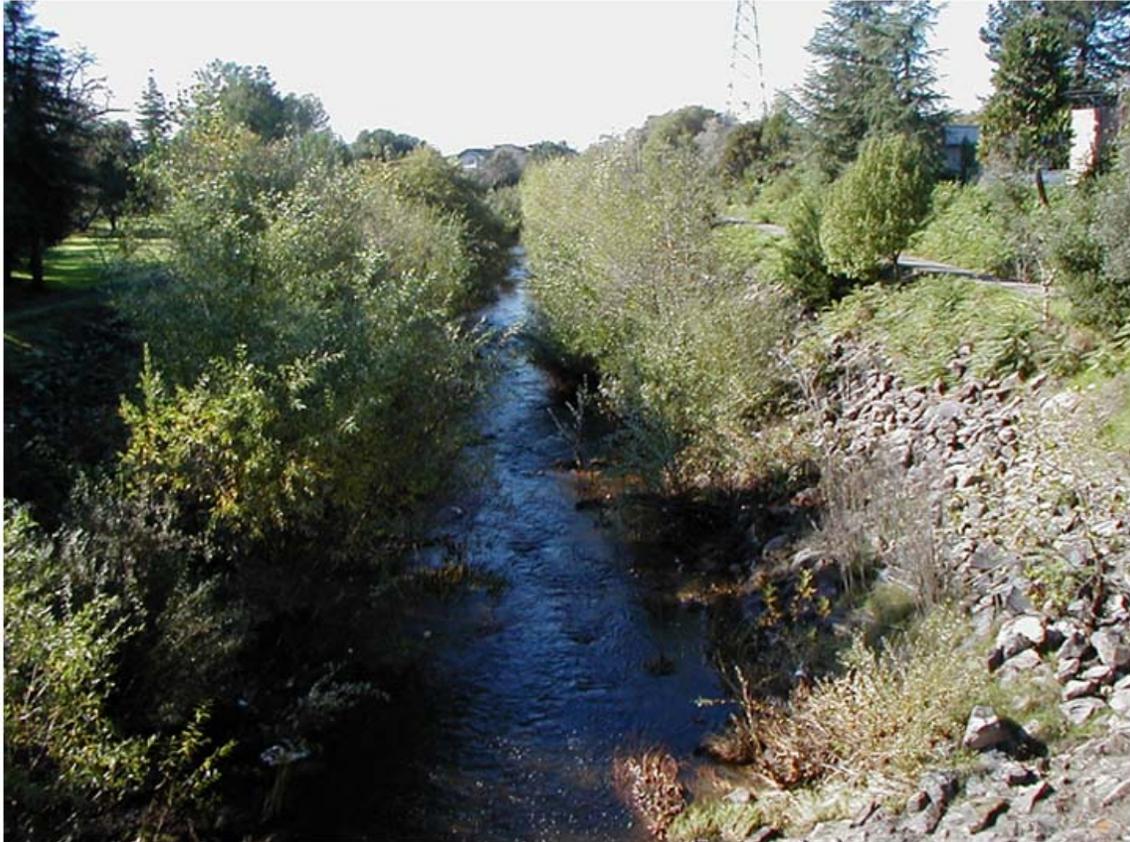
Photo 2

Santa Rosa Creek - Downstream of Pierson Street Bridge 2003

The picture above shows existing downstream conditions adjacent to the project site. Although the creek has been straightened for flood control purposes, instream habitat along with overstory growth provides wildlife habitat for salmonids and other species.

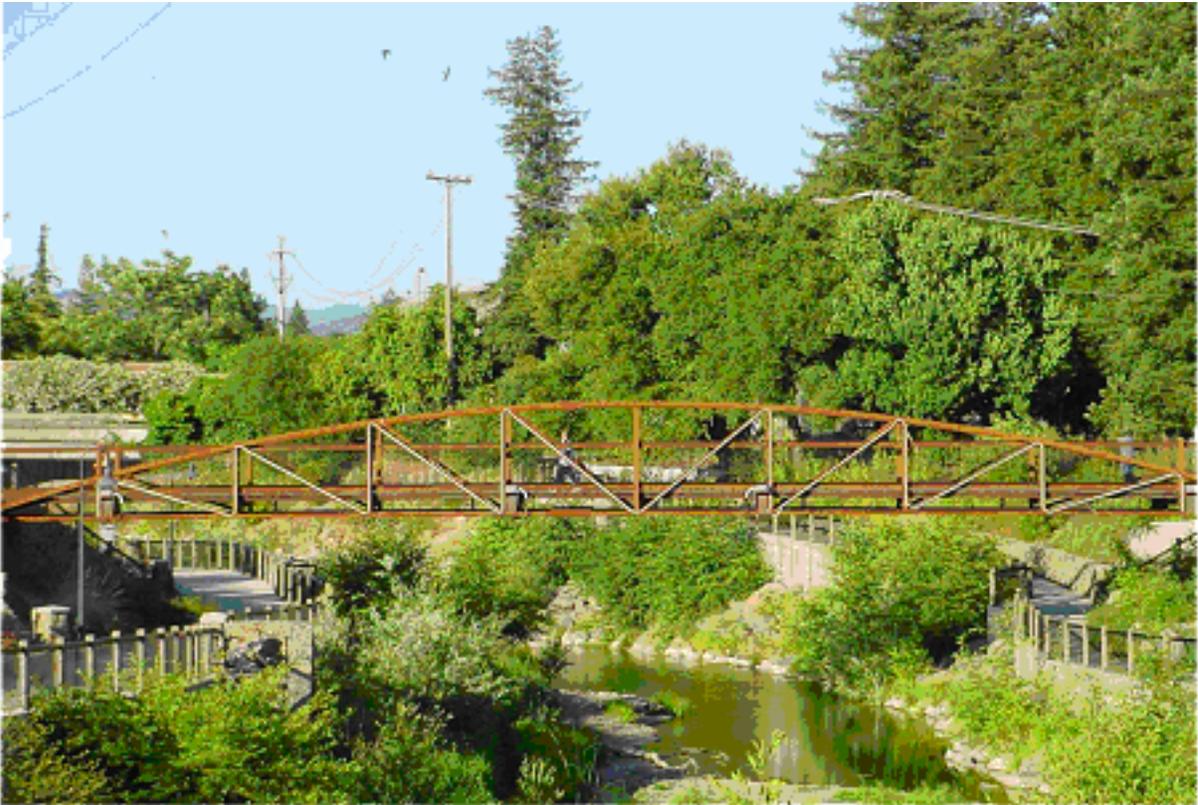
Photo 3

**Santa Rosa Creek - Prince Memorial Greenway Phase I
Upstream of Olive/Railroad Street, 2004**

Phase I restoration efforts along the Prince Memorial Greenway, which were completed in 2002, are taking hold in the picture shown above. The instream and riparian restoration efforts, along with trails and access have transformed the former flood control channel (see photo 1) into vibrant wildlife habitat and a community focal point in the center of the community's urban setting.

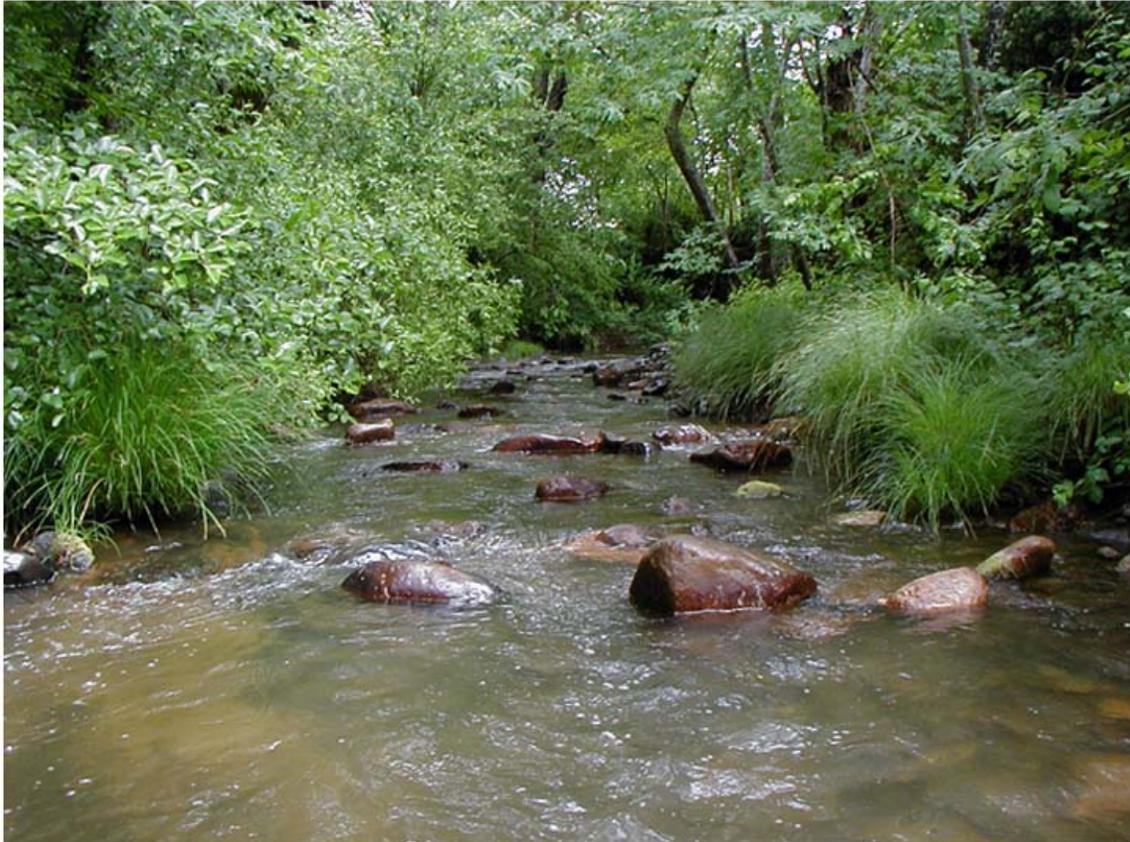
Photo 4

Santa Rosa Creek - Upstream near Melita Road 2002

The picture above shows existing conditions along Santa Rosa Creek upstream from the project site. Instream habitat and a well developed under and overstory provide spawning and rearing habitat for salmonids.
