**Notice of Determination
and
Mitigated Negative Declaration
for the
Rodeo Grounds Berm Removal and Restoration Project**

Rodeo Grounds Berm Removal and Restoration Project

SCH Number: 2006011040

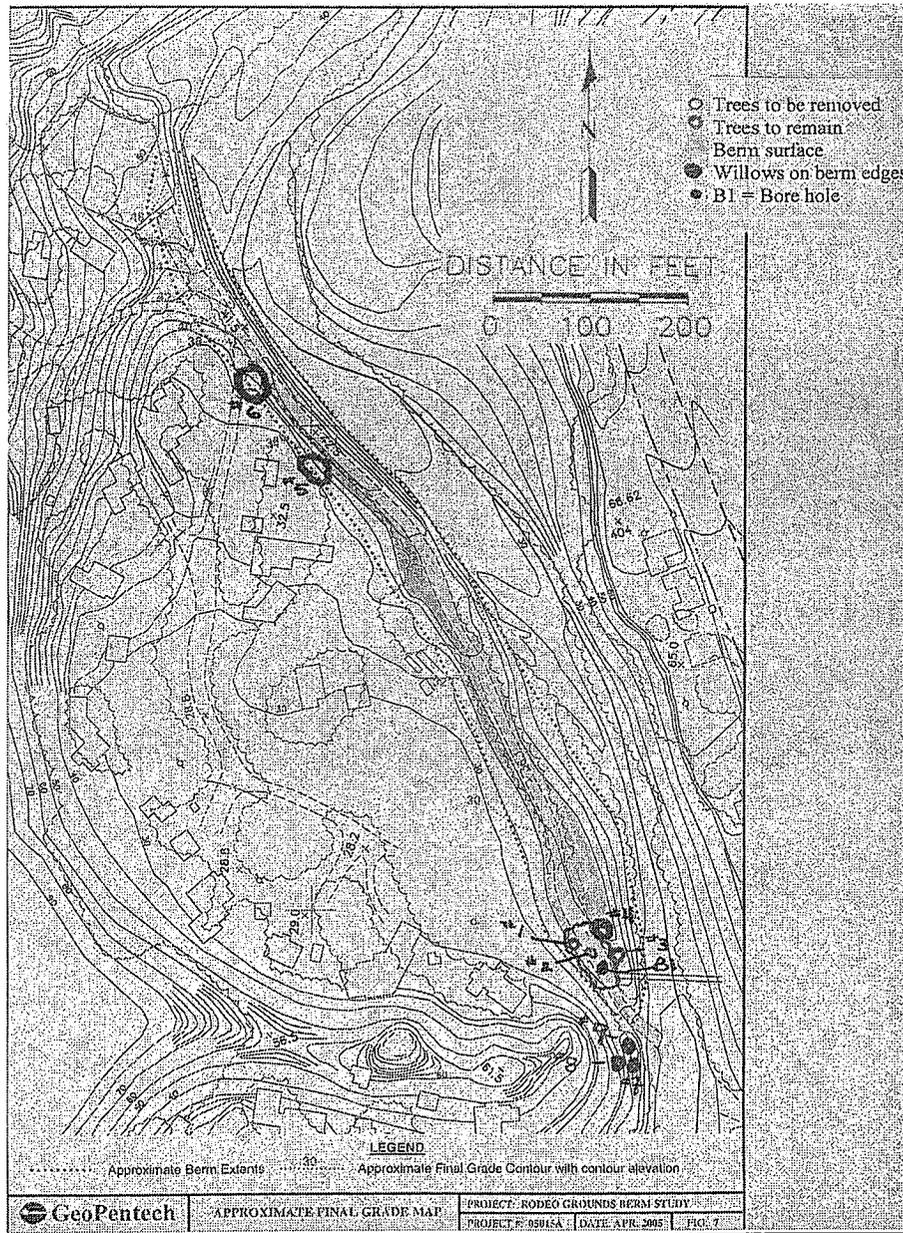
Figure 1. Location of Trees in the Rodeo Grounds Road Berm Project

Trees to be Removed:

- Approximately 30 willows (*Salix sp.*) of varying sizes
- Two toyon (*Heteromeles arbutifolia*)
- One elderberry (*Sambucus mexicanus*)
- One coast live oak (*Quercus agrifolia*) Tree #1
- One heritage cottonwood (*Populus fremontii*) Tree #2
- One CA walnut (*Juglans californica*) Tree #3

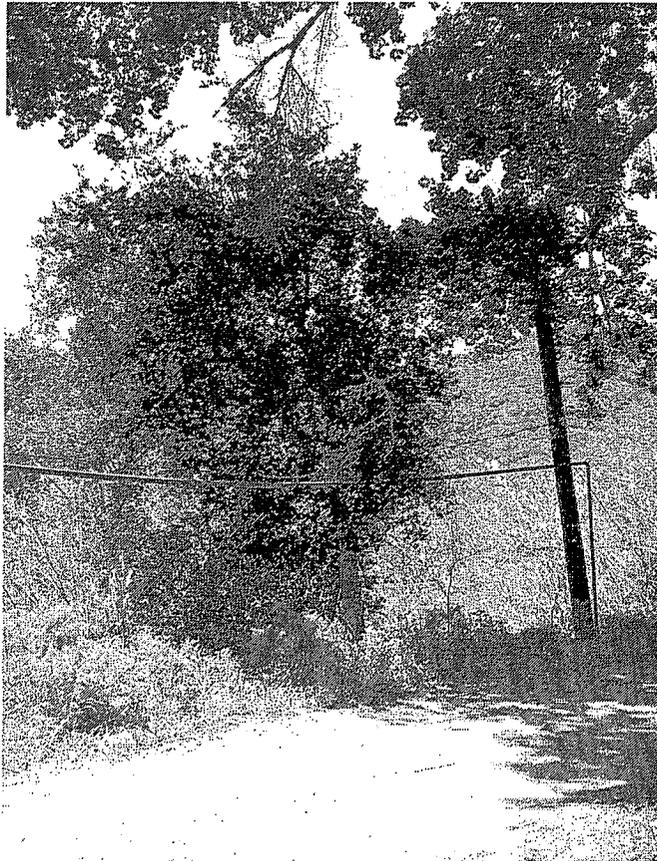
Figure 2. Tree # 1, Coast Live Oak

Site condition: Located on the upper edge of the west bank of fill material, directly under the canopy of the mature cottonwood.

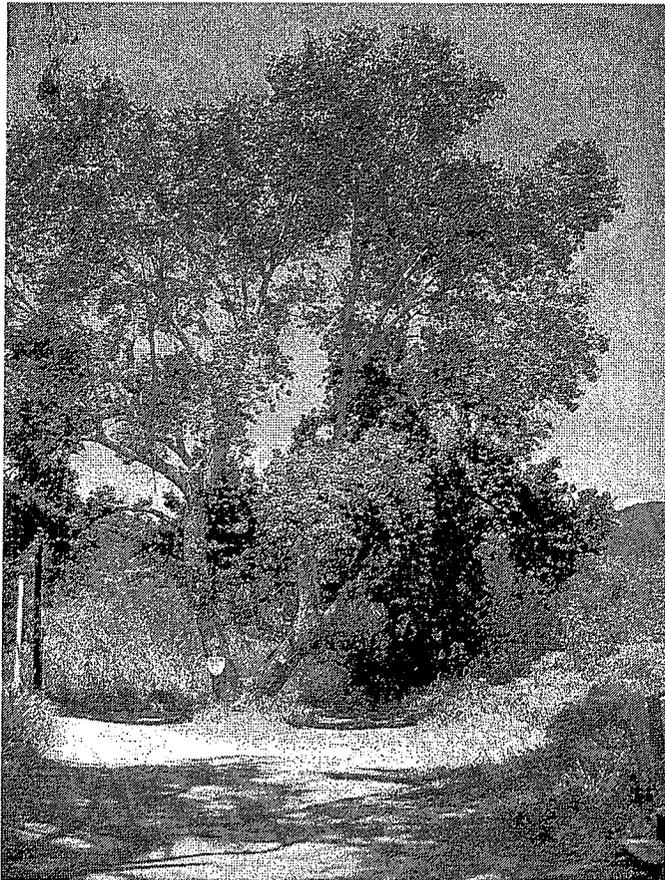
Figure 3. Tree # 2 Mature Cottonwood, south side April 2005

Site condition: It is located totally within the fill, and is approximately 50 feet from the edge of the creek on the east, and approximately 100 feet from the channel to the south.

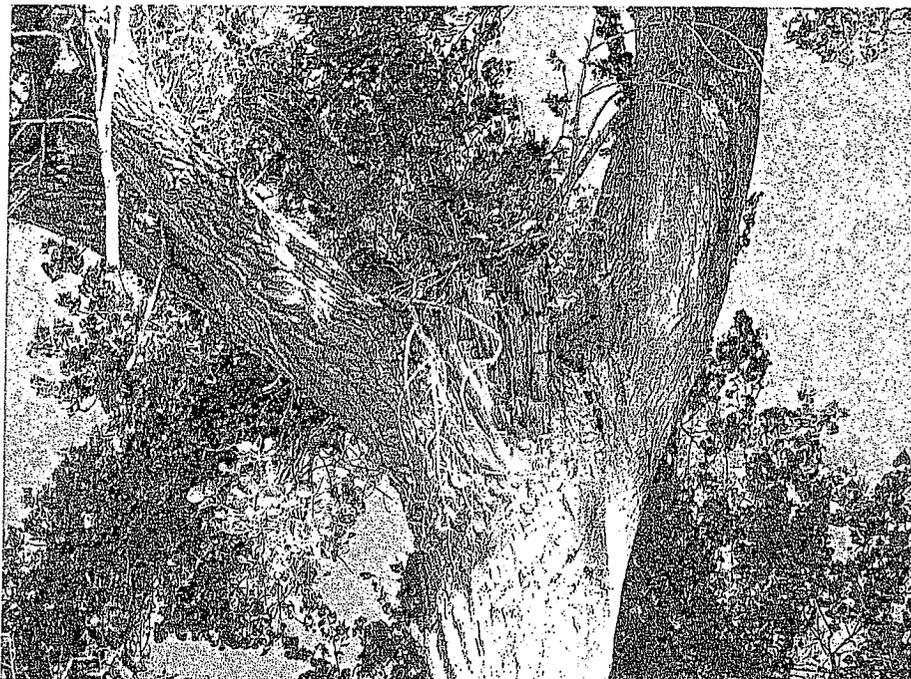
Tree #2 Broken branch in upper canopy

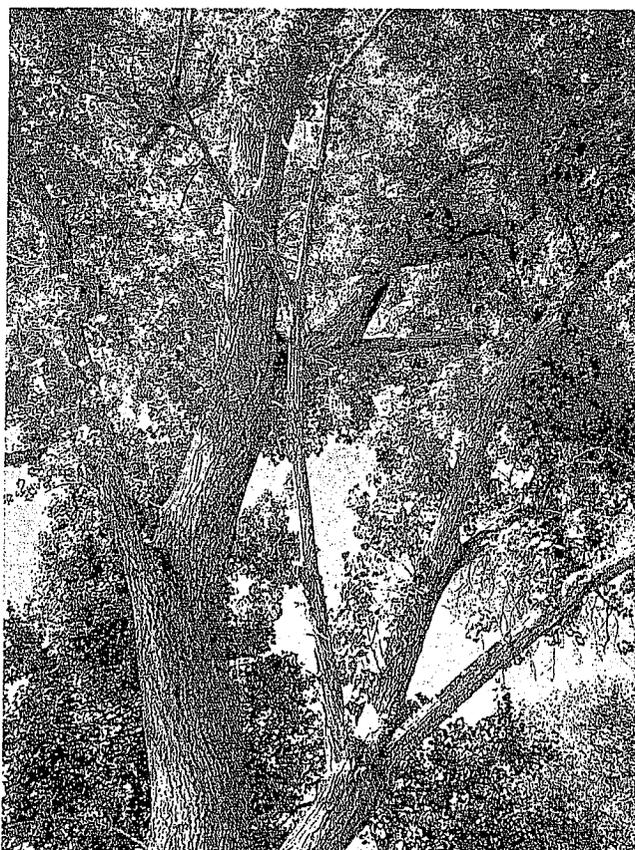
Tree #2 Exudate and dead branches in upper canopy

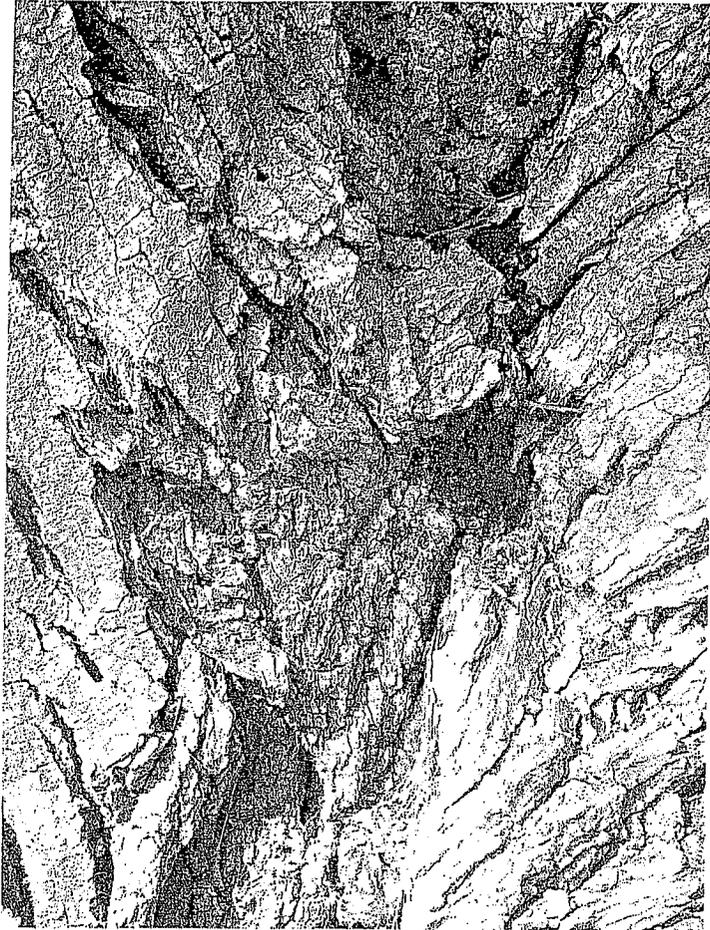
Tree #2 Decay in crotch near ground

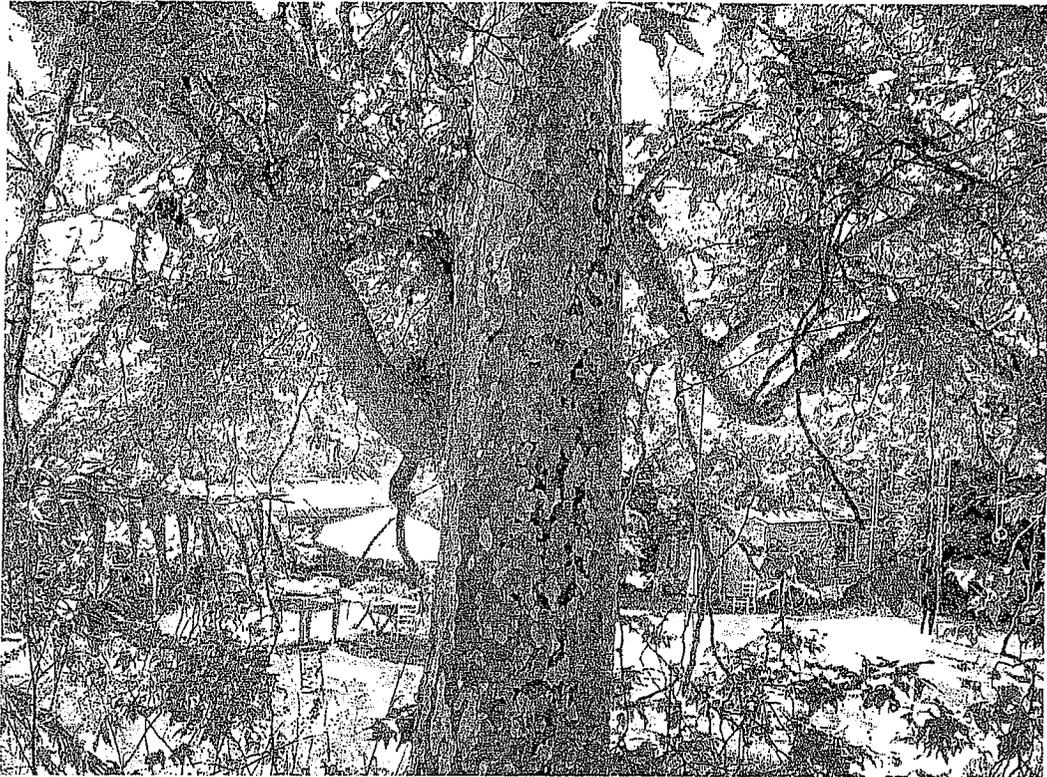
Tree #5 Unusual branch attachments on Sycamore

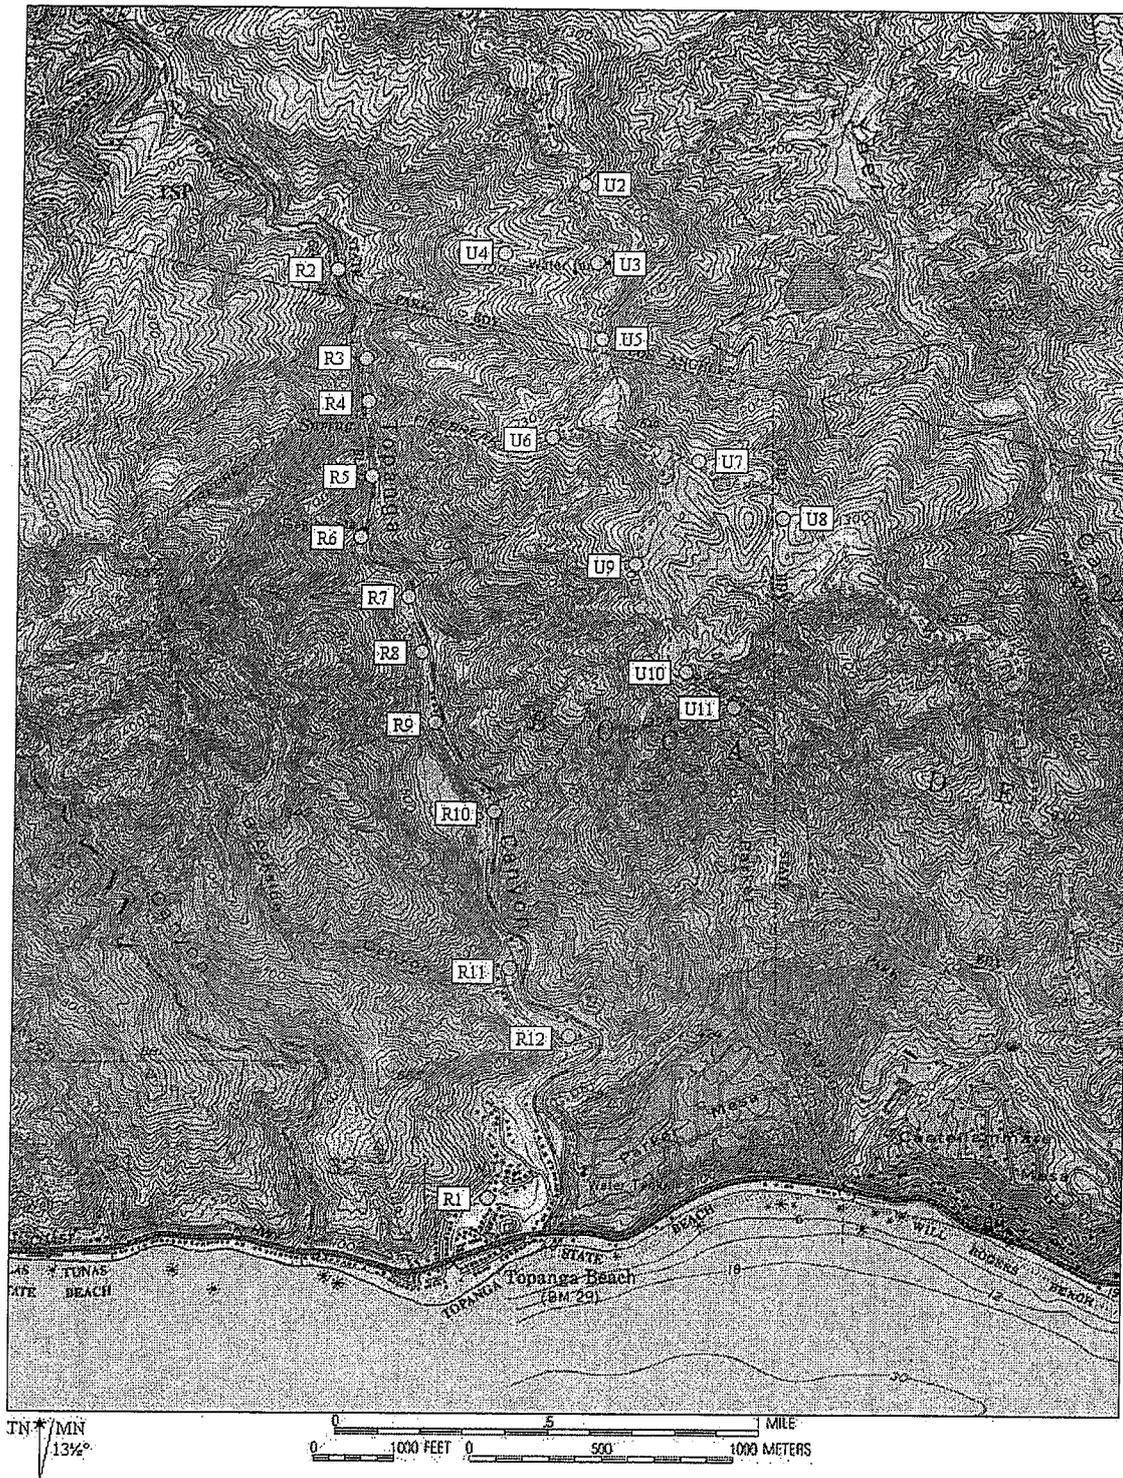
Figure 1. Locations of point count stations at Lower Topanga Canyon, 2004.

Birds were censused using point counts at stations situated at least 250 m apart from one another (Figure 1). Twenty-two of 23 stations established in 2003 were surveyed in 2004; point "U1" (Kus et al. 2003) was not surveyed because the point location, 350 m up a scrub-covered cliff, was inaccessible in 2004. Twelve stations were located along the length of the riparian habitat at the site (designated with an "R"

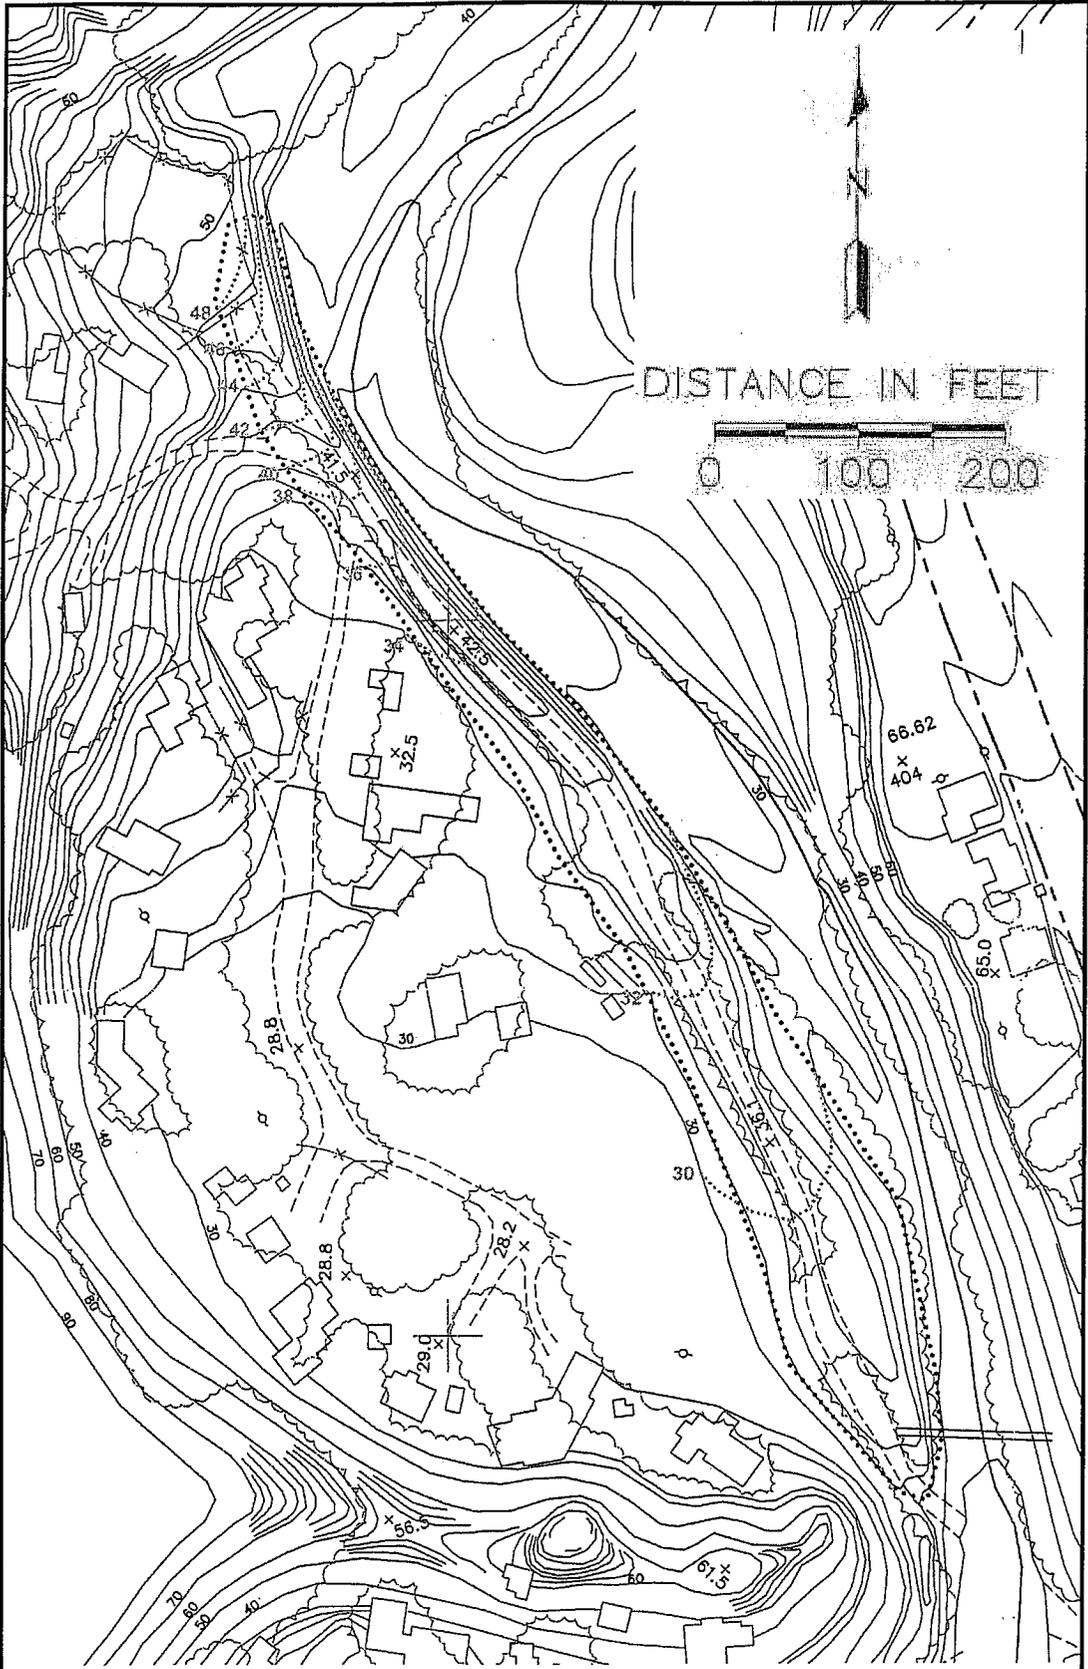
..... Approximate Berm Extents ³⁰..... Approximate Final Grade Contour with contour elevation
