Exhibit 3. Site Photos

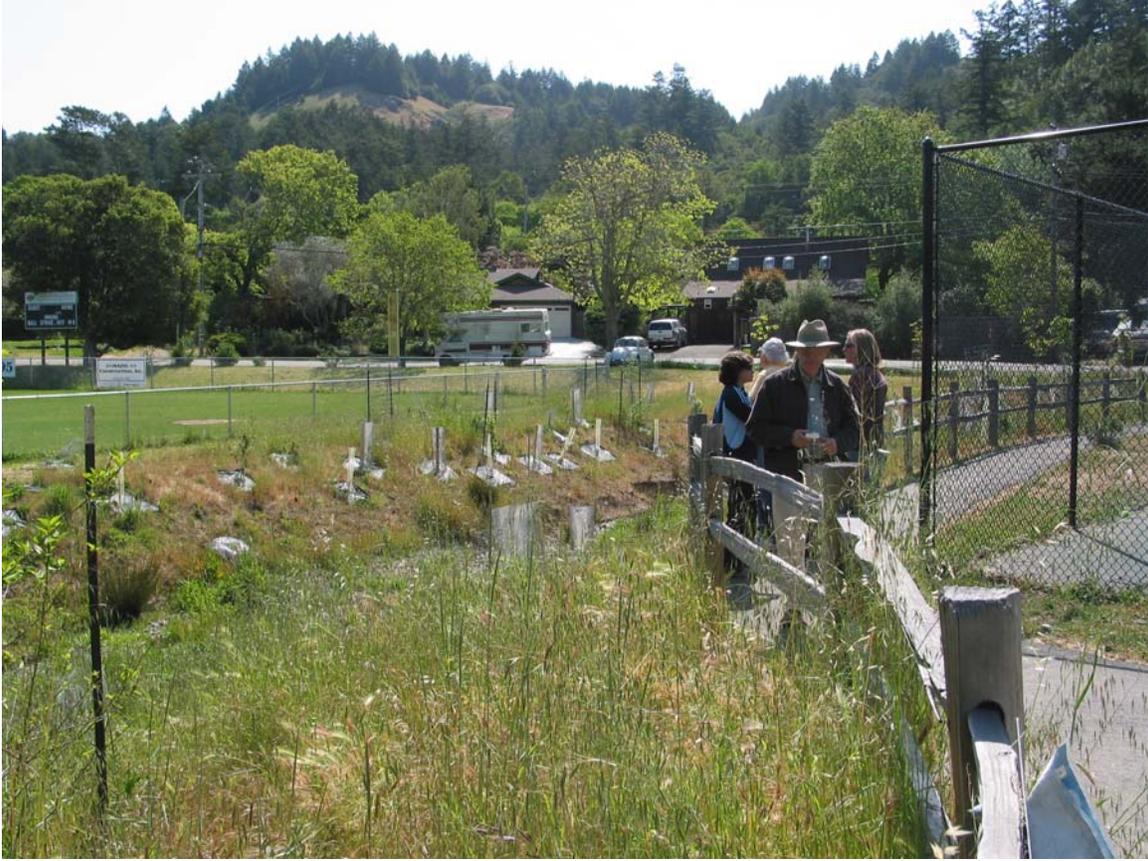
Daylighted reach of Woodacre Creek with riparian plantings at Woodacre Creek Improvement Club.

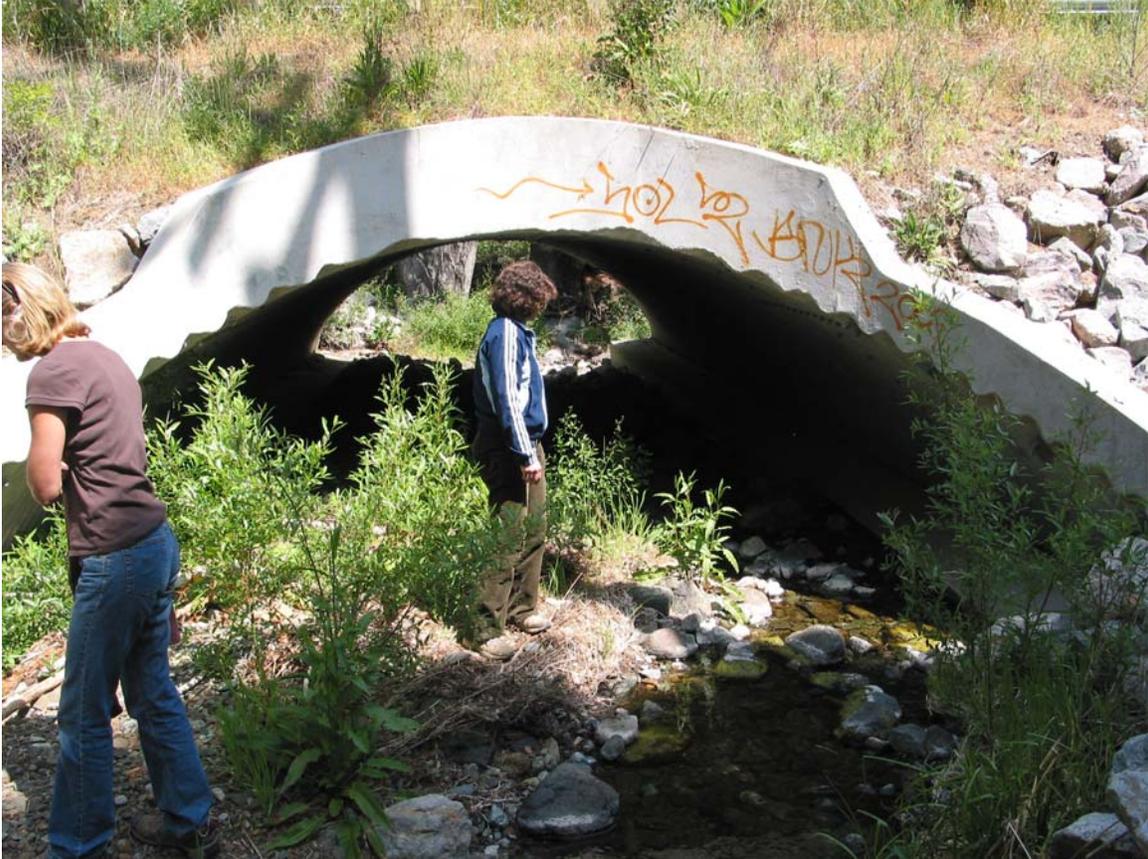
Stream Simulation in bottomless arch culvert that replaced fish passage barrier just upstream of the confluence of Woodacre and San Geronimo Creeks

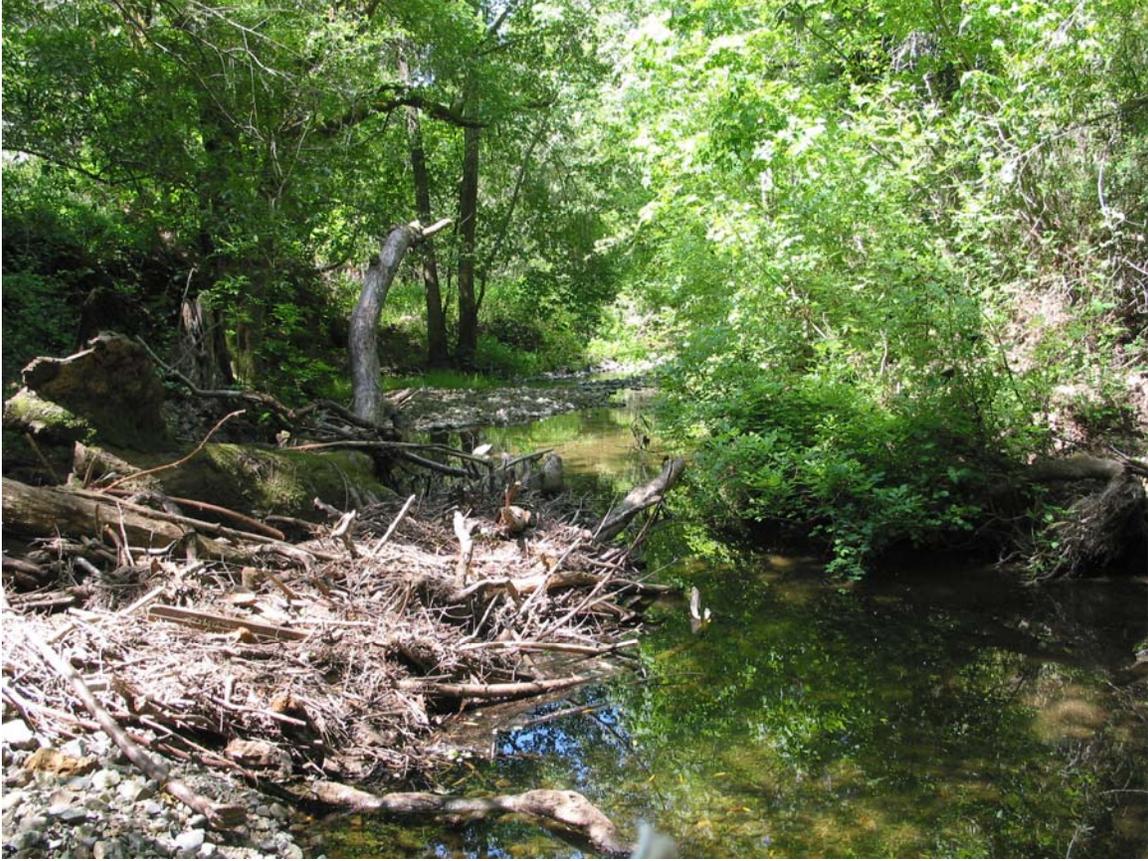
Looking upstream on San Geronimo Creek, just upstream of the confluence with Woodacre Creek.

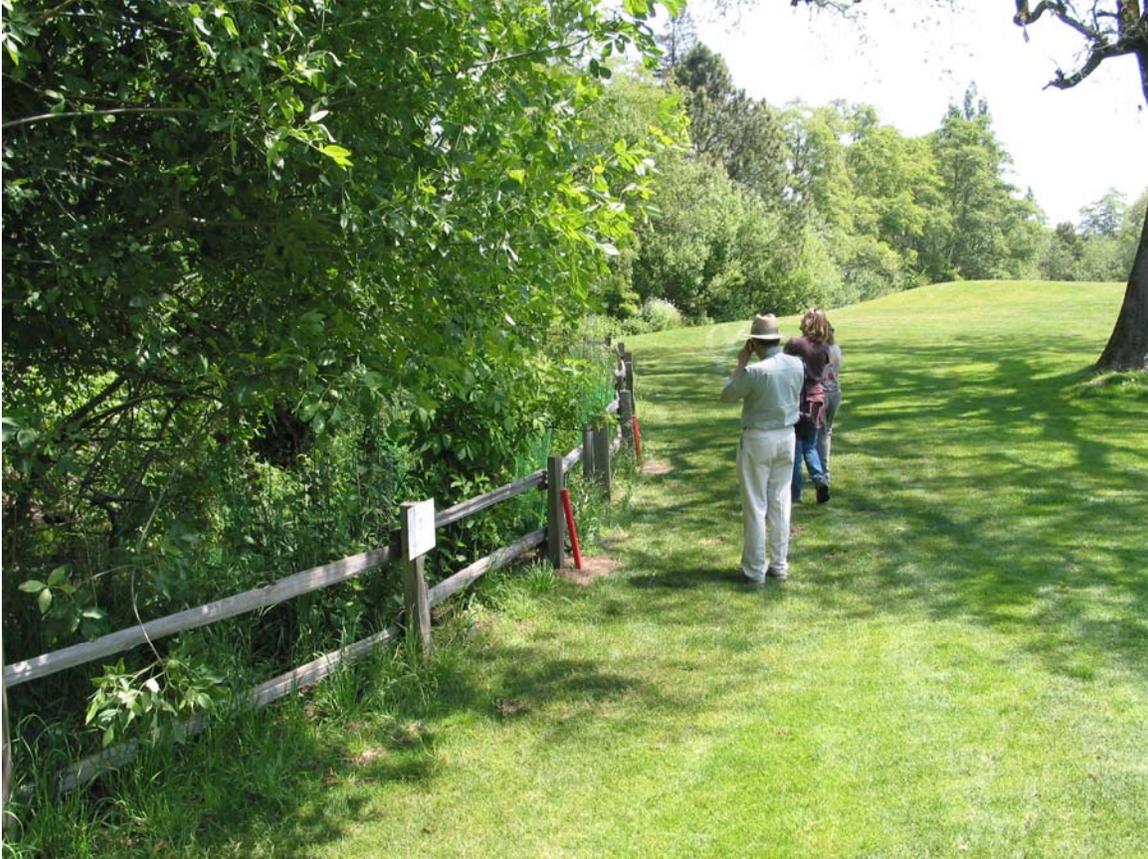
San Geronimo Valley Golf Course, just upstream of Roy's Pools. The creek is to the left of the picture. Note fence to keep golfers from entering creek to retrieve golf balls and causing bank erosion and loss of riparian vegetation.

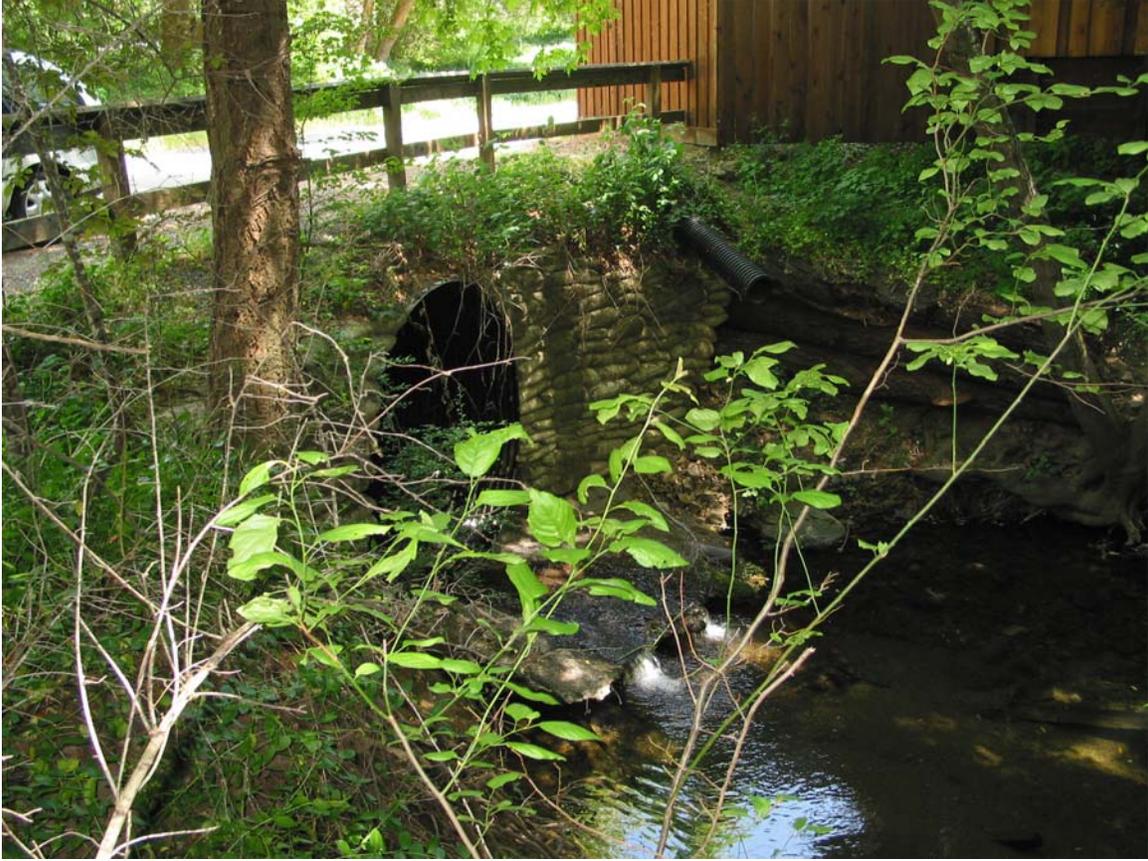
Castro Road fish passage barrier at the base of the Arroyo Creek subwatershed. Confluence with San Geronimo Creek is approximately 200 ft downstream.
