Exhibit 3: Site Photographs

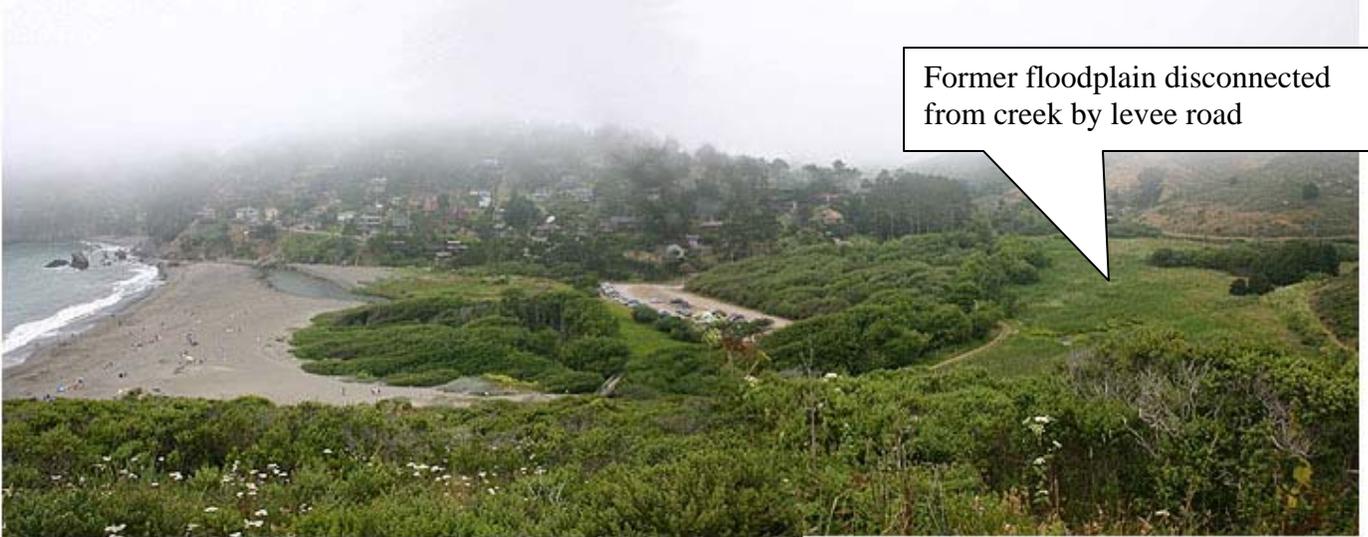
Looking north at Lower Redwood Creek and Muir Beach from the Coastal Trail on adjacent coastal hill. Note former floodplain, currently cut off from creek, which will be restored to riparian scrub and forest. Also note parking lot, which will be relocated out of a portion of the floodplain.

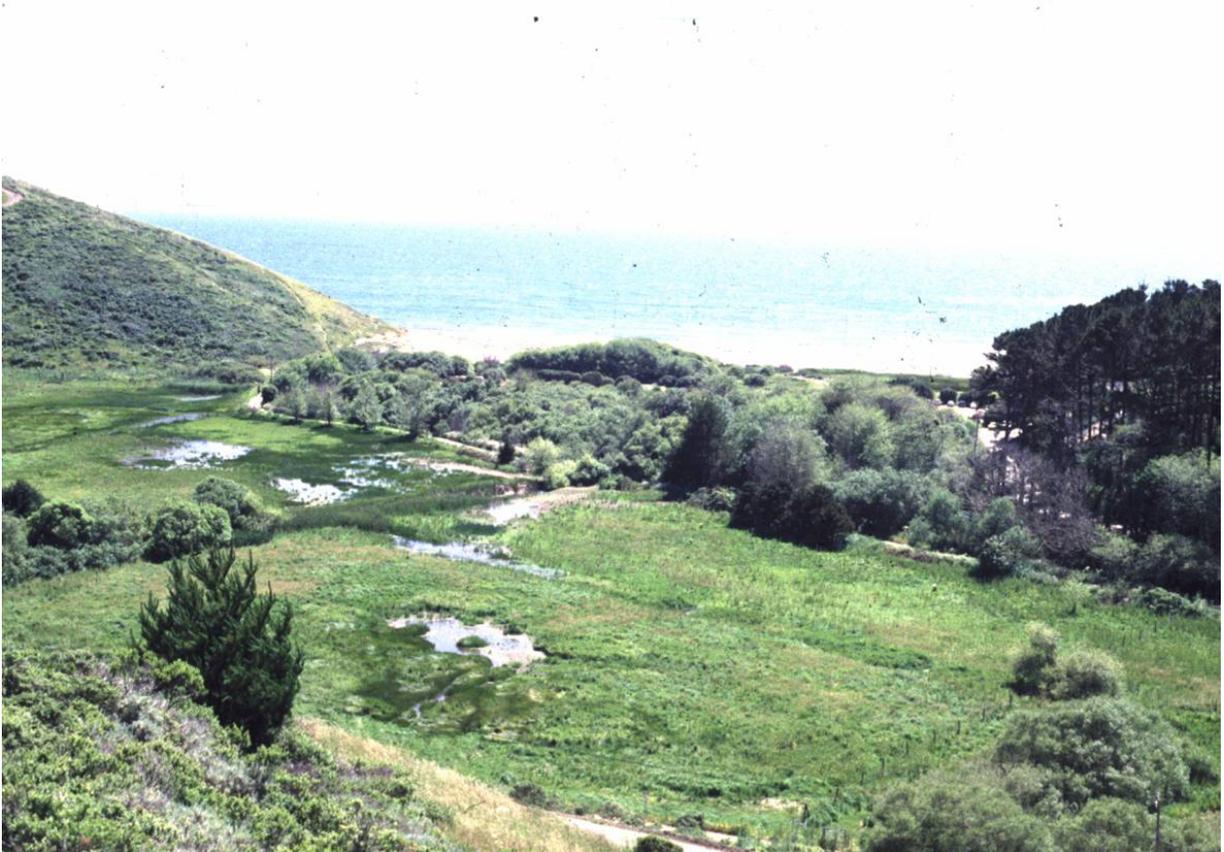
Looking northwest across Green Gulch Pasture, a portion of Redwood Creek's floodplain that is currently cut off from the creek by the levee road. The levee road is visible as the boundary between non-native pasture vegetation and riparian scrub and forest vegetation.

The project will realign a portion of Redwood Creek through this pasture and remove the levee road so that the whole floodplain will be connected to the creek.

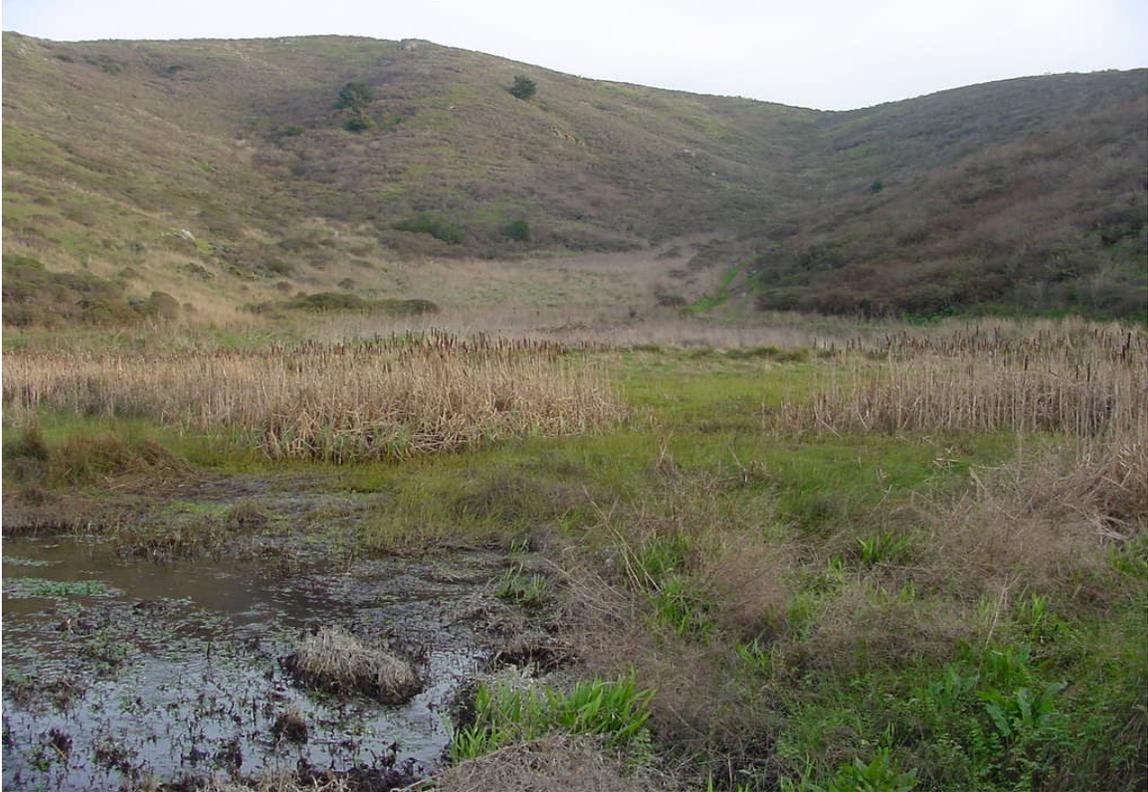
Looking southwest at freshwater emergent wetlands in the Green Gulch Pasture, with the coastal hills in the background. These wetlands are artificially sustained by the levee road and a flashboard weir, and provide habitat for the federally threatened California red-legged frog. The project will create groundwater fed emergent wetlands to provide sustainable habitat for the frog.

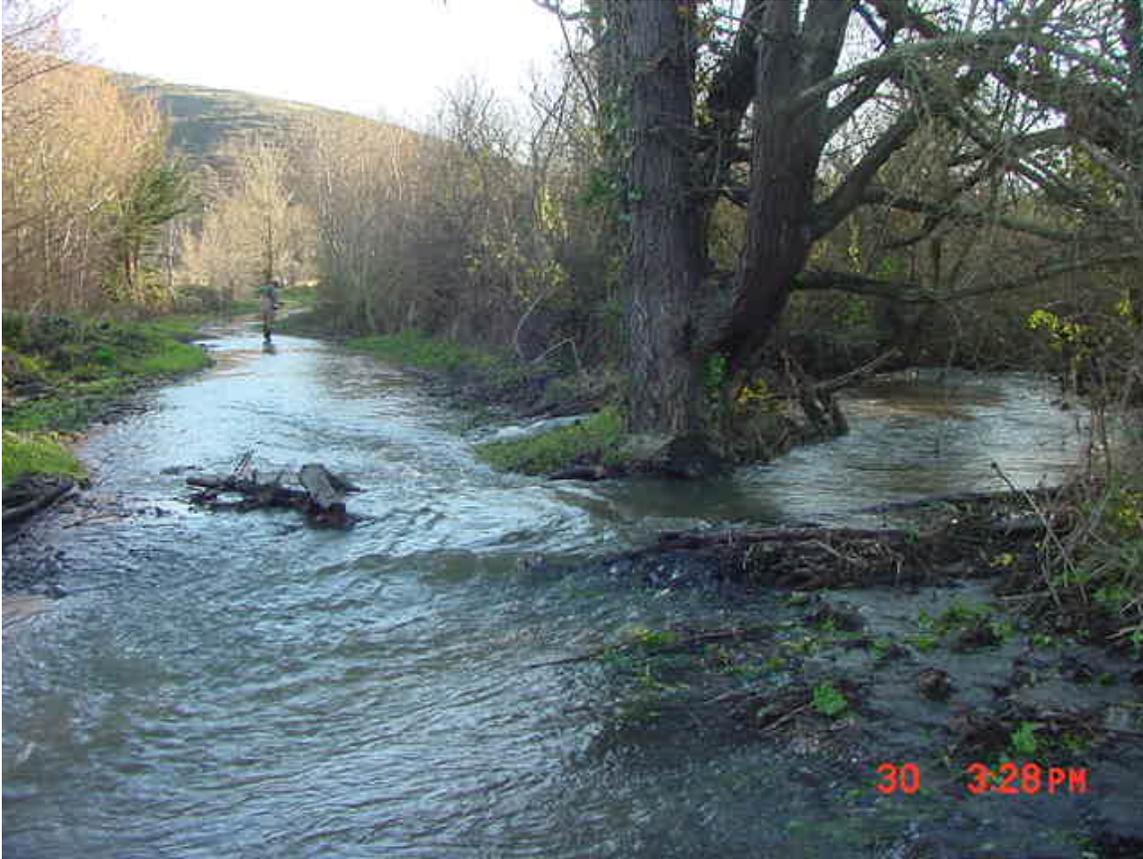
Looking southwest at the levee road, inundated by a flood event, and downstream at one of the main channels of Redwood Creek. This photo shows flows moving from the creek channel onto the levee road. The channel bed (on the right in the photo) is so aggraded that it is almost as high as the levee and actually higher than the pasture on the opposite side of the levee. Consequently, it has little flow capacity and is highly unstable. This sort of flow pattern can strand fish outside the creek channel. Stranded fish have difficulty returning to the creek.

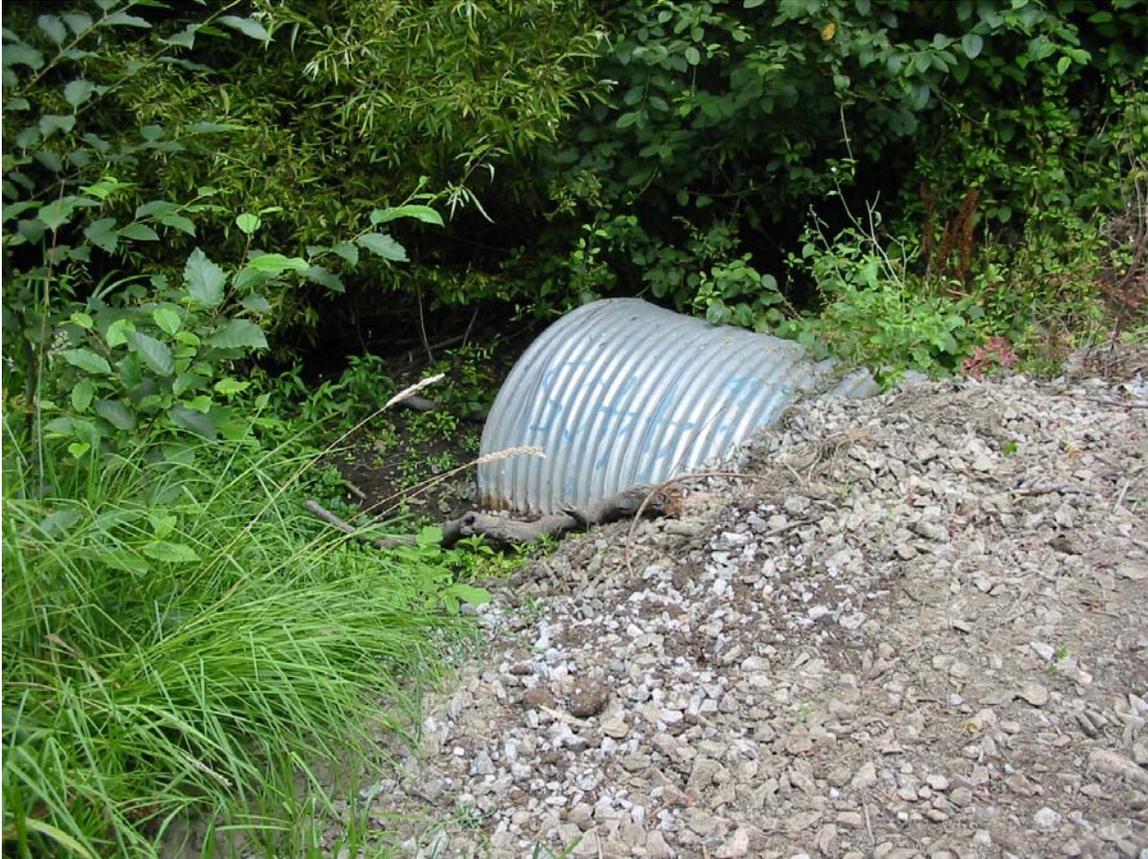
One of two culverts under the levee road that provide the only access for salmonids stranded in the Green Gulch pasture by high flows to return to Redwood Creek. The levee road will be removed as part of the project.

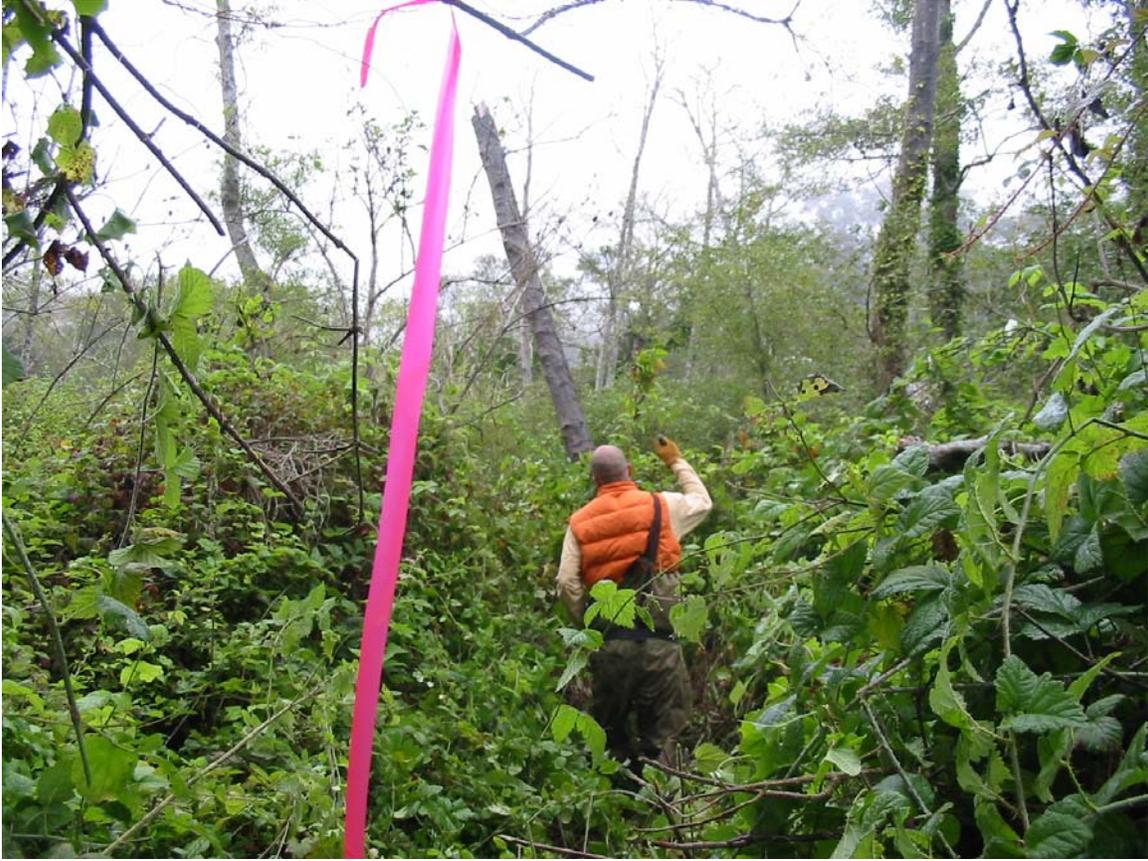
Looking north at riparian vegetation on left bank of Redwood Creek upstream of Pacific Way bridge. Note that invasive, non-native cape ivy dominates understory in the middle and background of the photo. Also note that alders have died due to prolonged inundation related to the undersized Pacific Way bridge. The project will remove cape ivy and other non-native invasives, and will restore riparian forest in this area.

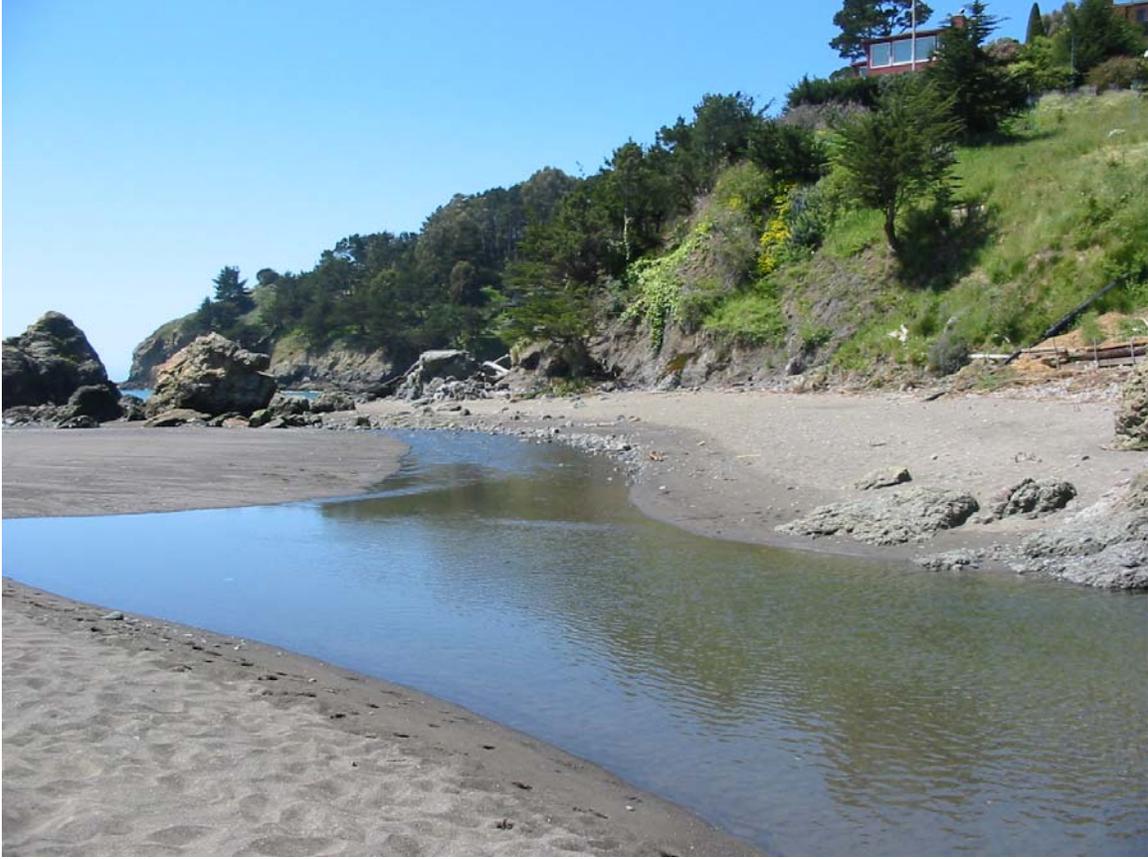
Looking northwest towards the Pacific Ocean at a portion of the tidal lagoon. Photo was taken when the beach berm was open. The project will expand and enhance the tidal lagoon, by removing fill that was placed on the landward side of the lagoon, and installing large woody debris to enhance habitat for salmonids and other fish.

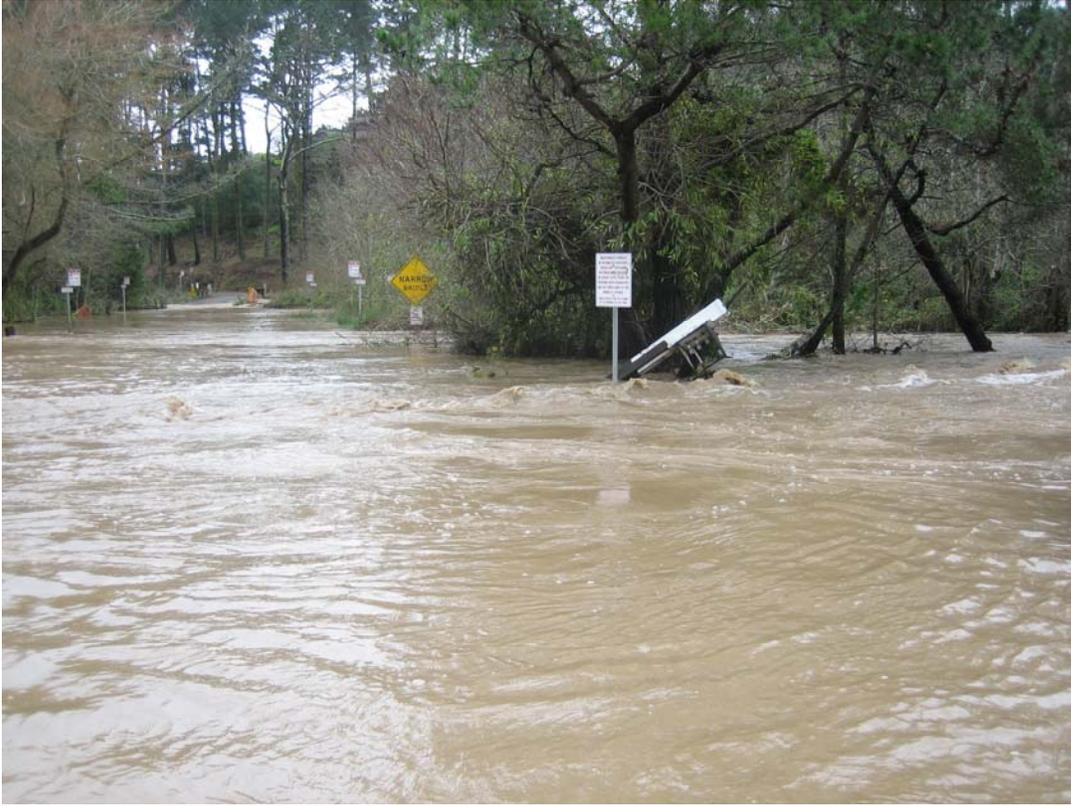
Looking west at Pacific Way (road into Muir Beach) during December 2005 flood. Note undersized bridge in background, past yellow “Narrow Bridge” sign. The project will realign the creek channel to its natural location in the foreground, and construct a bridge that will span the floodplain and will therefore not constrain flows.

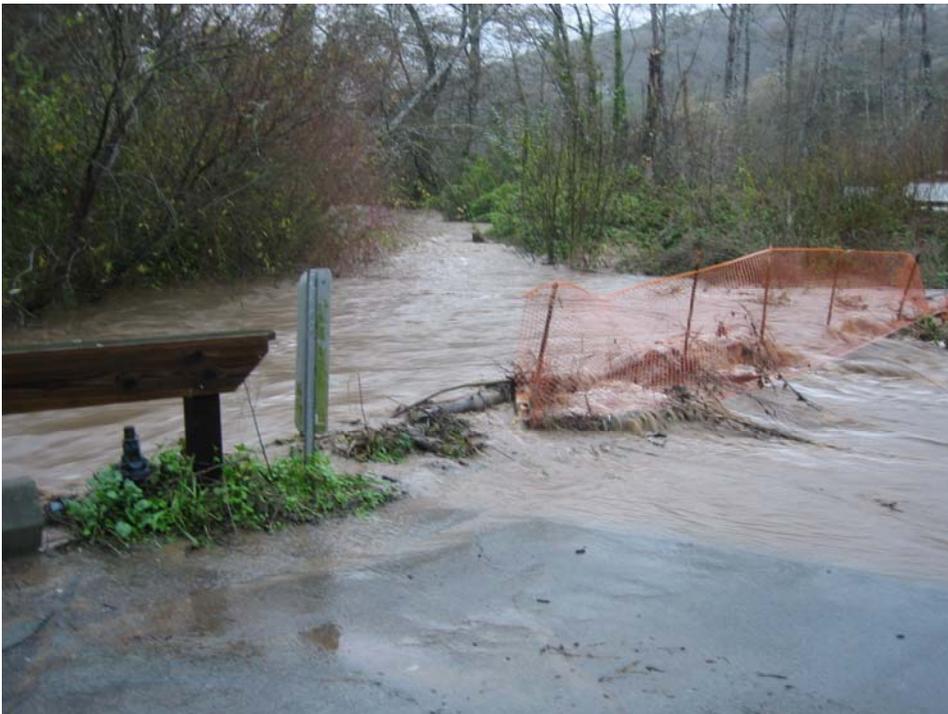
Looking upstream from Pacific Way bridge during Dec 2005 flood. Alder Grove in right background has died due to prolonged inundation. The project will restore riparian forest to this area.

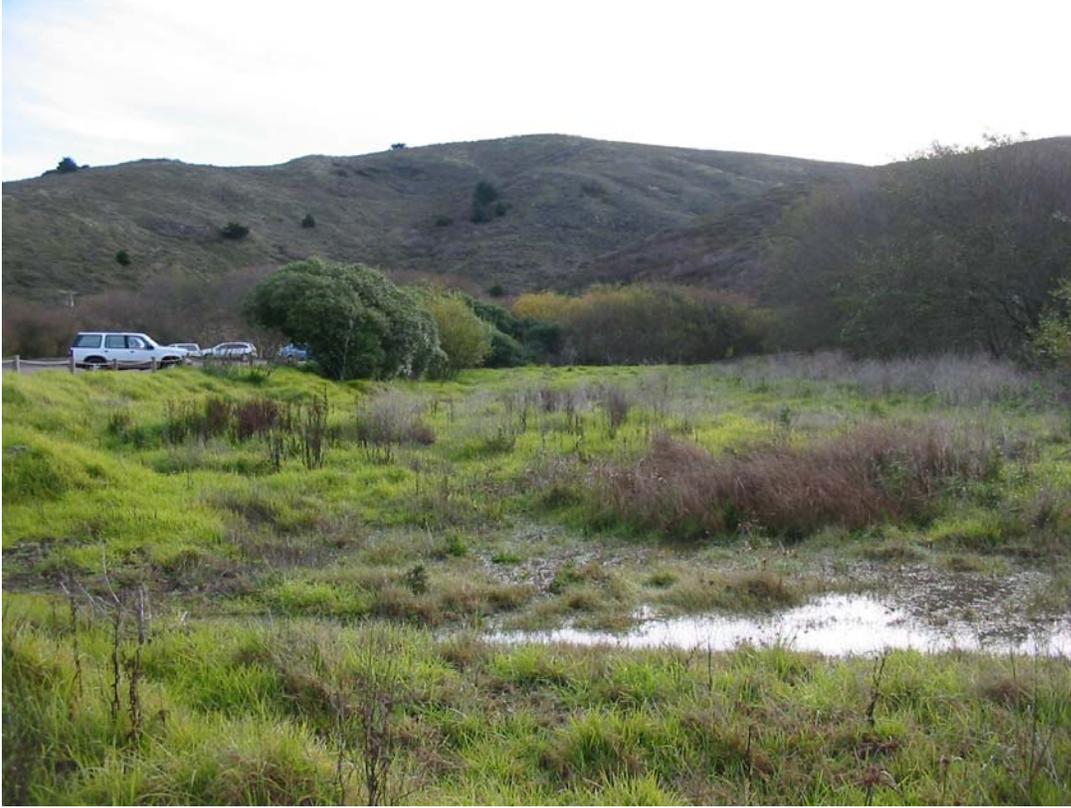
Looking southeast across the kikuyu grass-dominated brackish marsh adjacent to the existing parking lot. The proposed project would remove the invasive non-native kikuyu grass from this wetland, and revegetate with native species. The parking lot, which is on a fill pad, would be removed from this area.
