Exhibit 2: Photos and Figures

Whistlestop Lagoon Levee — Existing Conditions

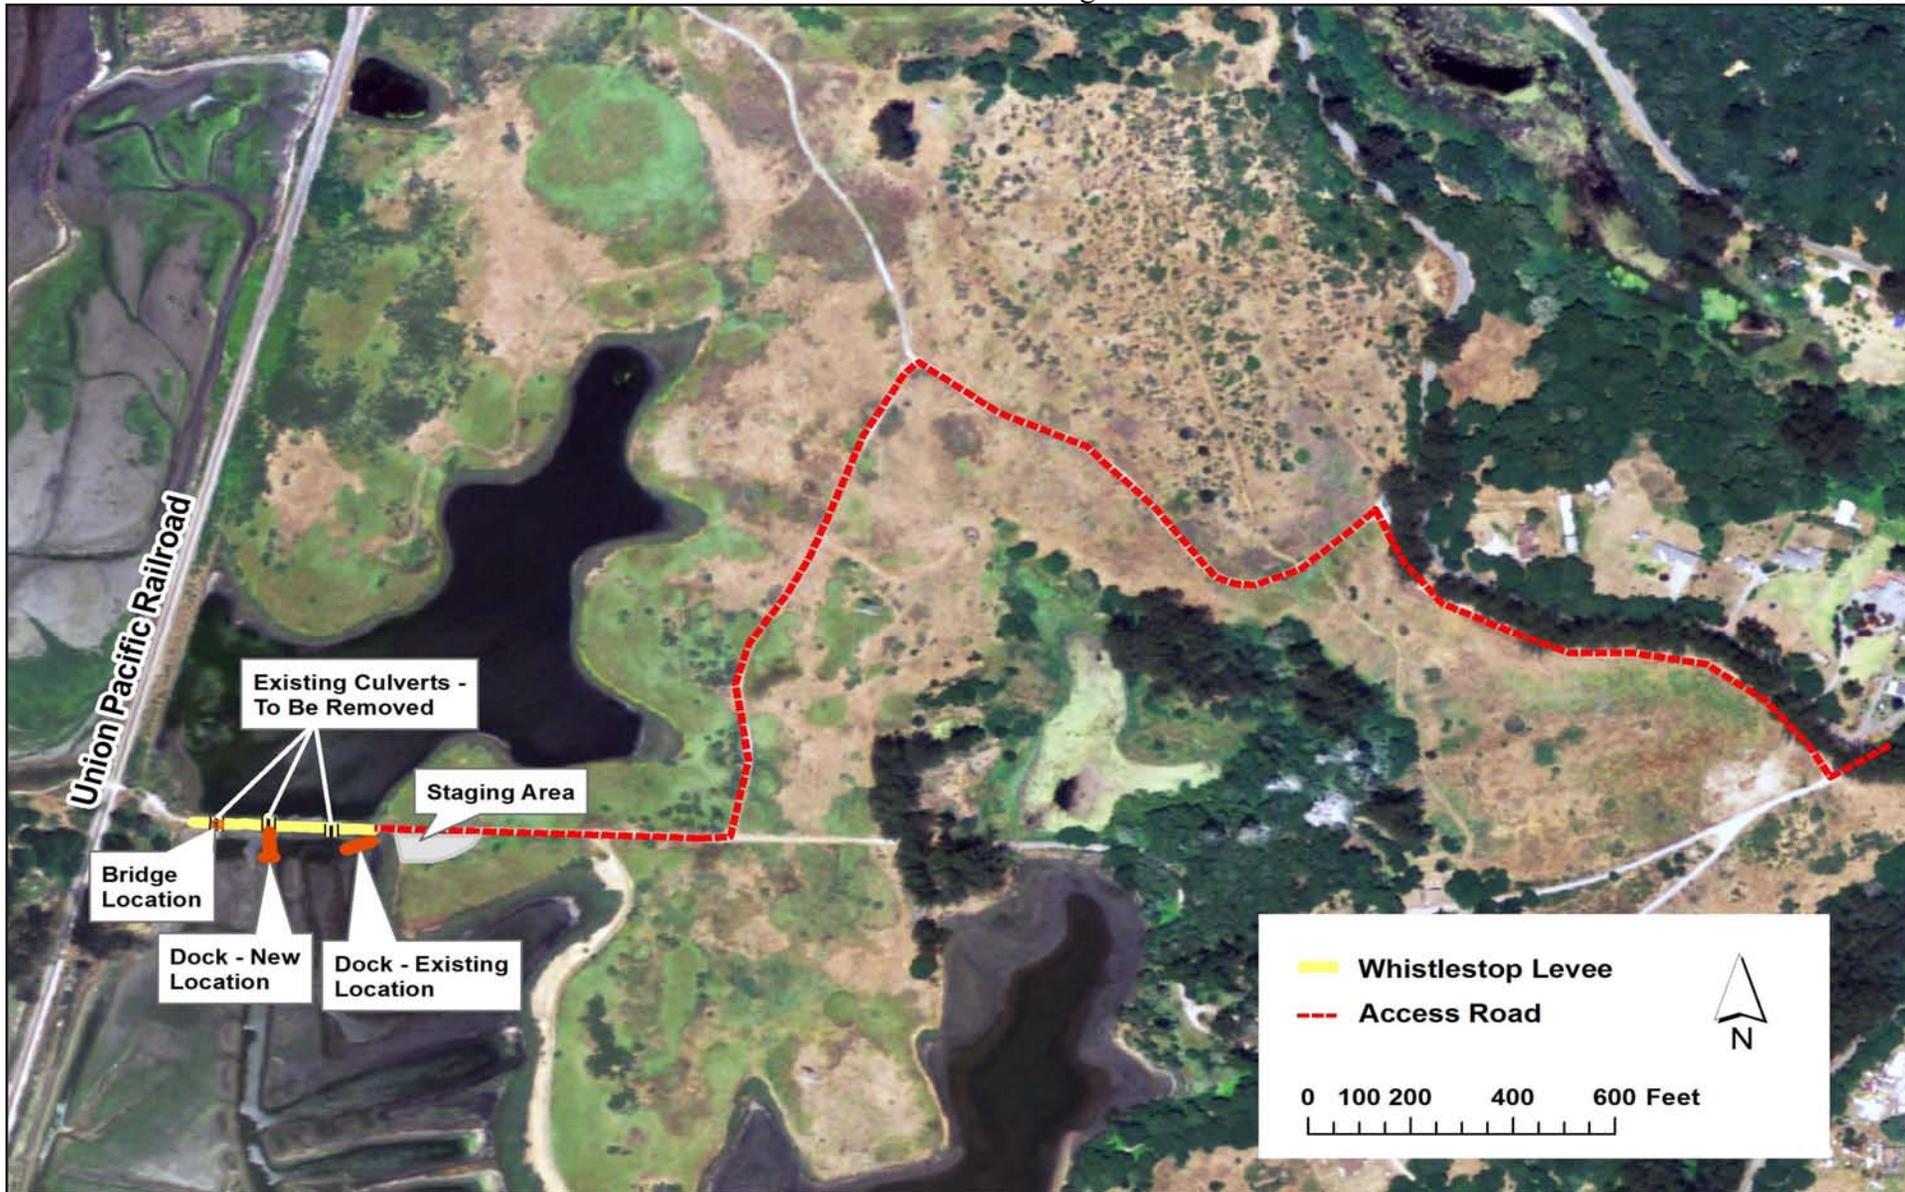
3

Proposed Project Components and Existing Infrastructure

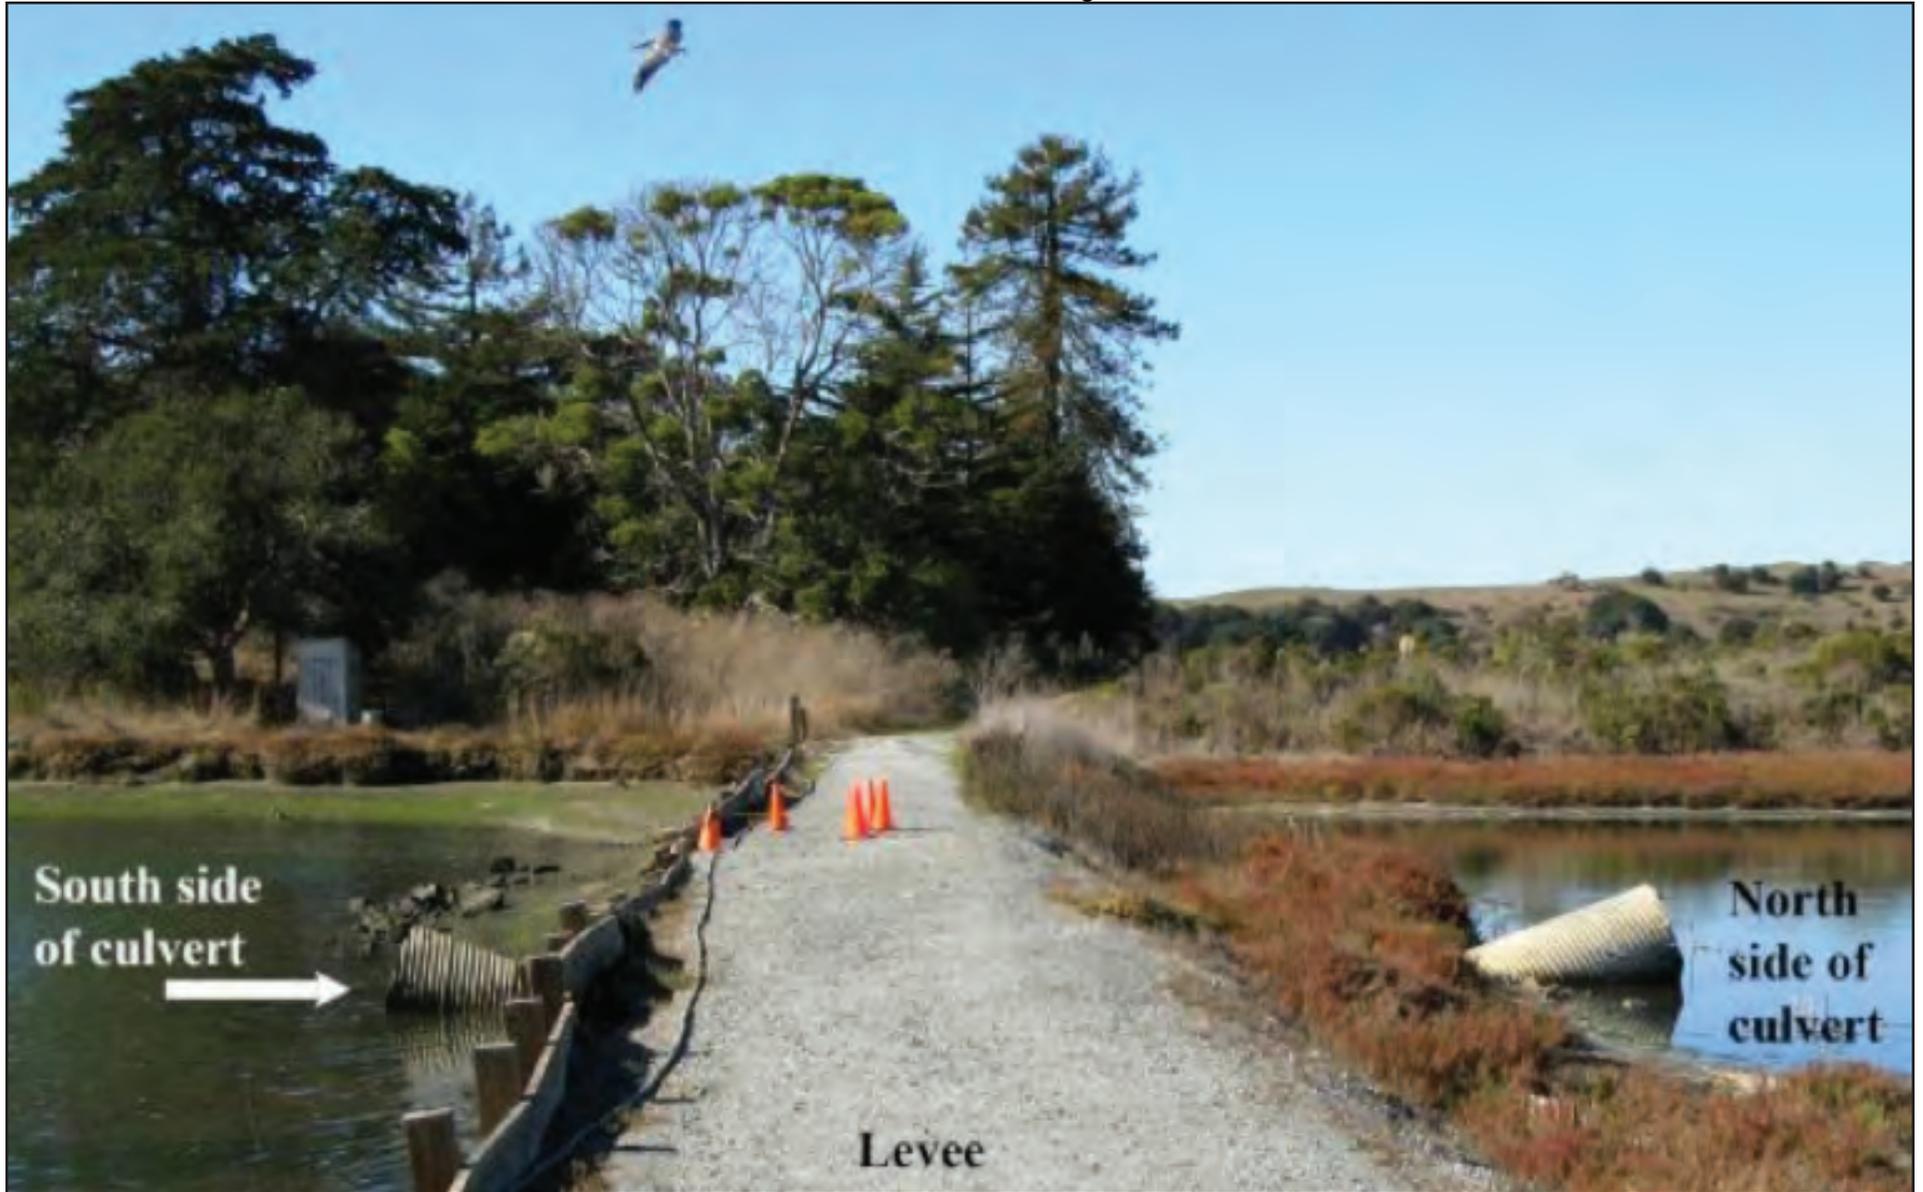
4a

Deformed 36-inch diameter culvert, looking west across Whistlestop levee. Cones mark the location of a large sink hole.

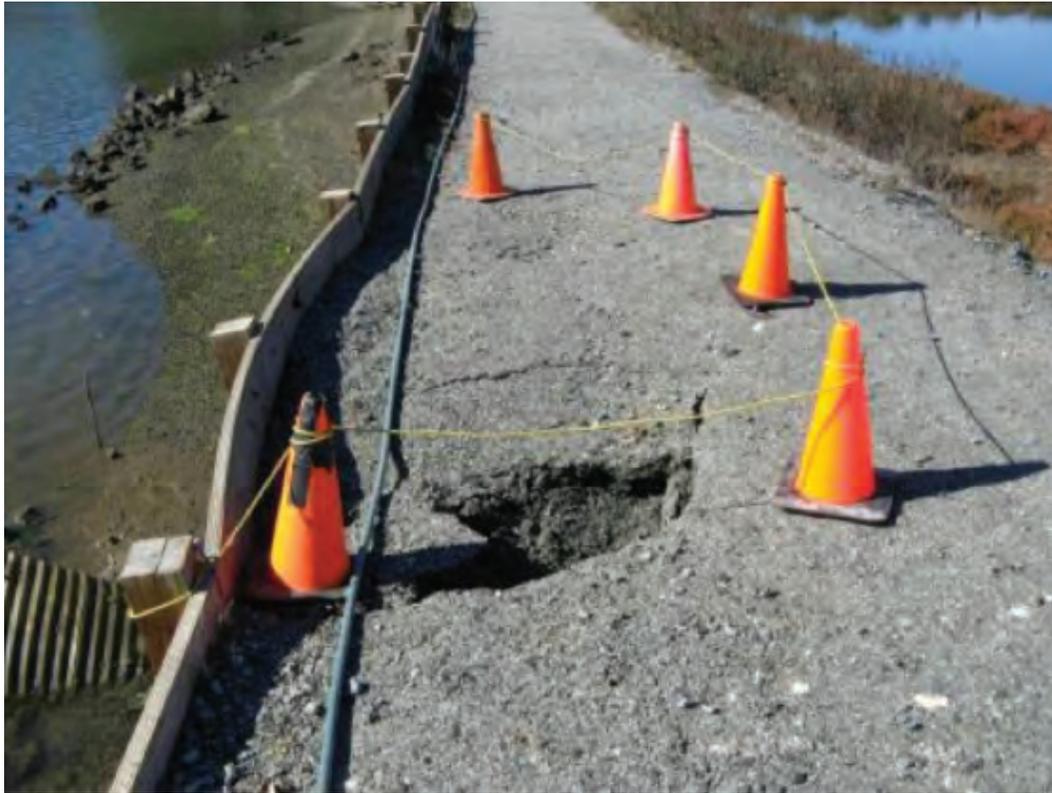
A

Recently formed sinkholes on Whistlestop levee, November 2010. A. at 36-inch diameter culvert, and B. near the 24-inch diameter culvert.

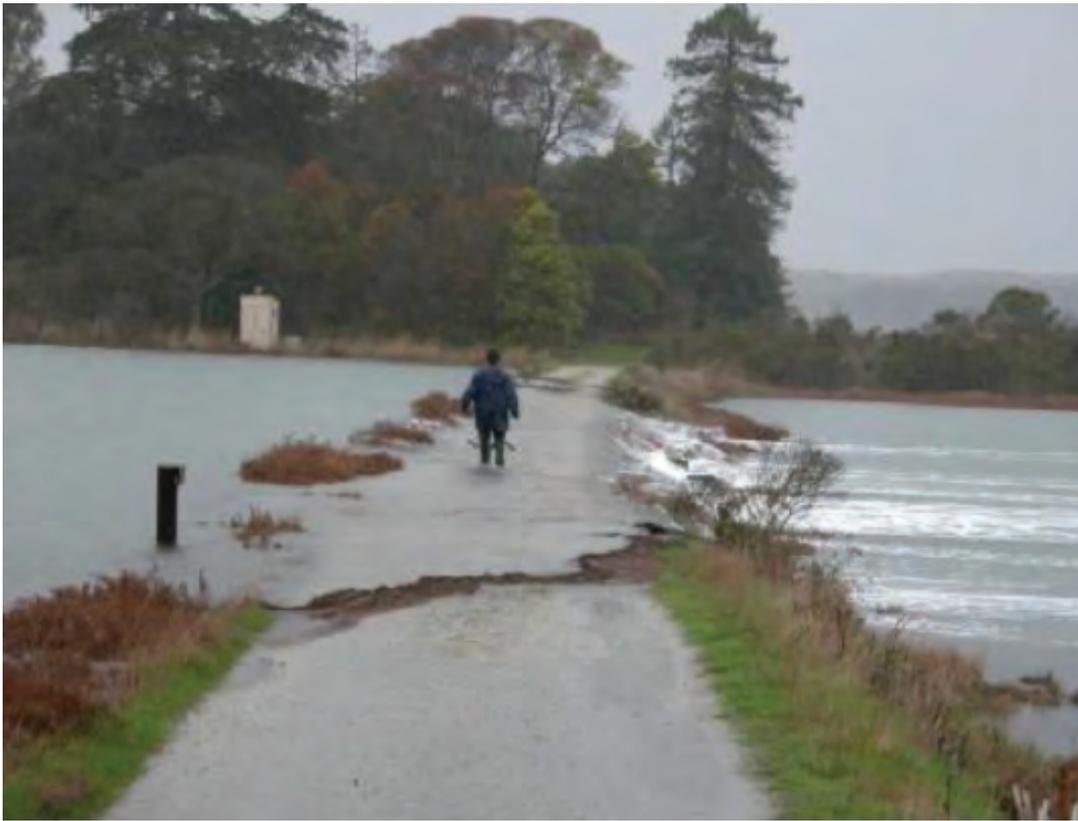
A

Whistlestop levee; A. flooded during a high tide event, and B. showing the deformed retaining wall on its south side.
