## ROUGHENED CHANNEL CONSTRUCTION

**SAN FRANCISQUITO CREEK  
 BONDE WEIR FISH PASSAGE  
 IMPROVEMENT  
 Plan Sheet**

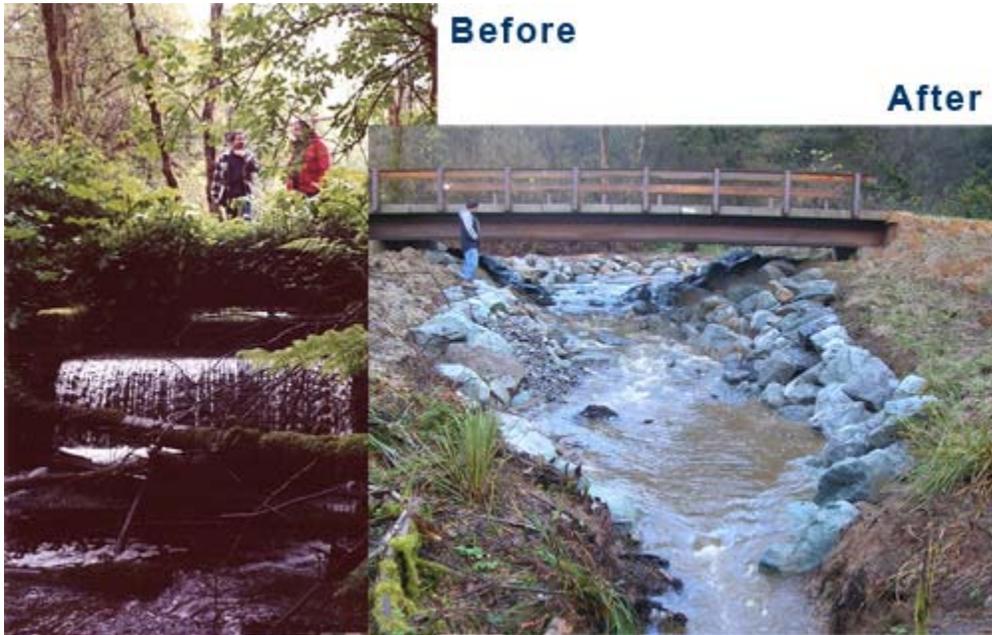
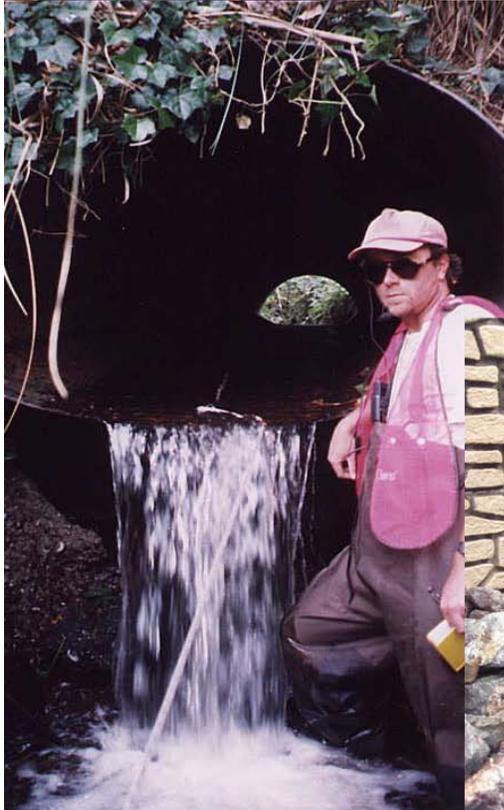
**Culvert outlet before (left) and after (right) replacement. Photos: Ross Taylor and Mendocino Dept. of Transportation.**
