Exhibit 2: Figures and Photos

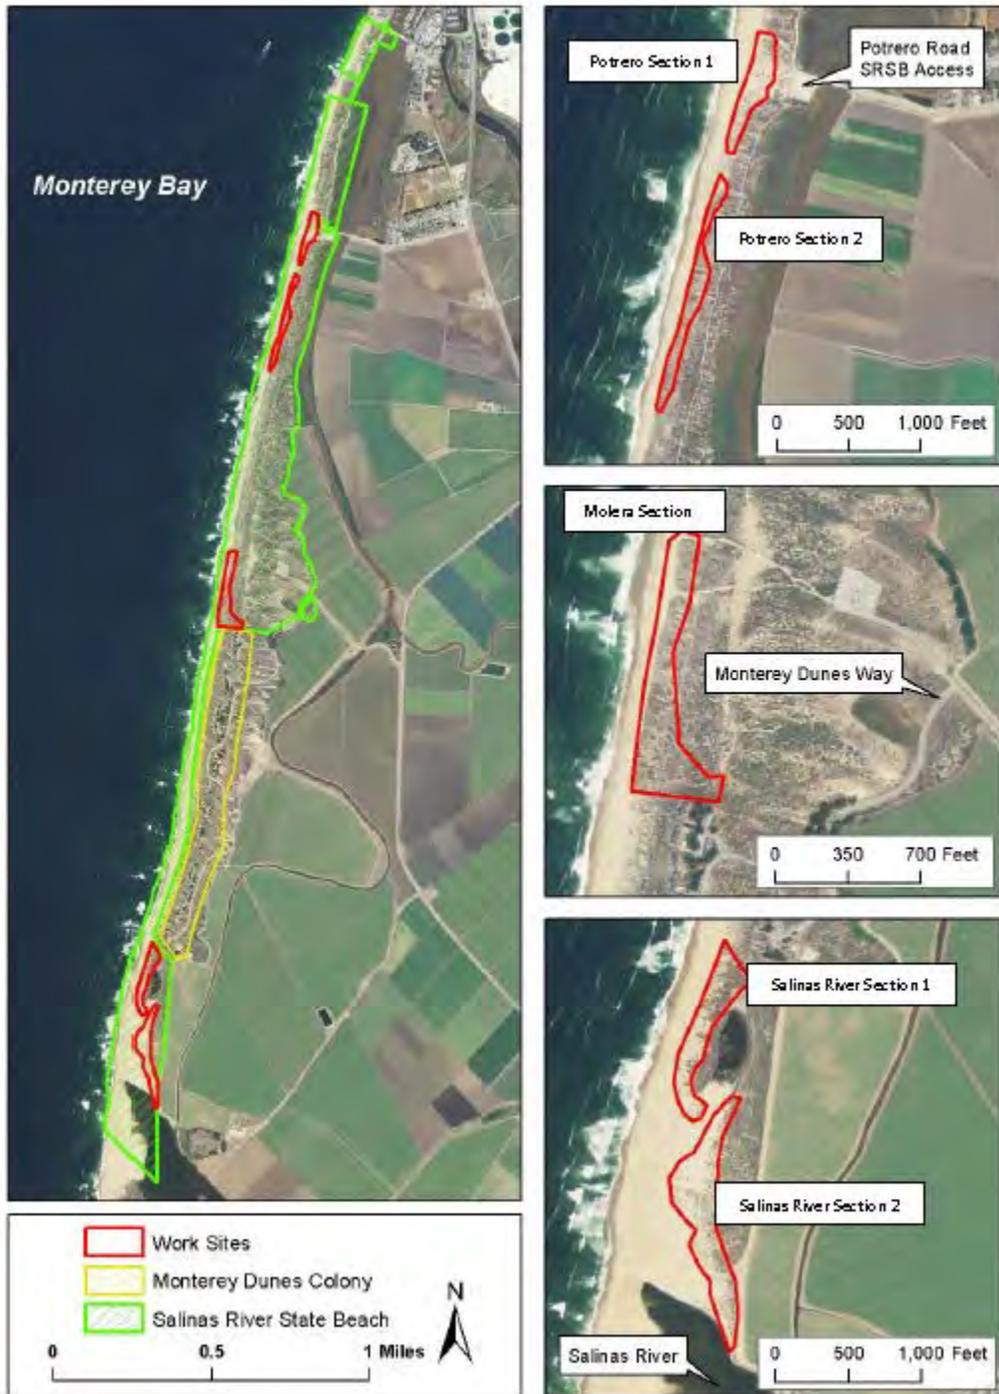
Figure 1. Work sites targeted for invasive species removal and reestablishment of native dune vegetation. Left panel shows overview of all field sites. Three right panels show closeups of individual restoration sites.

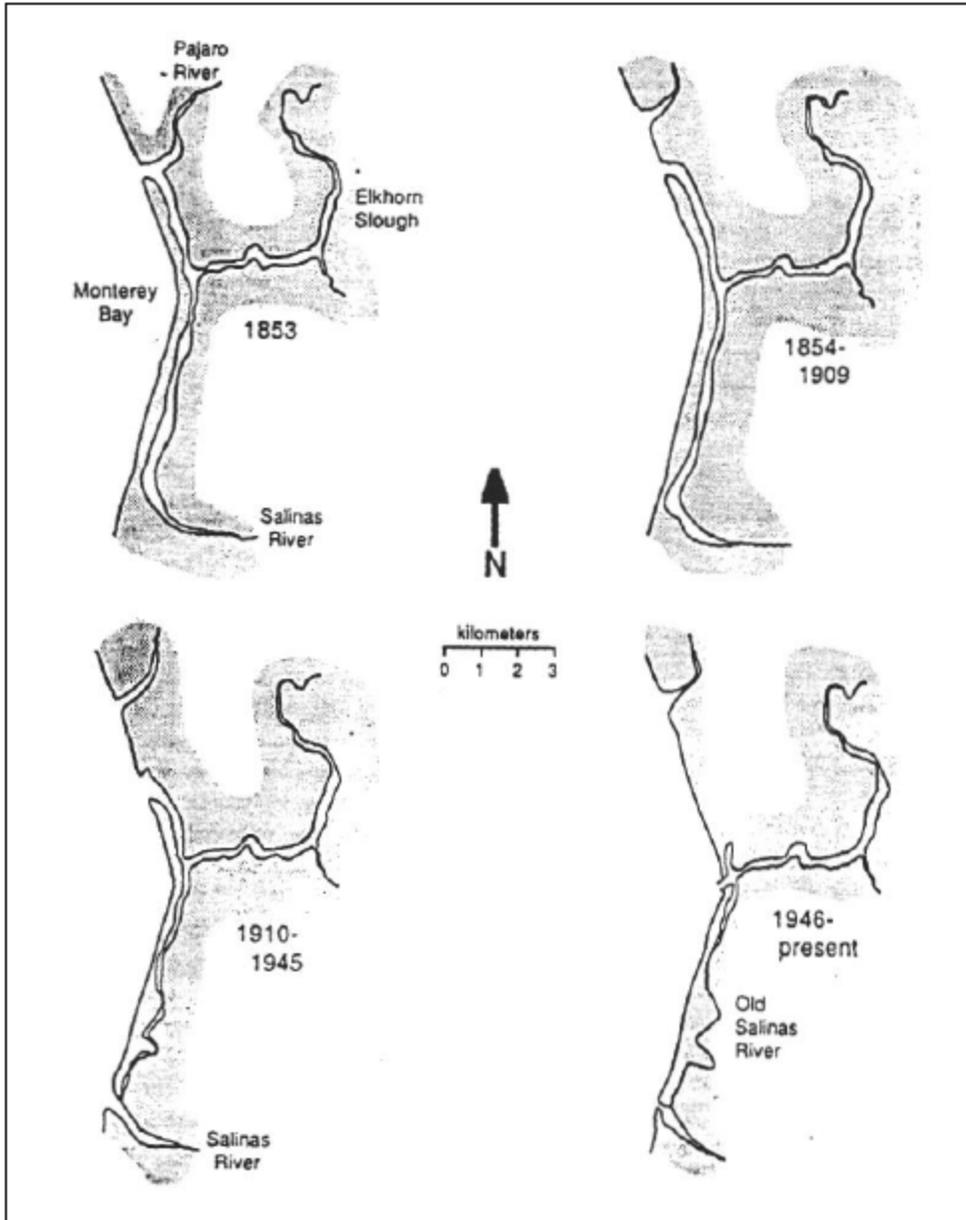
Figure 2. Historical flows of the Salinas River

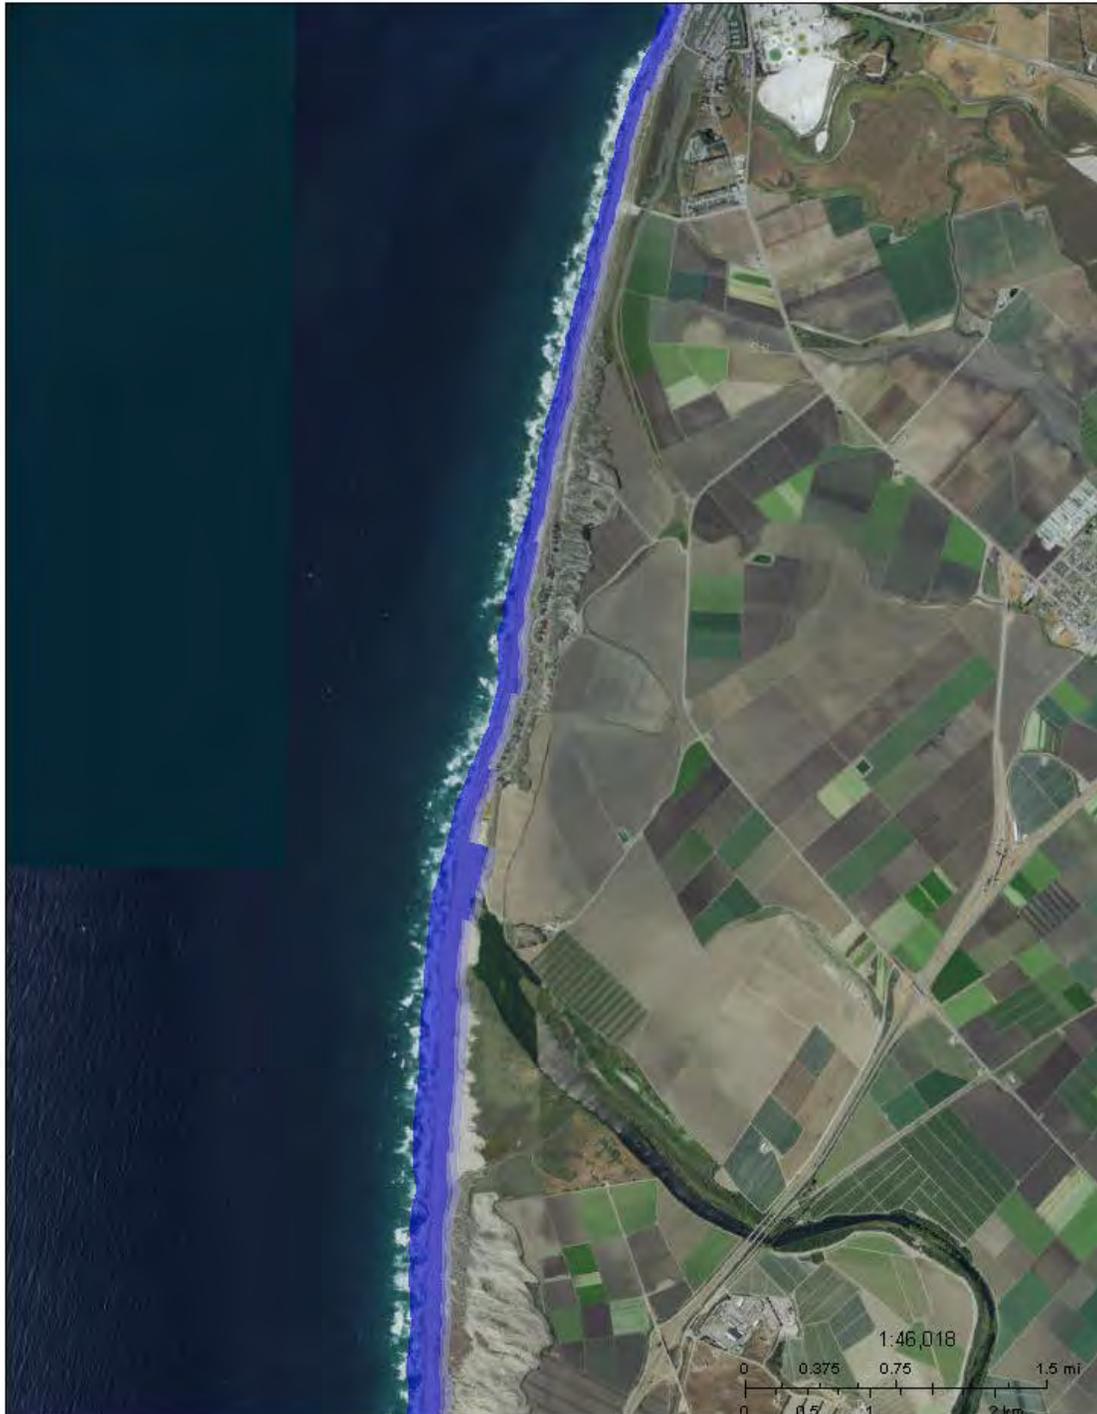
Dune Erosion 2030 High

Figure 3. Aggregate 2030 High Dune Erosion at project location (Map from Coastalresilience.org using ESA hazard layers).

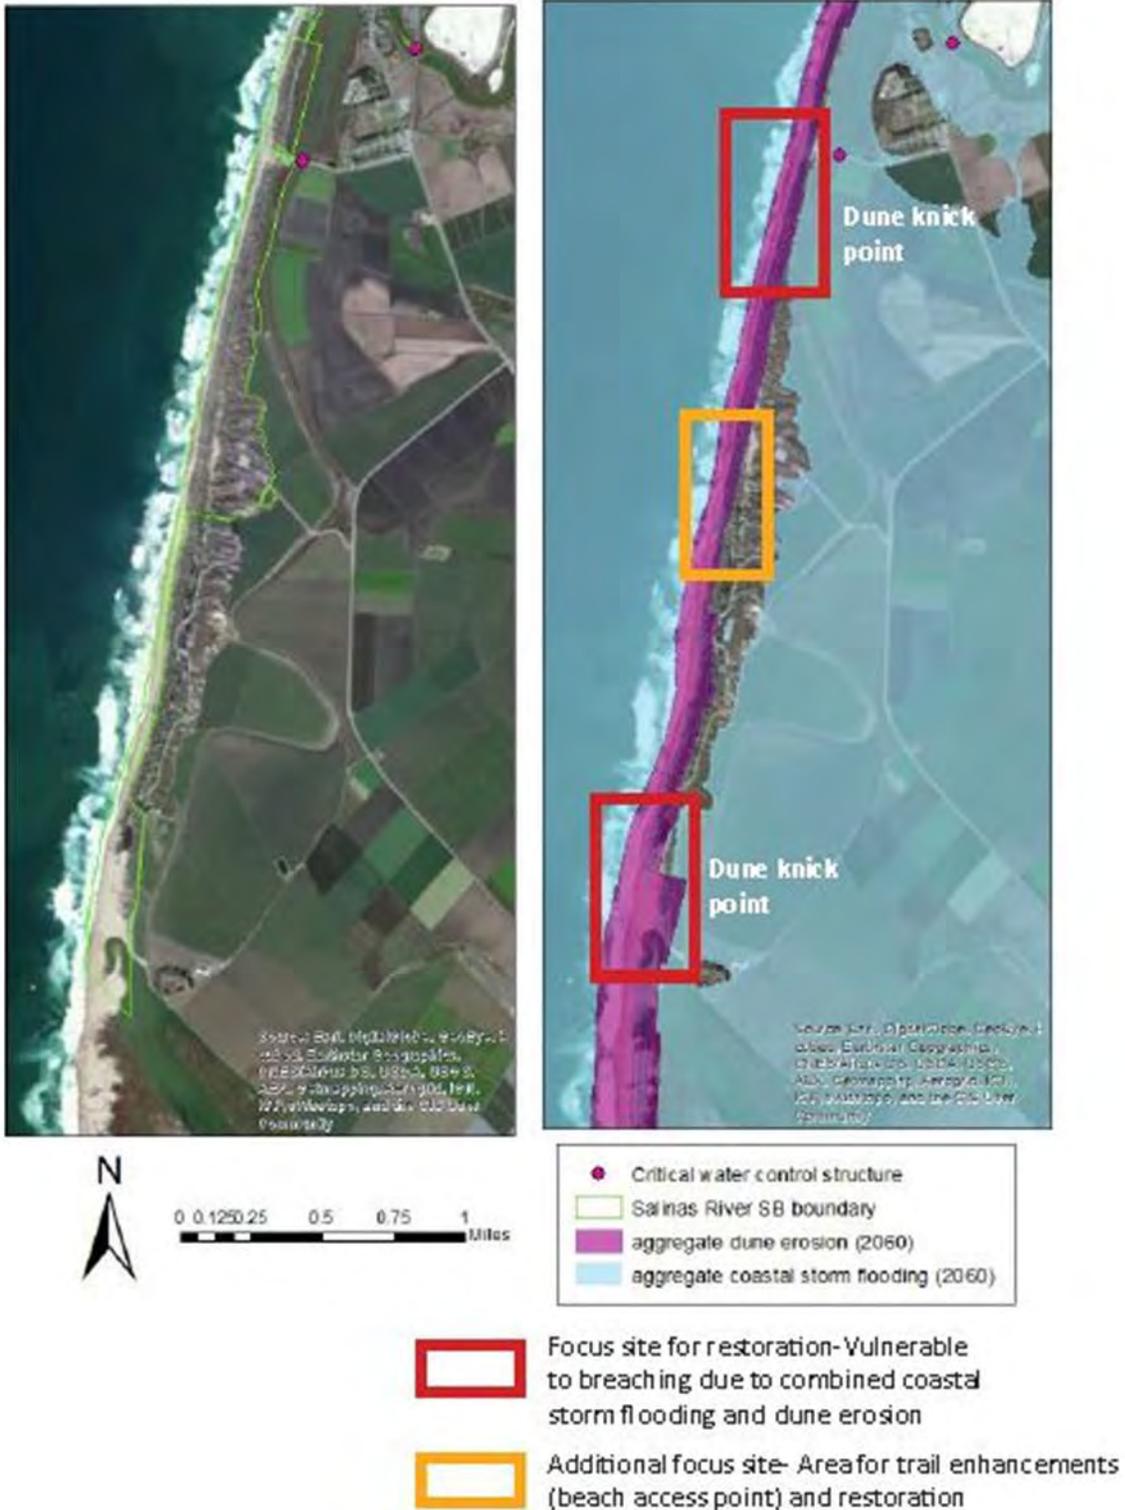
Figure 4. Identified areas vulnerable to breaching due to dune erosion and coastal storm flooding (ESA PWA 2014, 2060 aggregate dune erosion and coastal storm flooding layers).

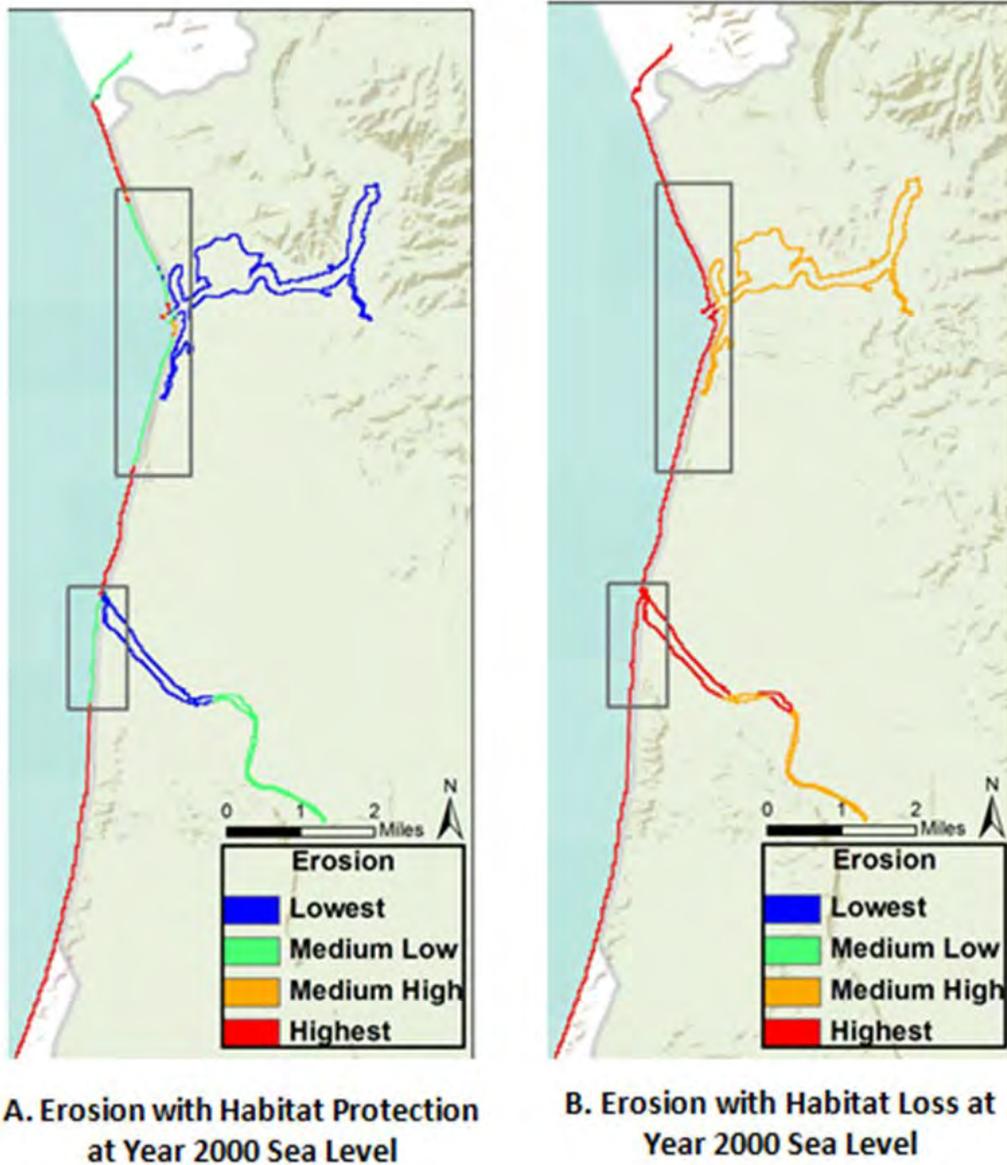
Figure 5. Effects of habitat on Erosion Index. Distribution of Erosion Index ranks along the northern GMC region at year 2000 sea levels in two scenarios: A) with habitat protection and B) with habitat loss. Note that the Erosion Index values of the boxed region increase from medium low to highest erosion ranking without the protective services of habitat. (Vulnerability analysis conducted by Center for Ocean Solutions and Natural Capital Project during IRWM Planning process, 2012.)

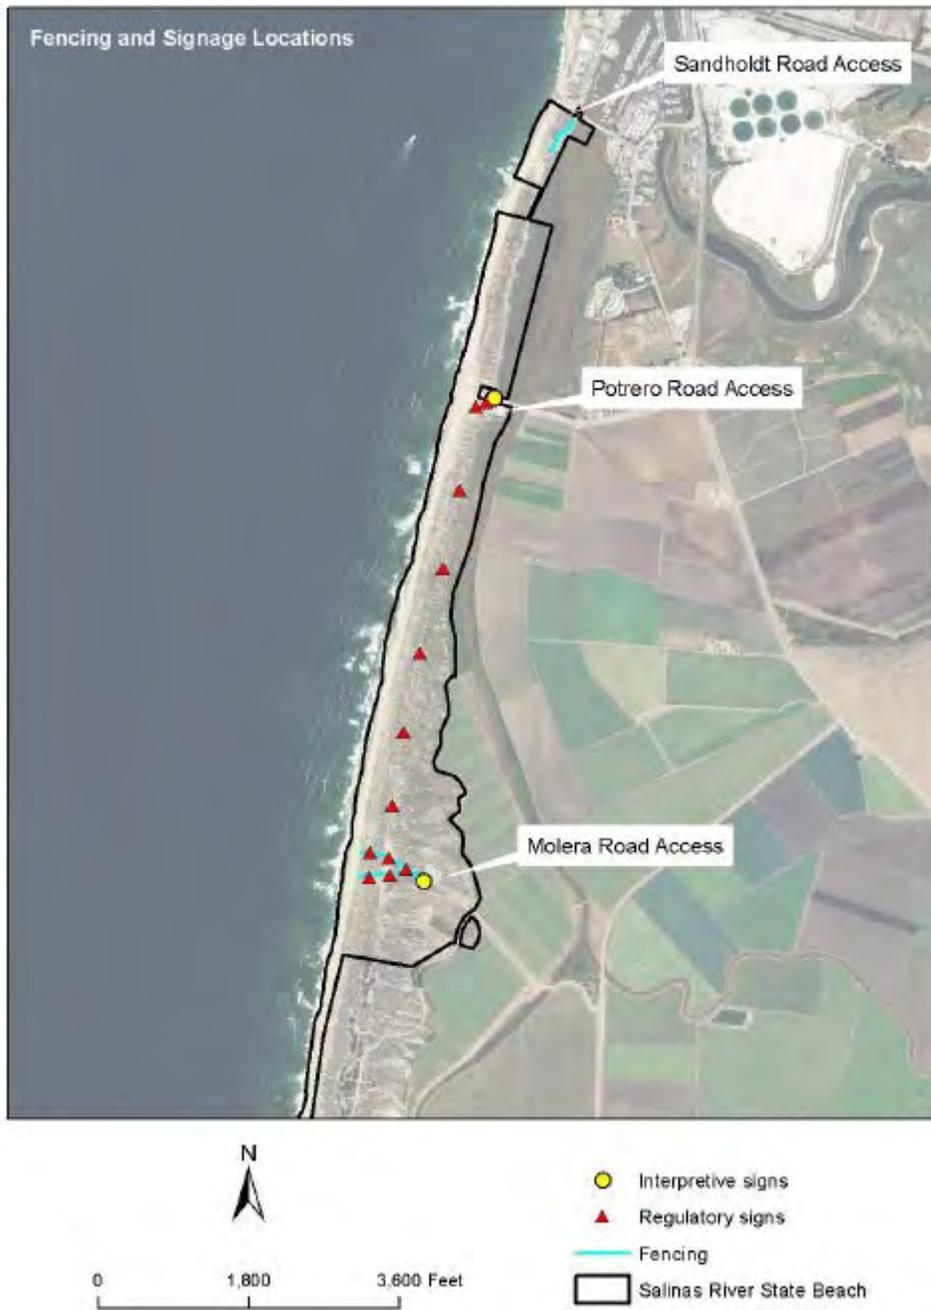
Figure 6. Fencing and signage priority locations

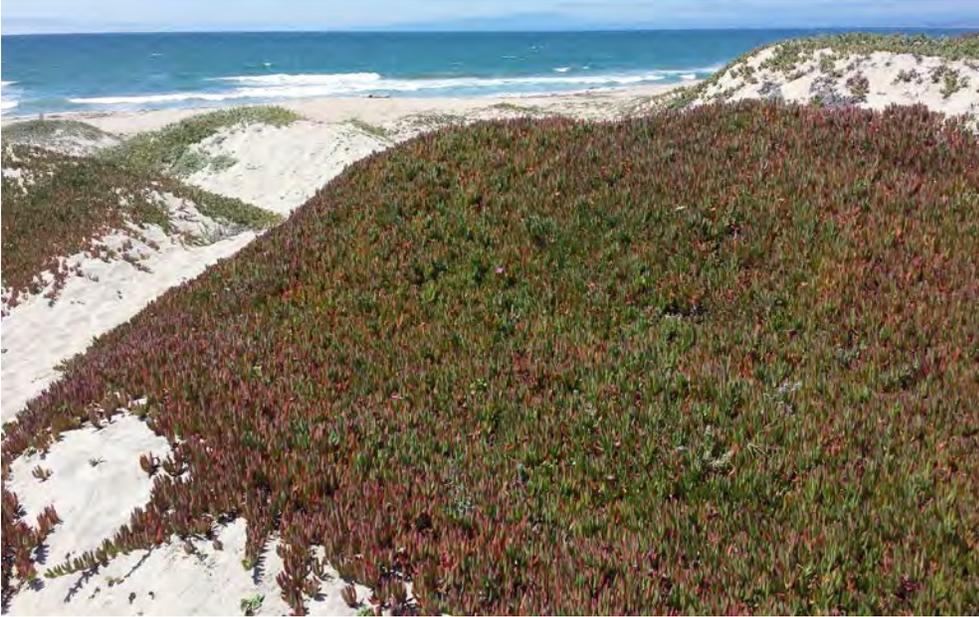
Photo 1. Large mats of iceplant cover the foredunes at Salinas River State Beach

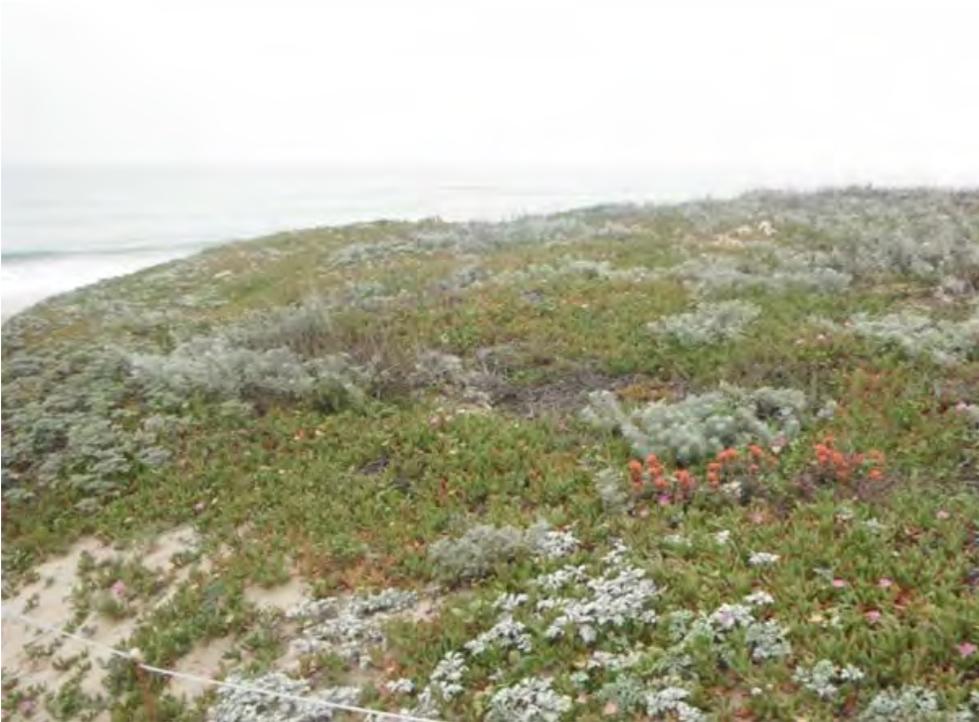
Photo 2. In some locations native plants are interspersed among the iceplant. During iceplant eradication efforts, care will be taken to avoid spraying herbicide on natives; handpulling of iceplant around natives will occur instead.

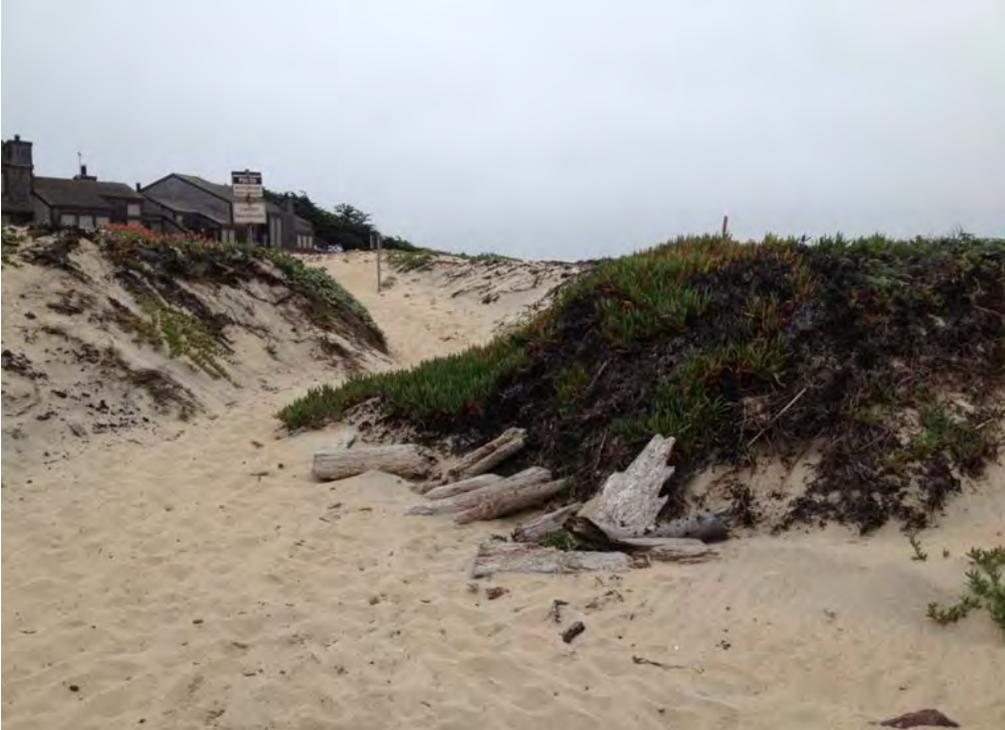
Photo 3. Combined effects of iceplant and unmanaged pathways create erosional scars in the dunes.
