Coastal Conservancy Proposition 1 Proposal - Section 8 Project Maps and Graphics
Indian Creek Habitat Connectivity and Restoration Project - Yurok Tribe

INDEX OF FIGURES

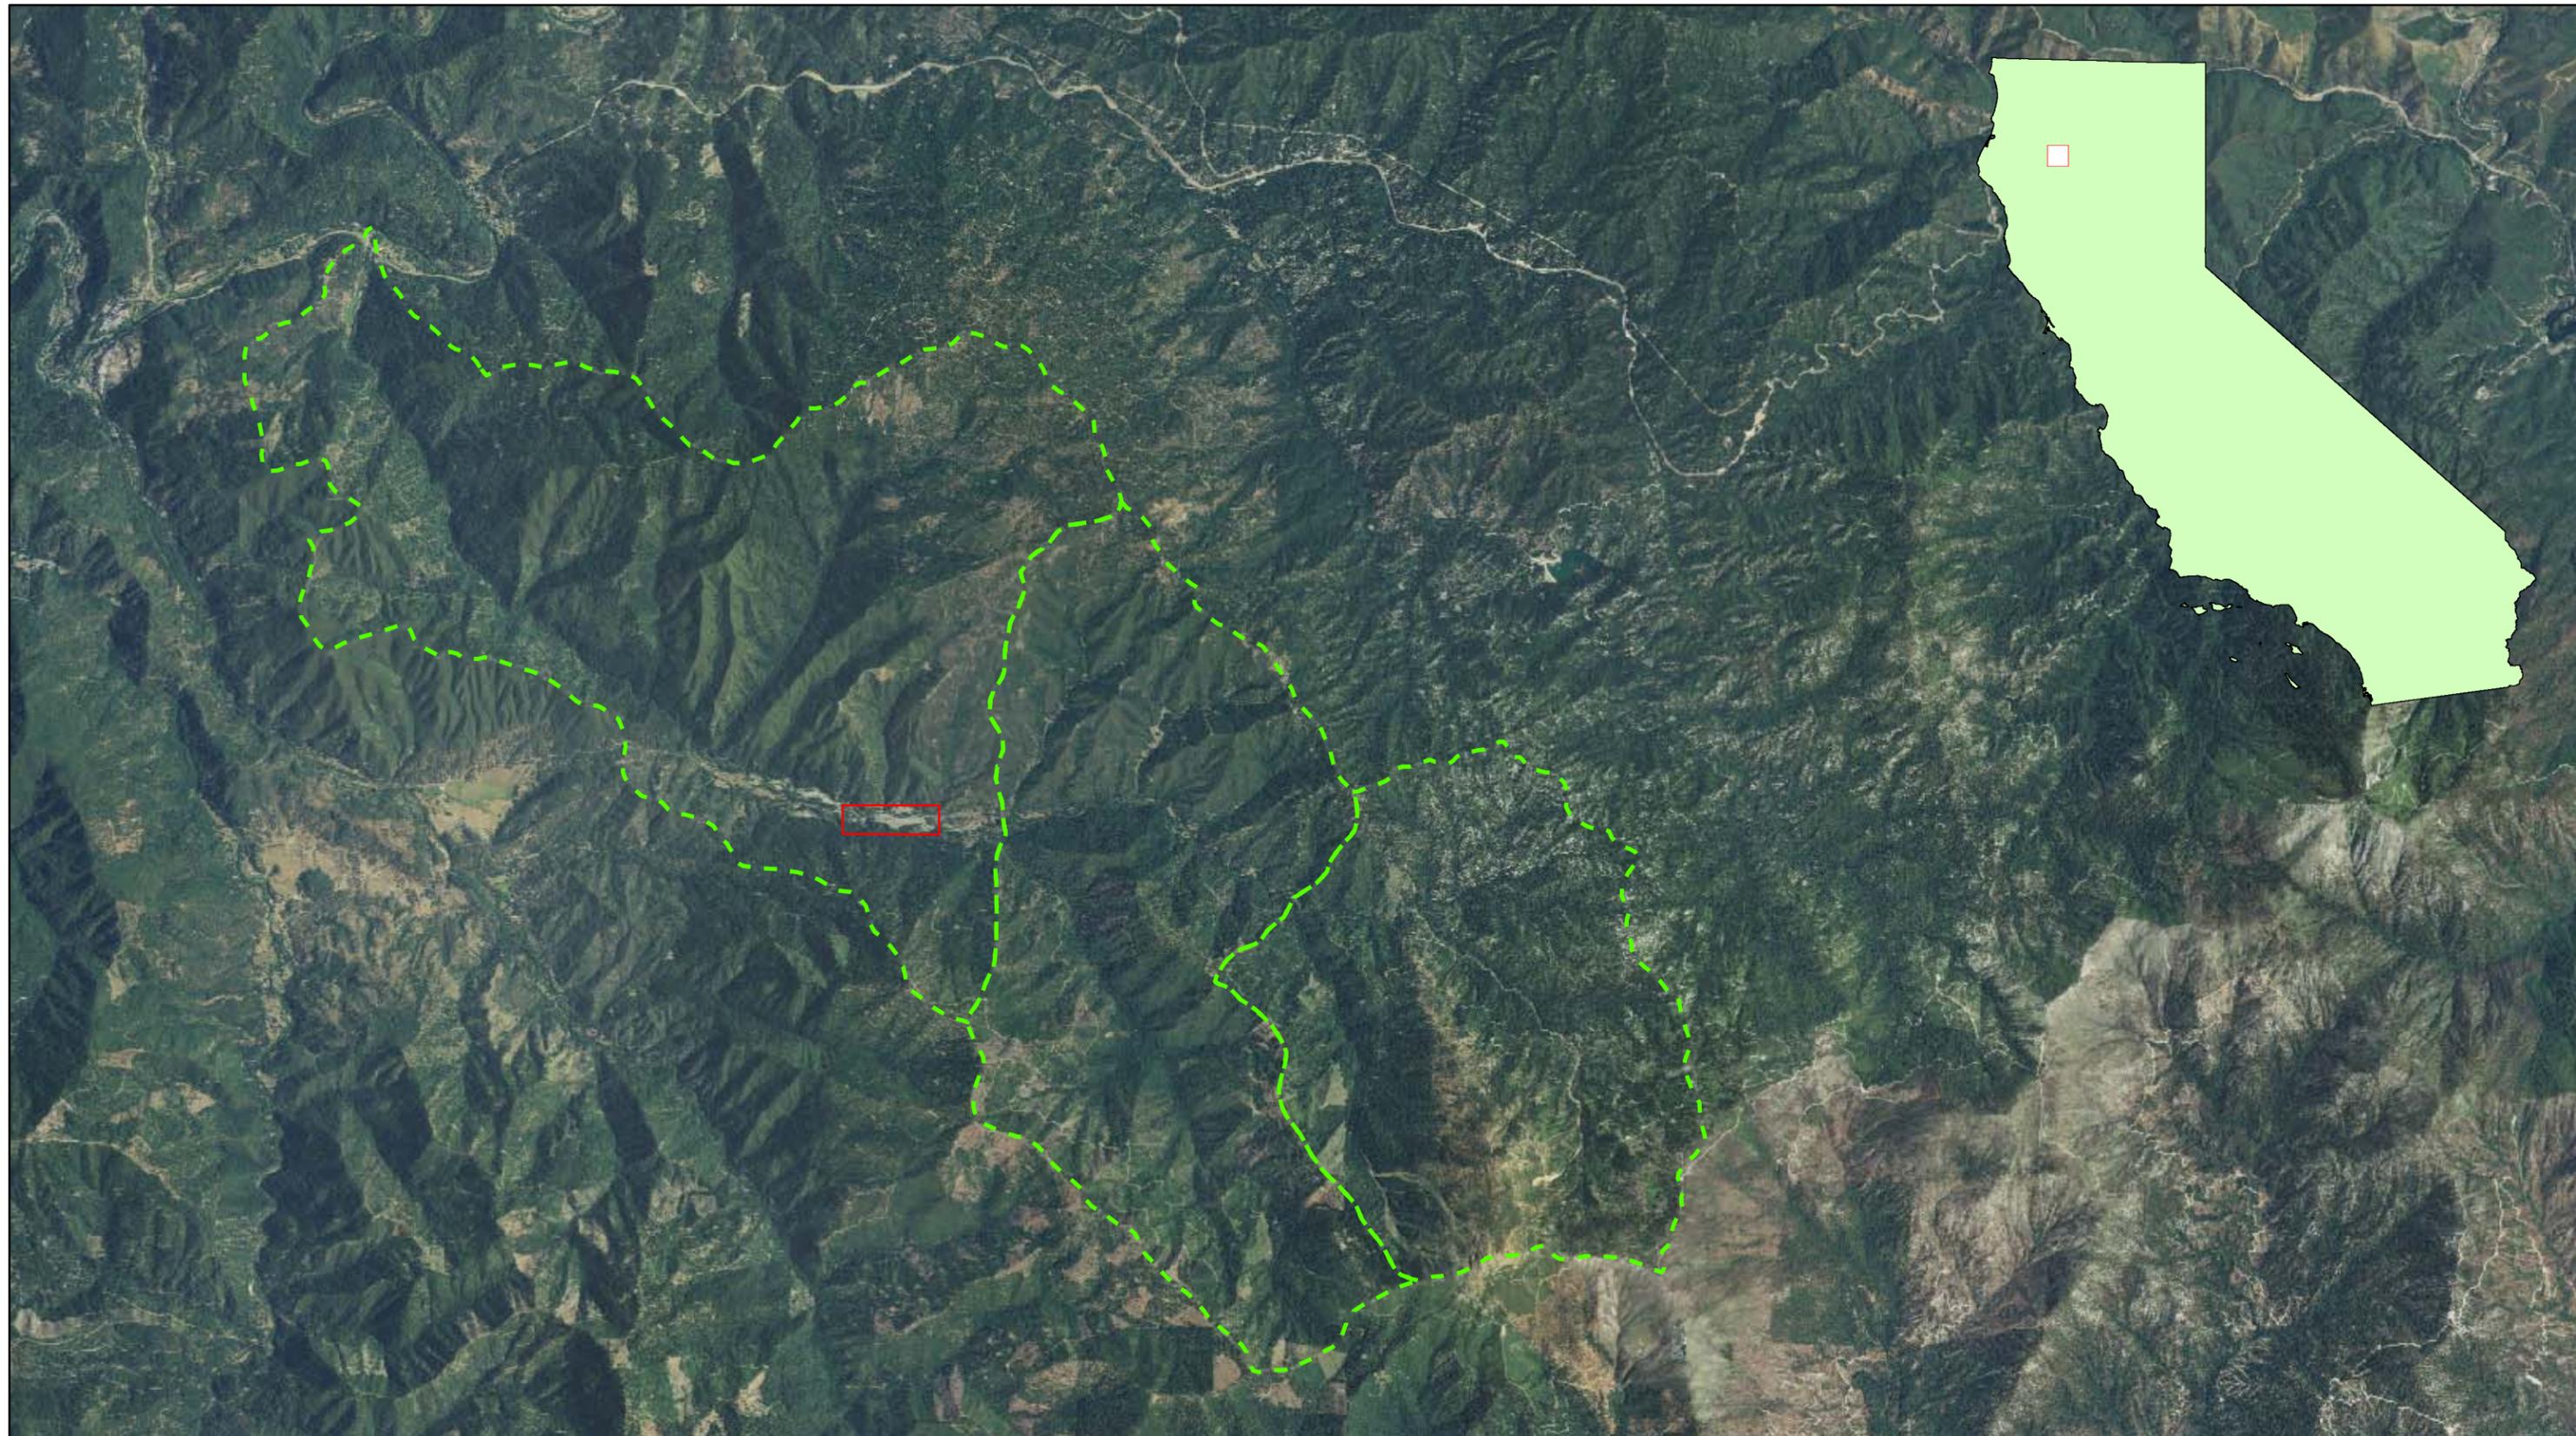
figure 3-1
Indian Creek

Indian Creek Watershed and Project Site

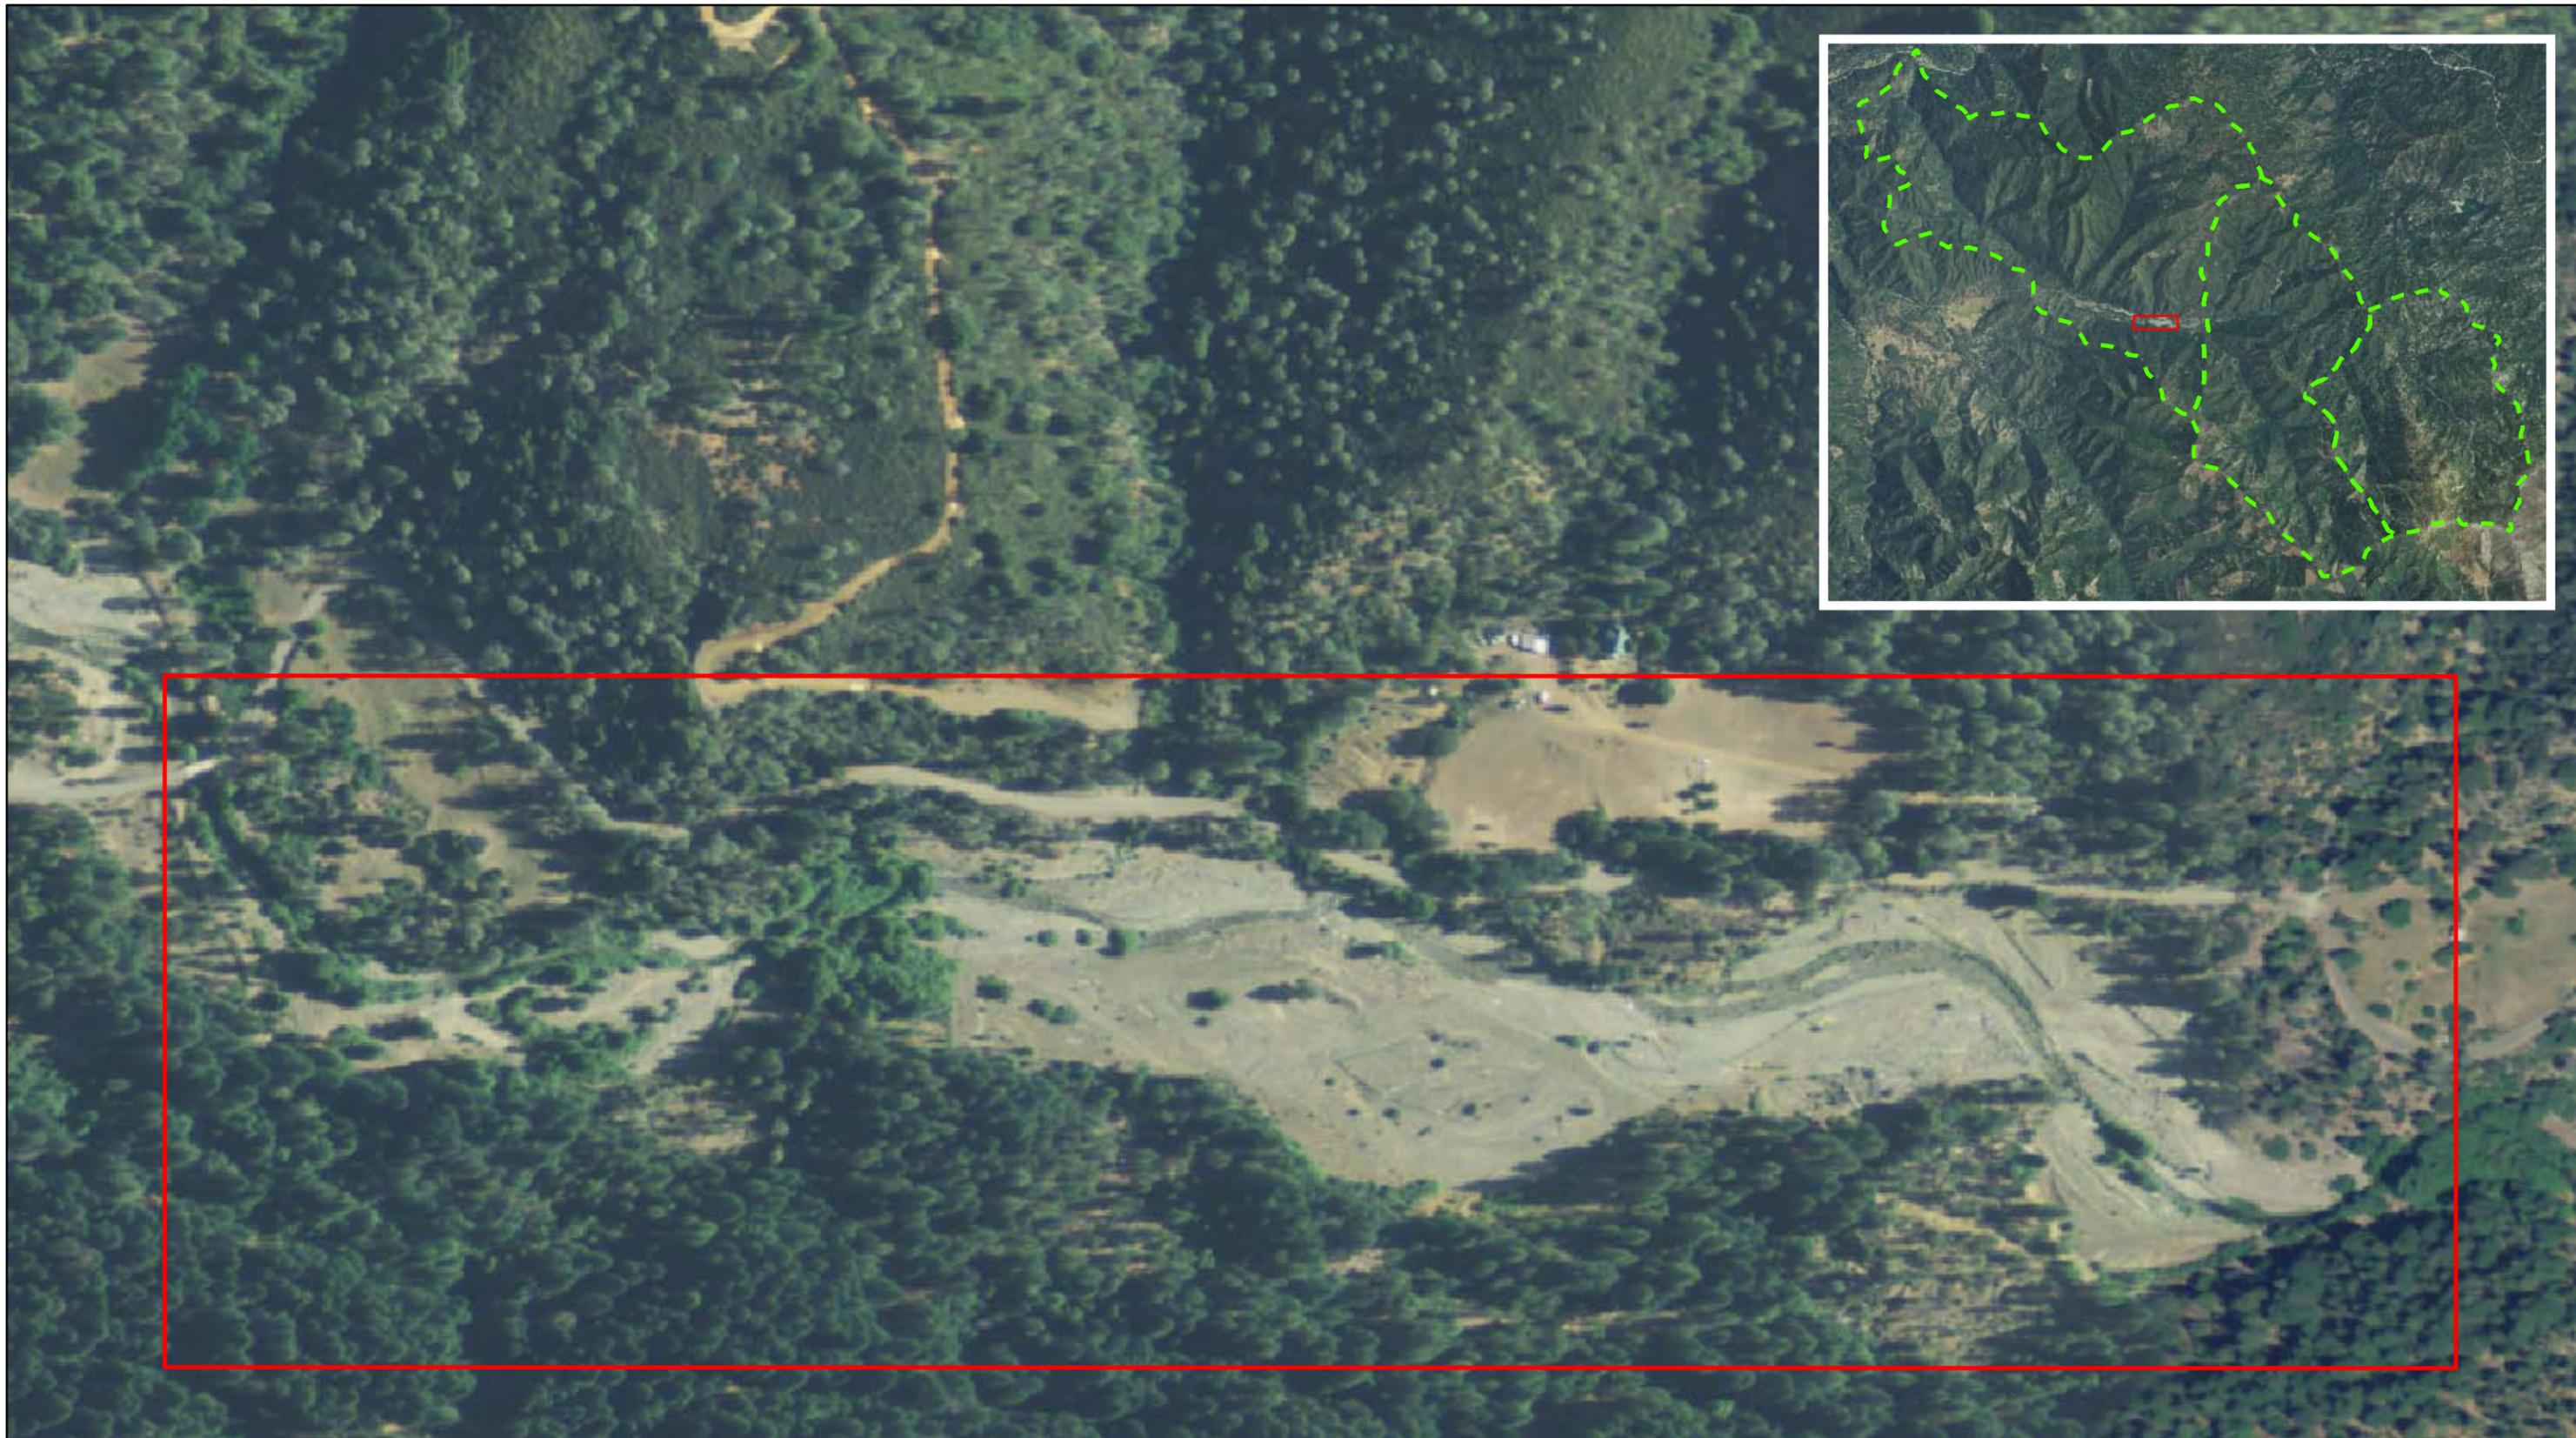
figure 3-2
Indian Creek

Project Site Extents

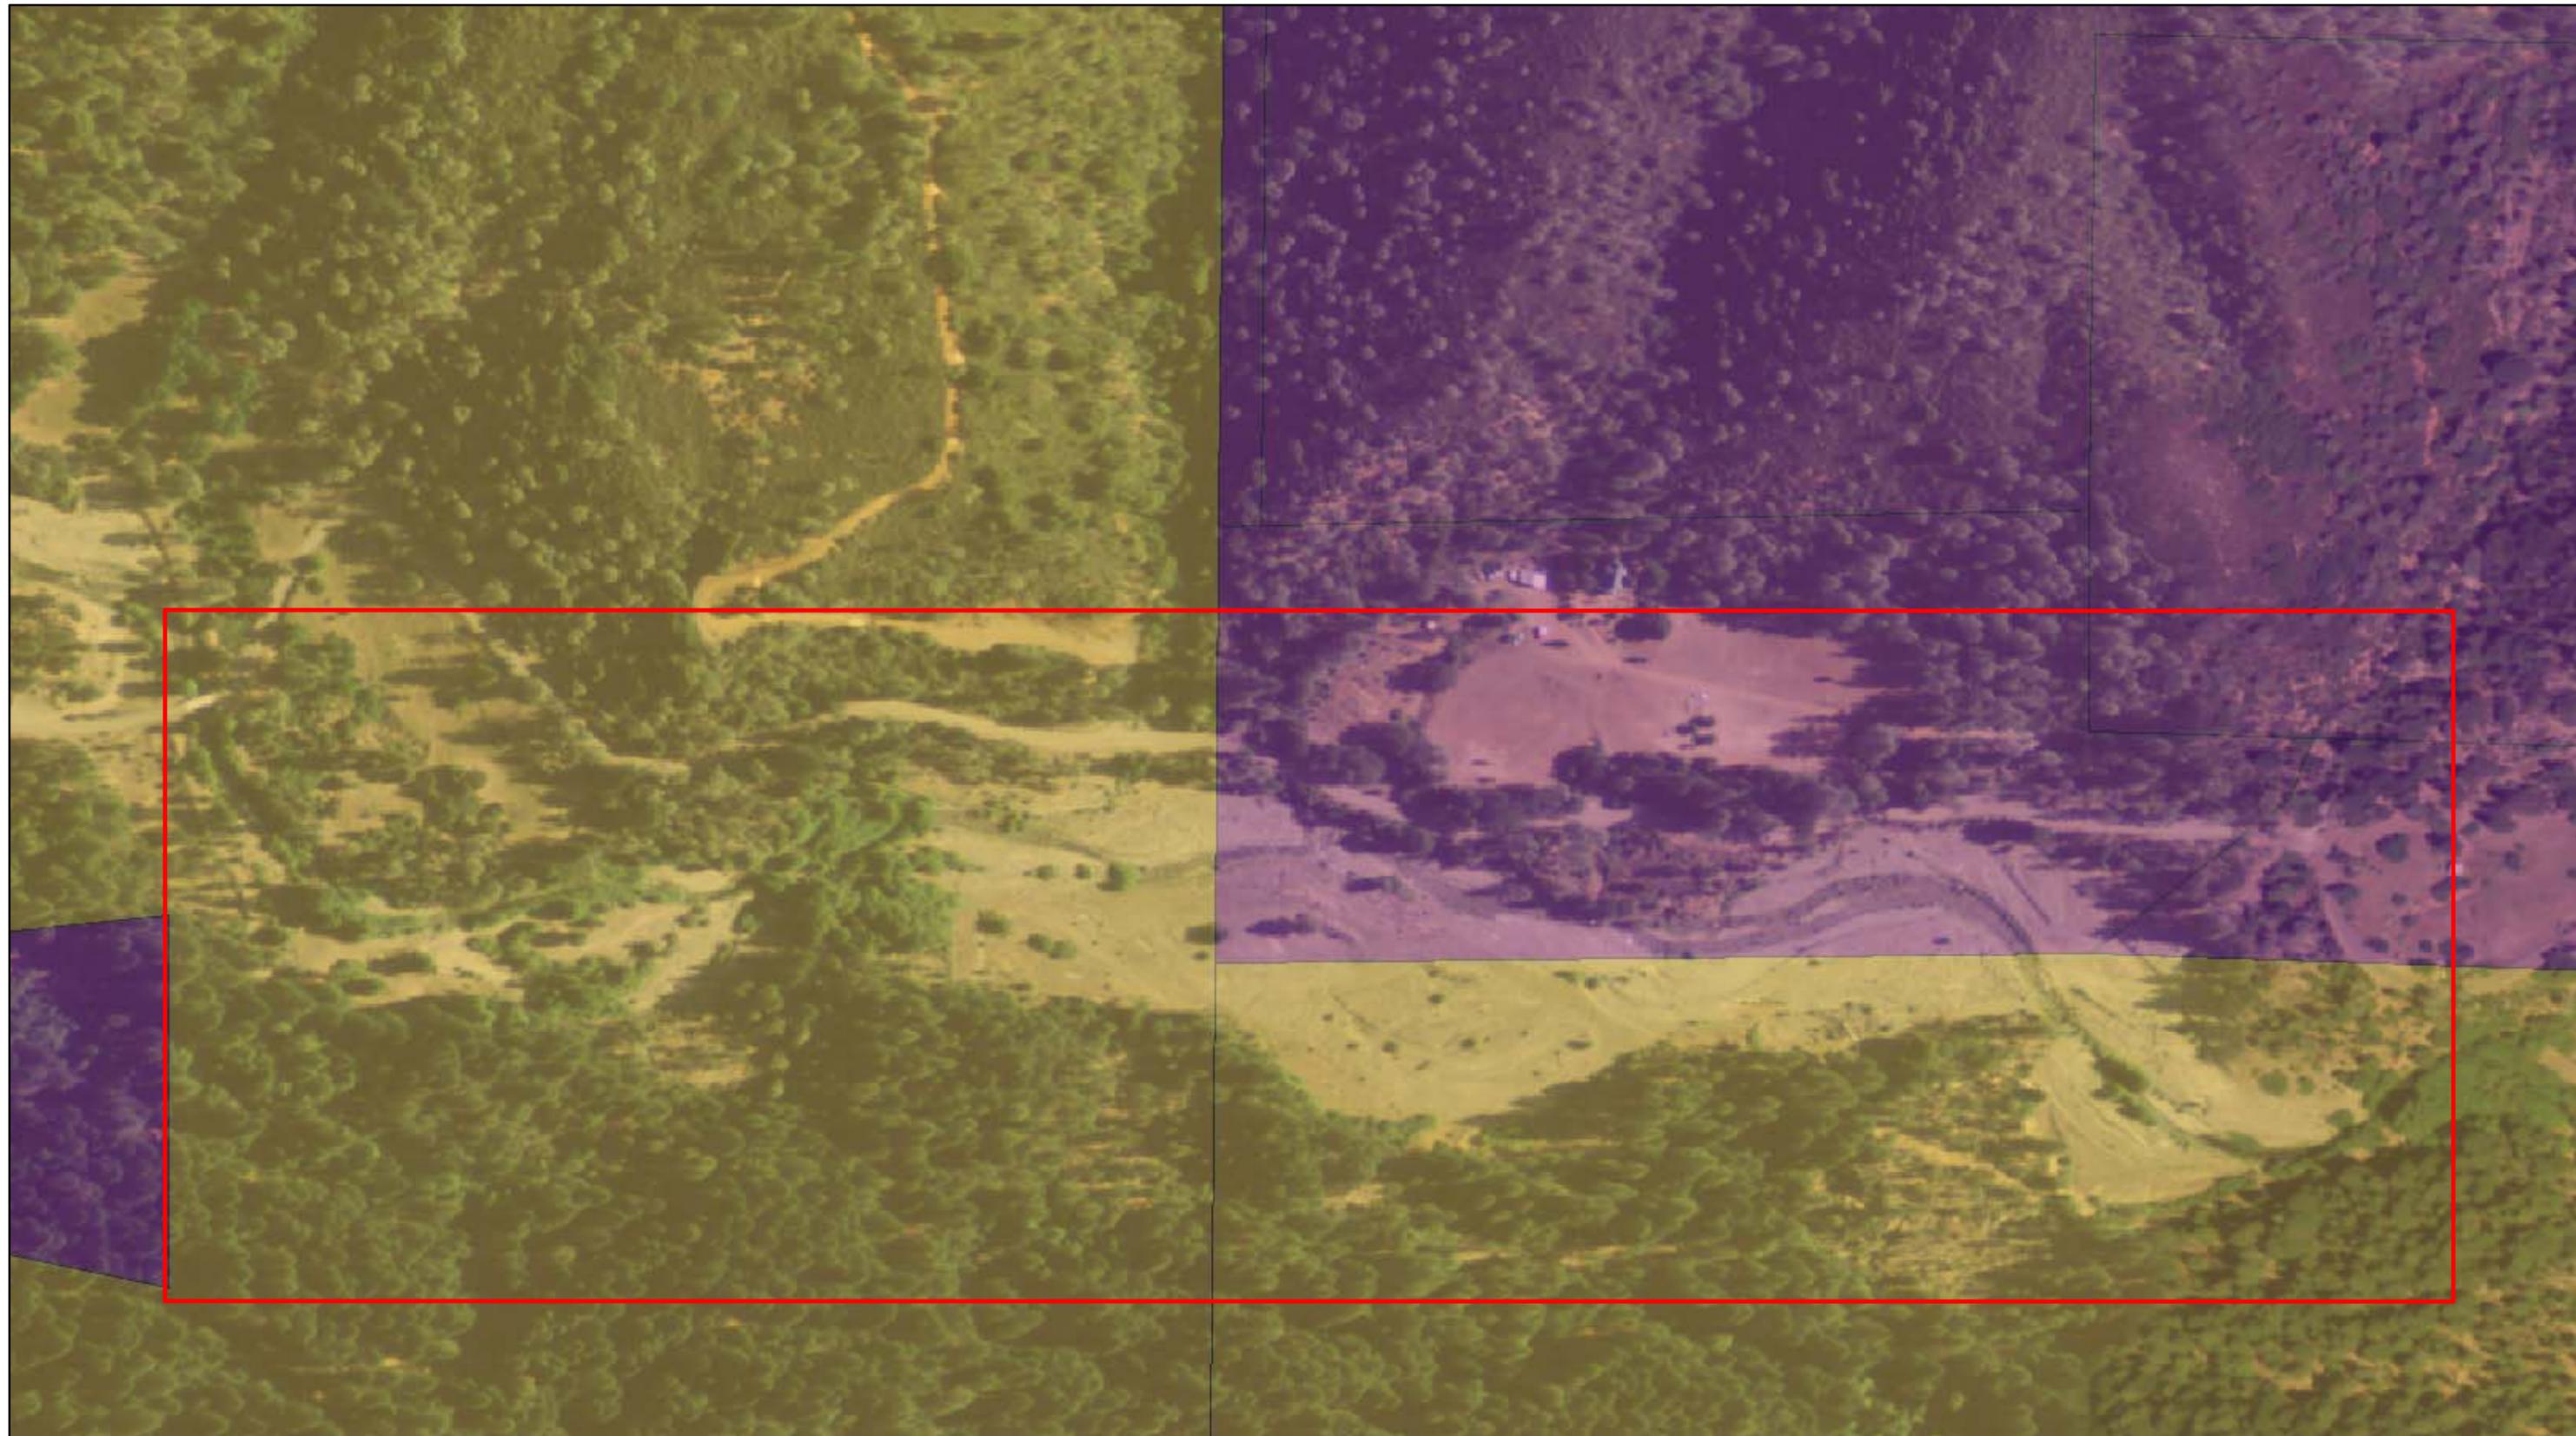
figure 3-3
Indian Creek

Project Site Property Parcels

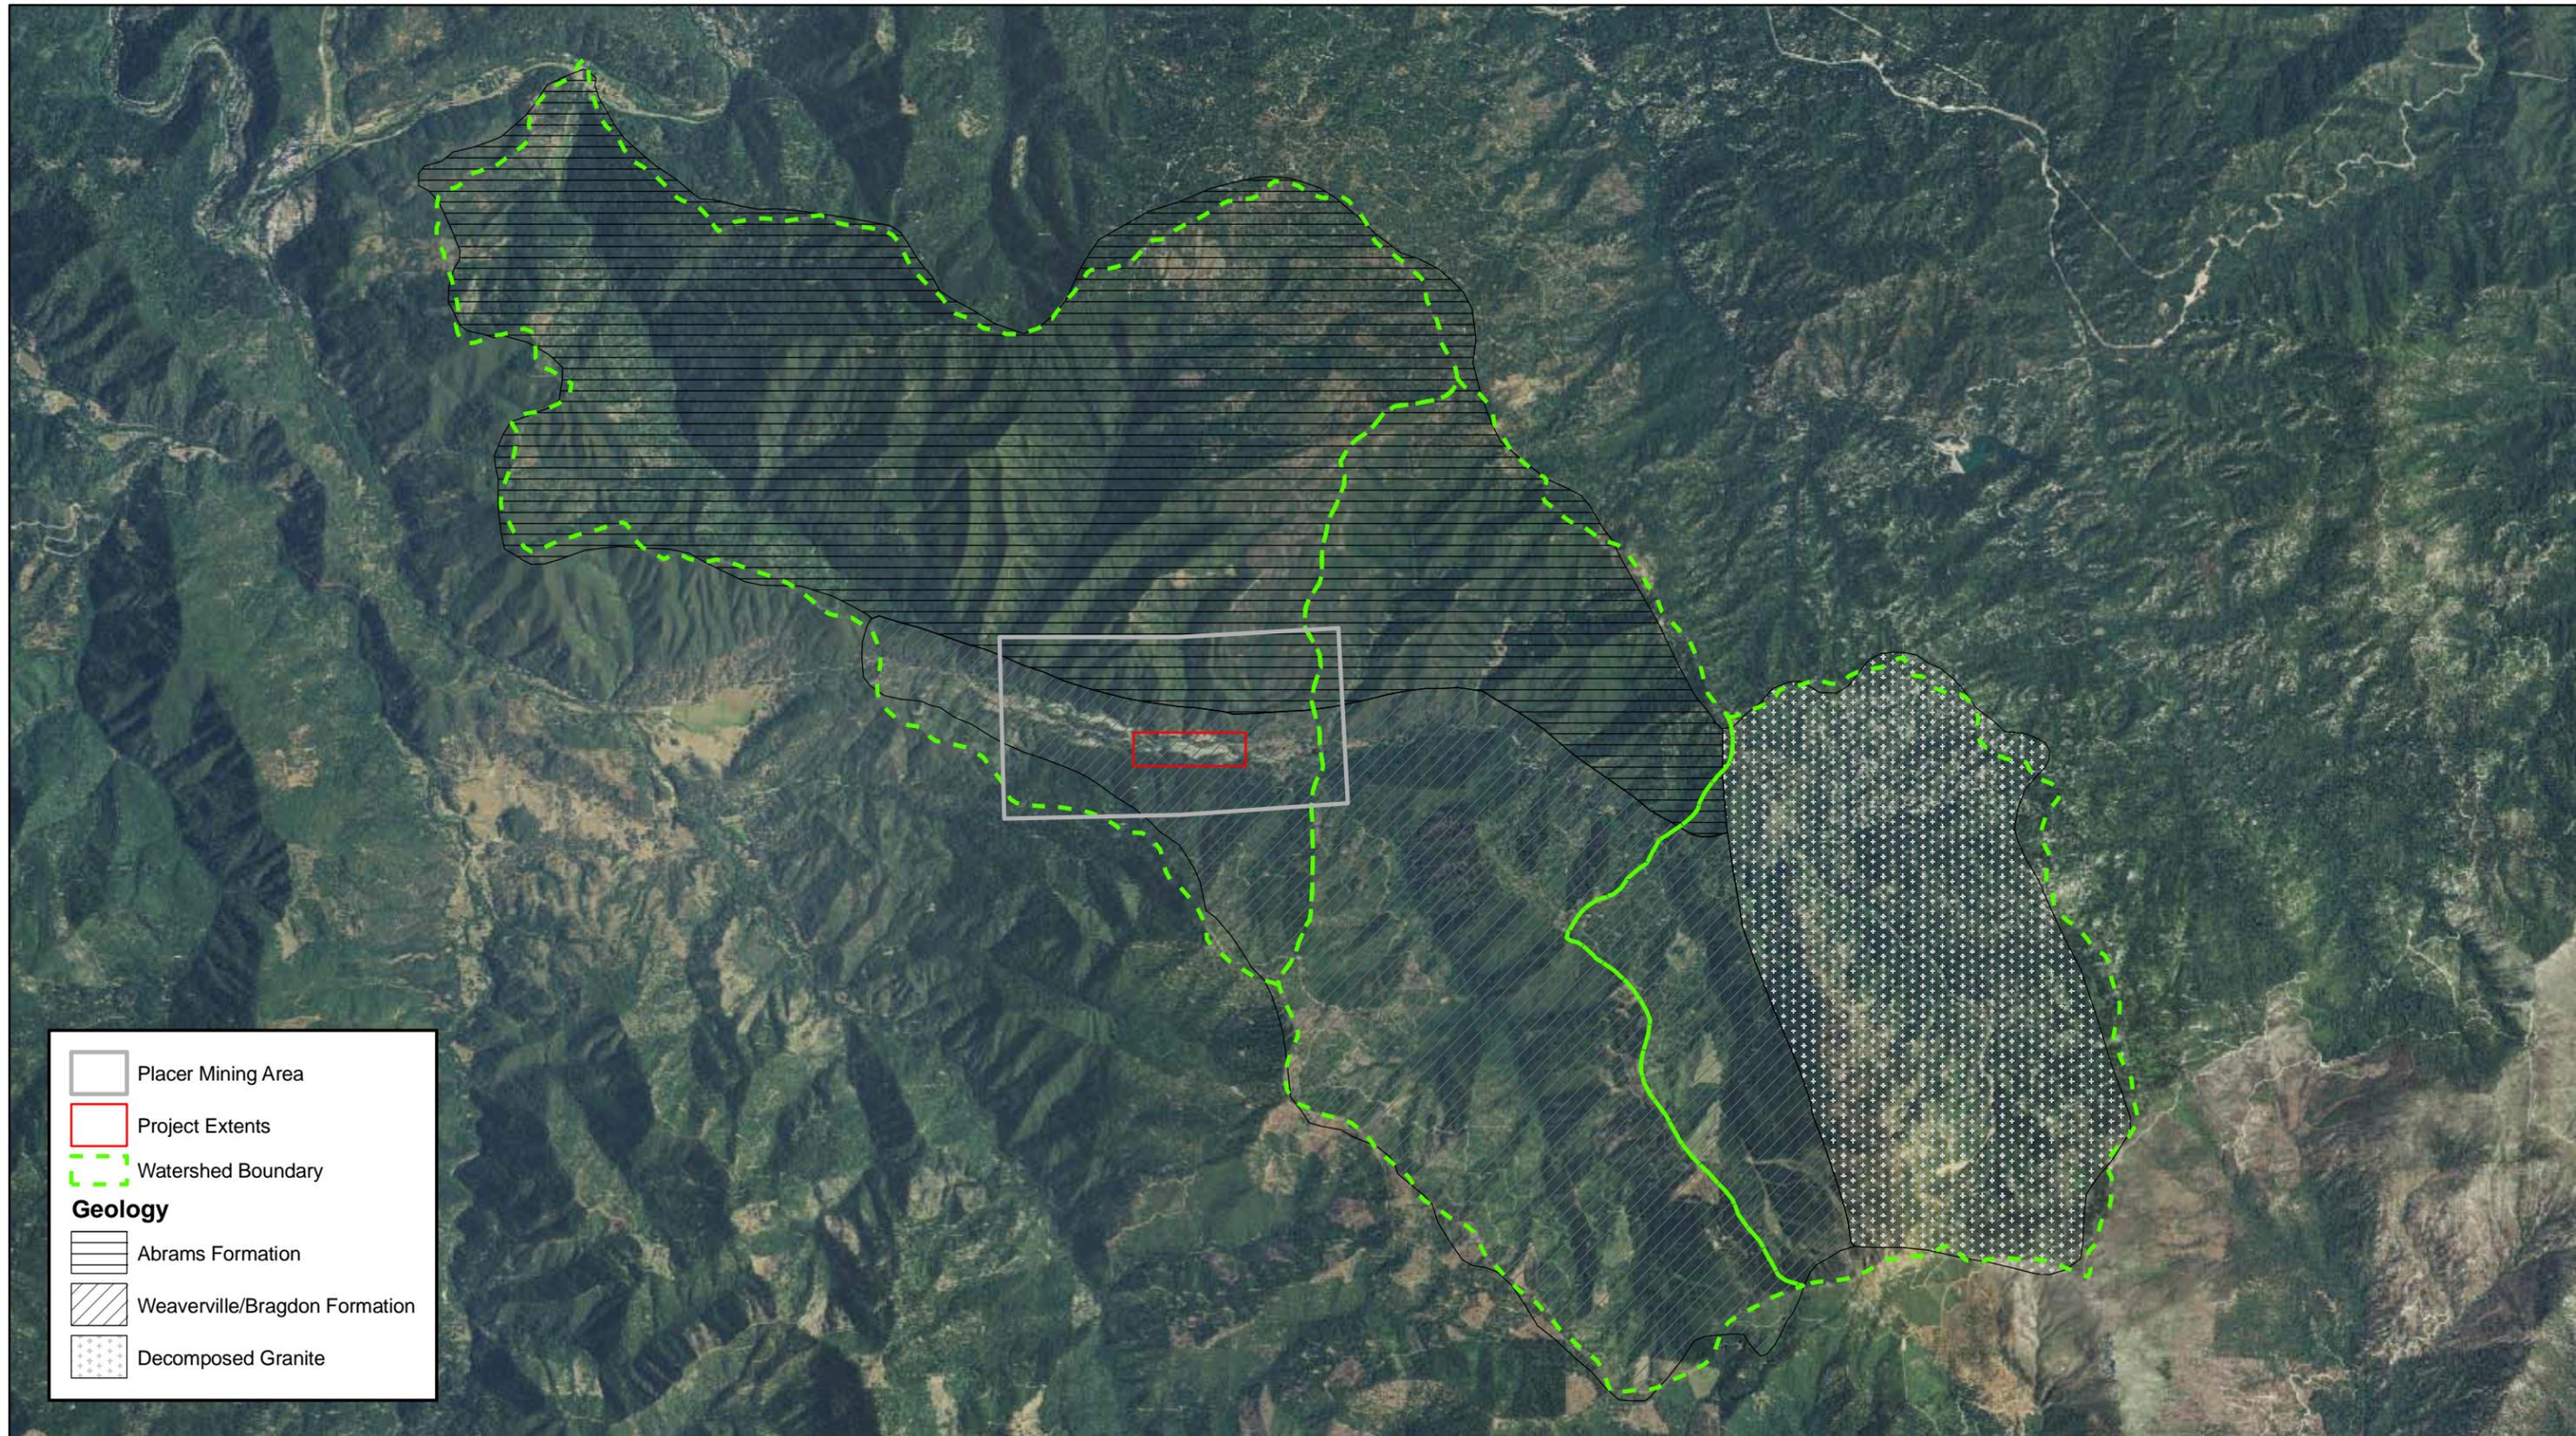
figure 3-4
Indian Creek

- Placer Mining Area (White outline)
- Project Extents (Red outline)
- Watershed Boundary (Dashed green line)
- Geology**
- Abrams Formation (Horizontal black lines)
- Weaverville/Bragdon Formation (Diagonal black lines)
- Decomposed Granite (White crosses)

Indian Creek Watershed Geology

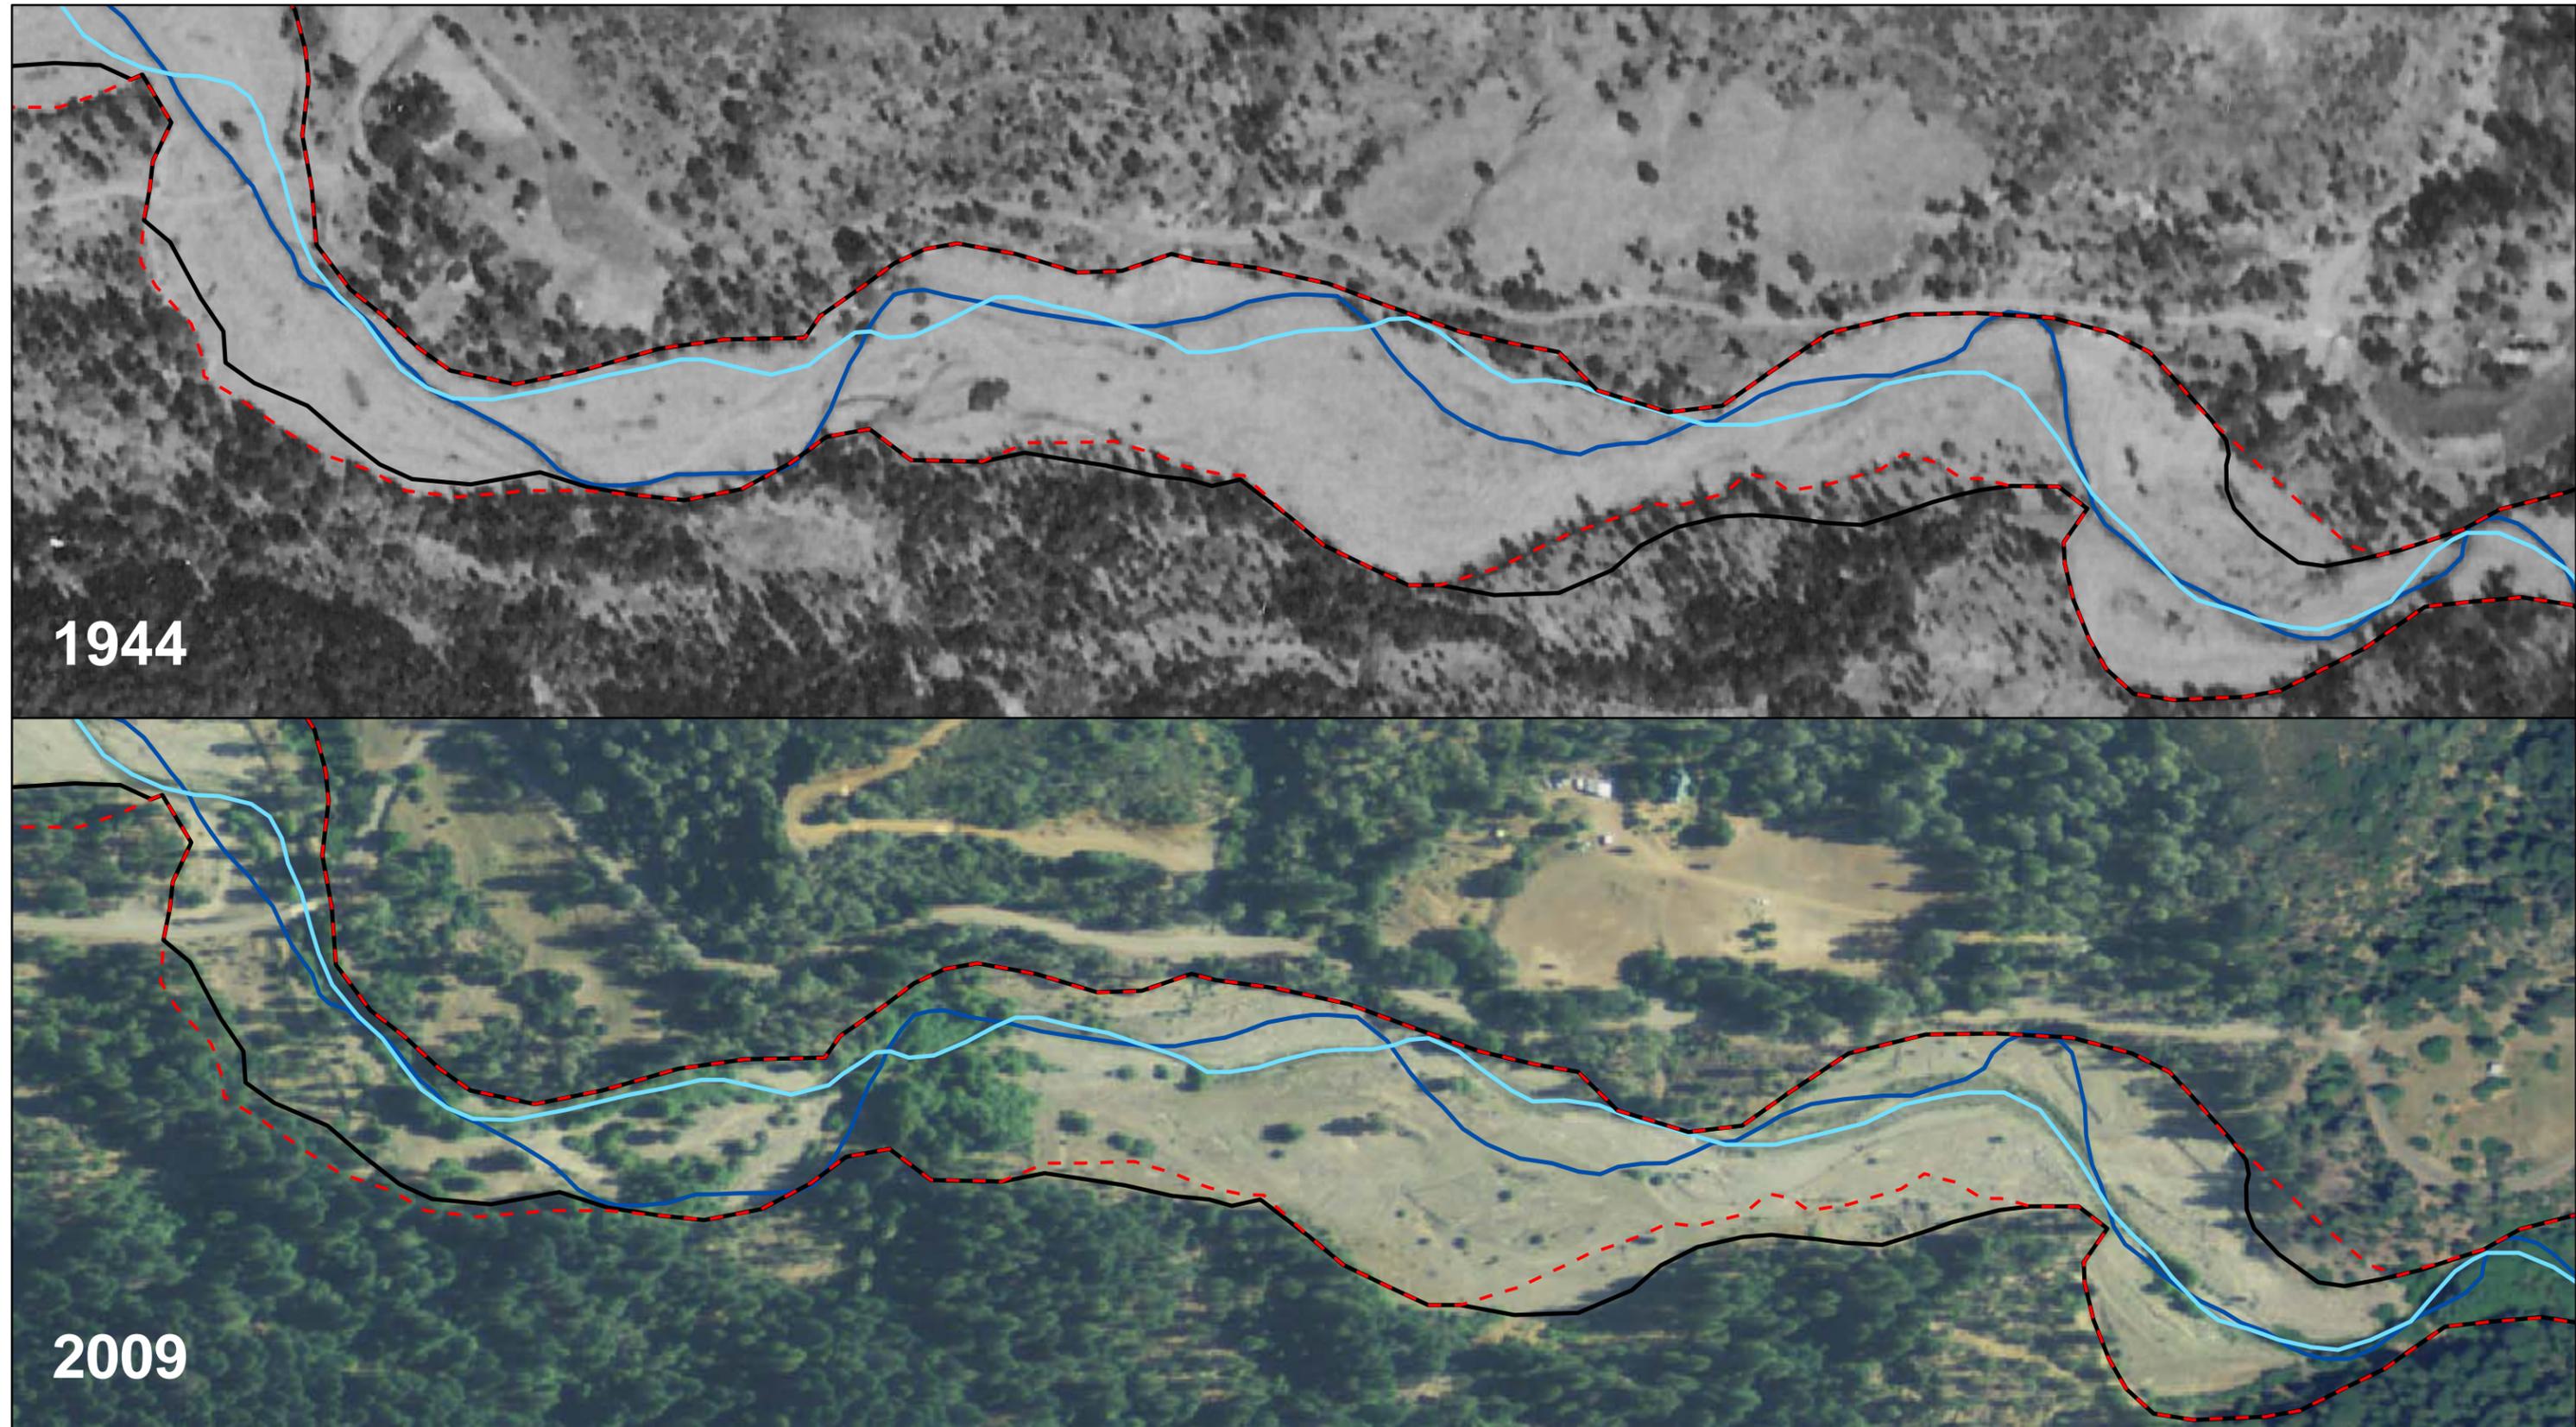
figure 5-1
Indian Creek

- 1944 CMZ
- 2009 CMZ
- 2009 Channel
- 1944 Channel

Site Comparison: 1944 and 2009

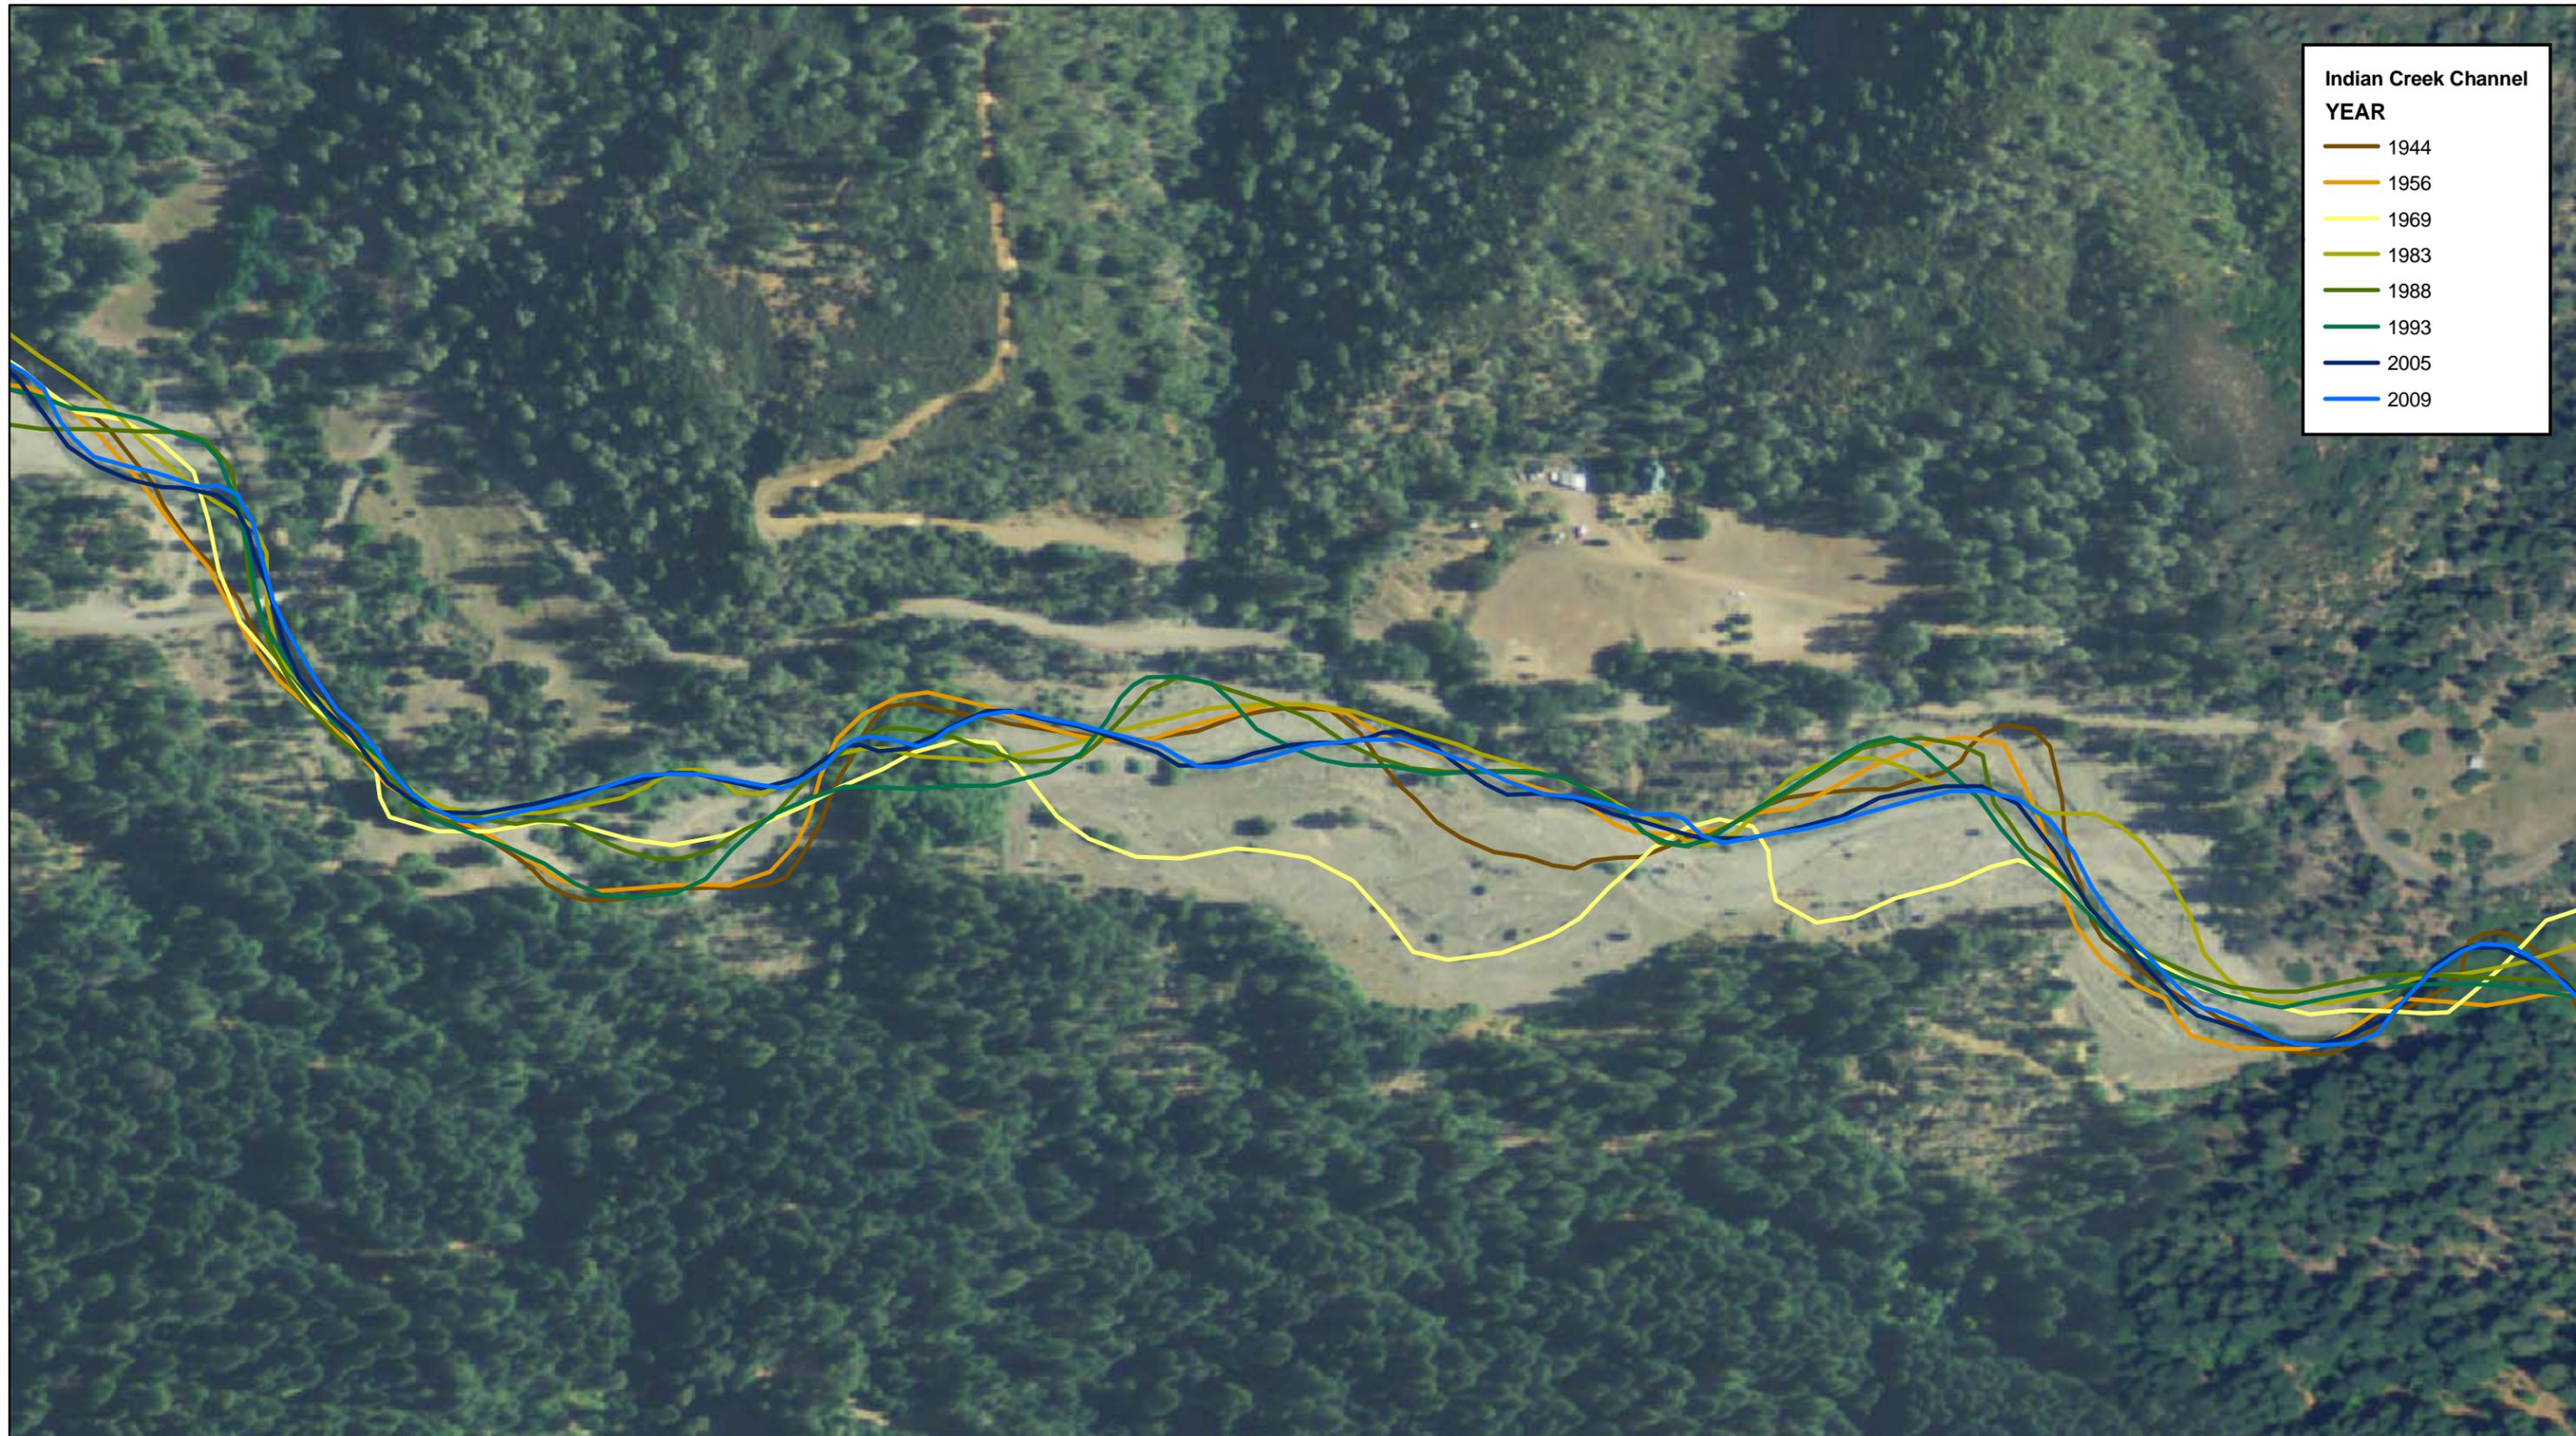
figure 5-2
Indian Creek

Channel Evolution: 1944 through 2009
