Coastal Conservancy Proposition 1 Proposal - Section 8 Project Maps and Graphics
Indian Creek Habitat Connectivity and Restoration Project - Yurok Tribe

INDEX OF FIGURES

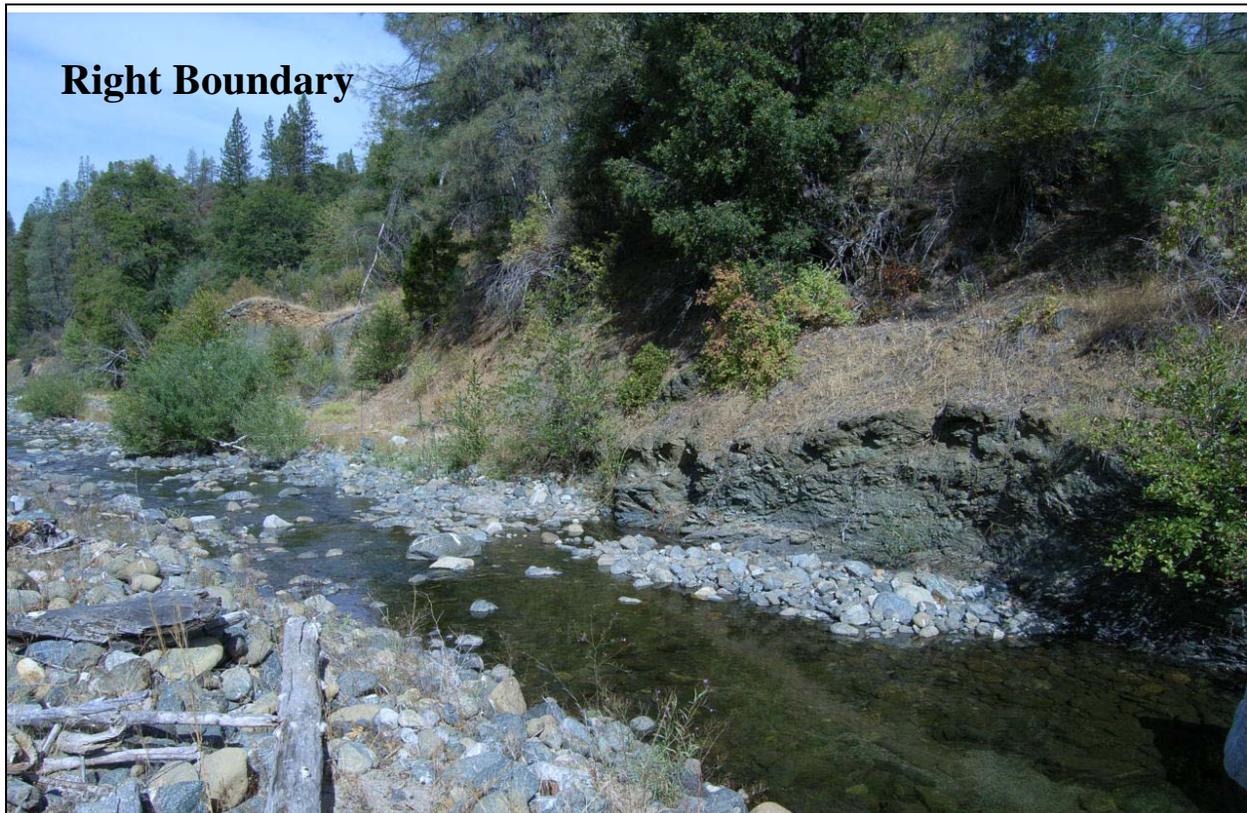
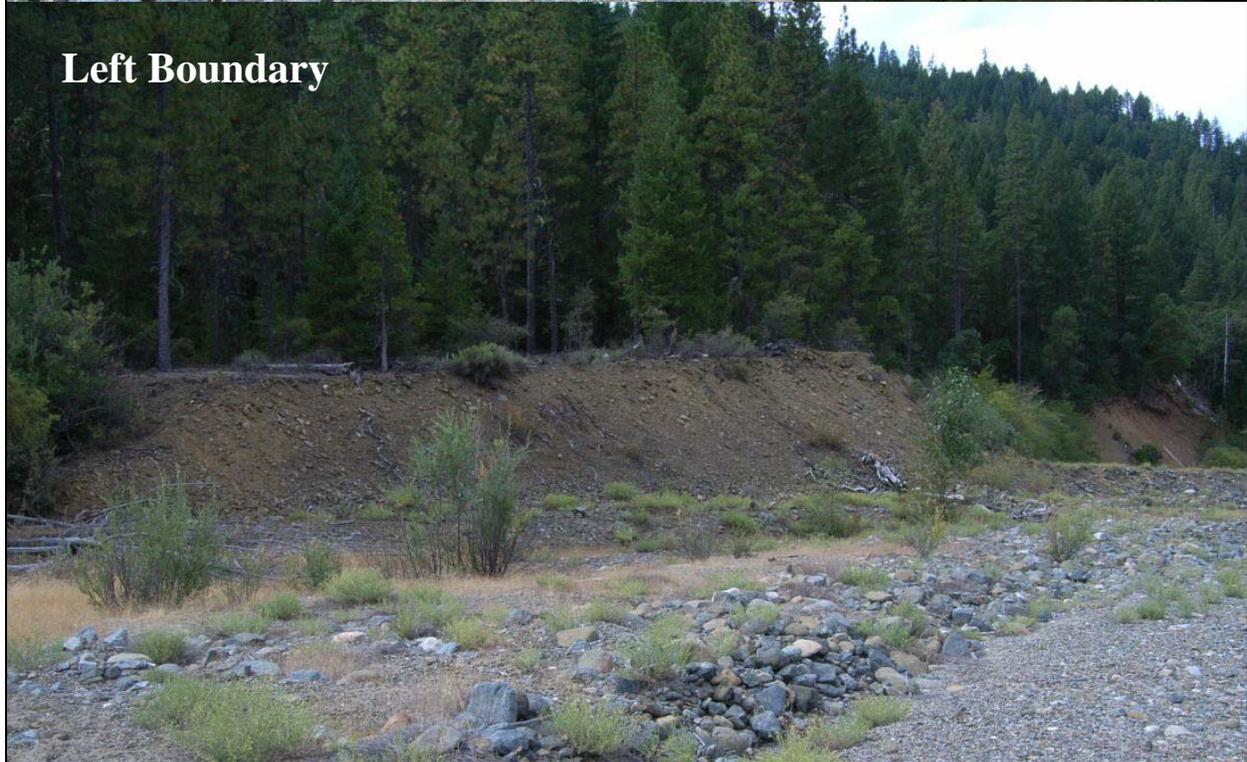
figure 5.3
Indian Creek

Channel Migration Zone Boundary

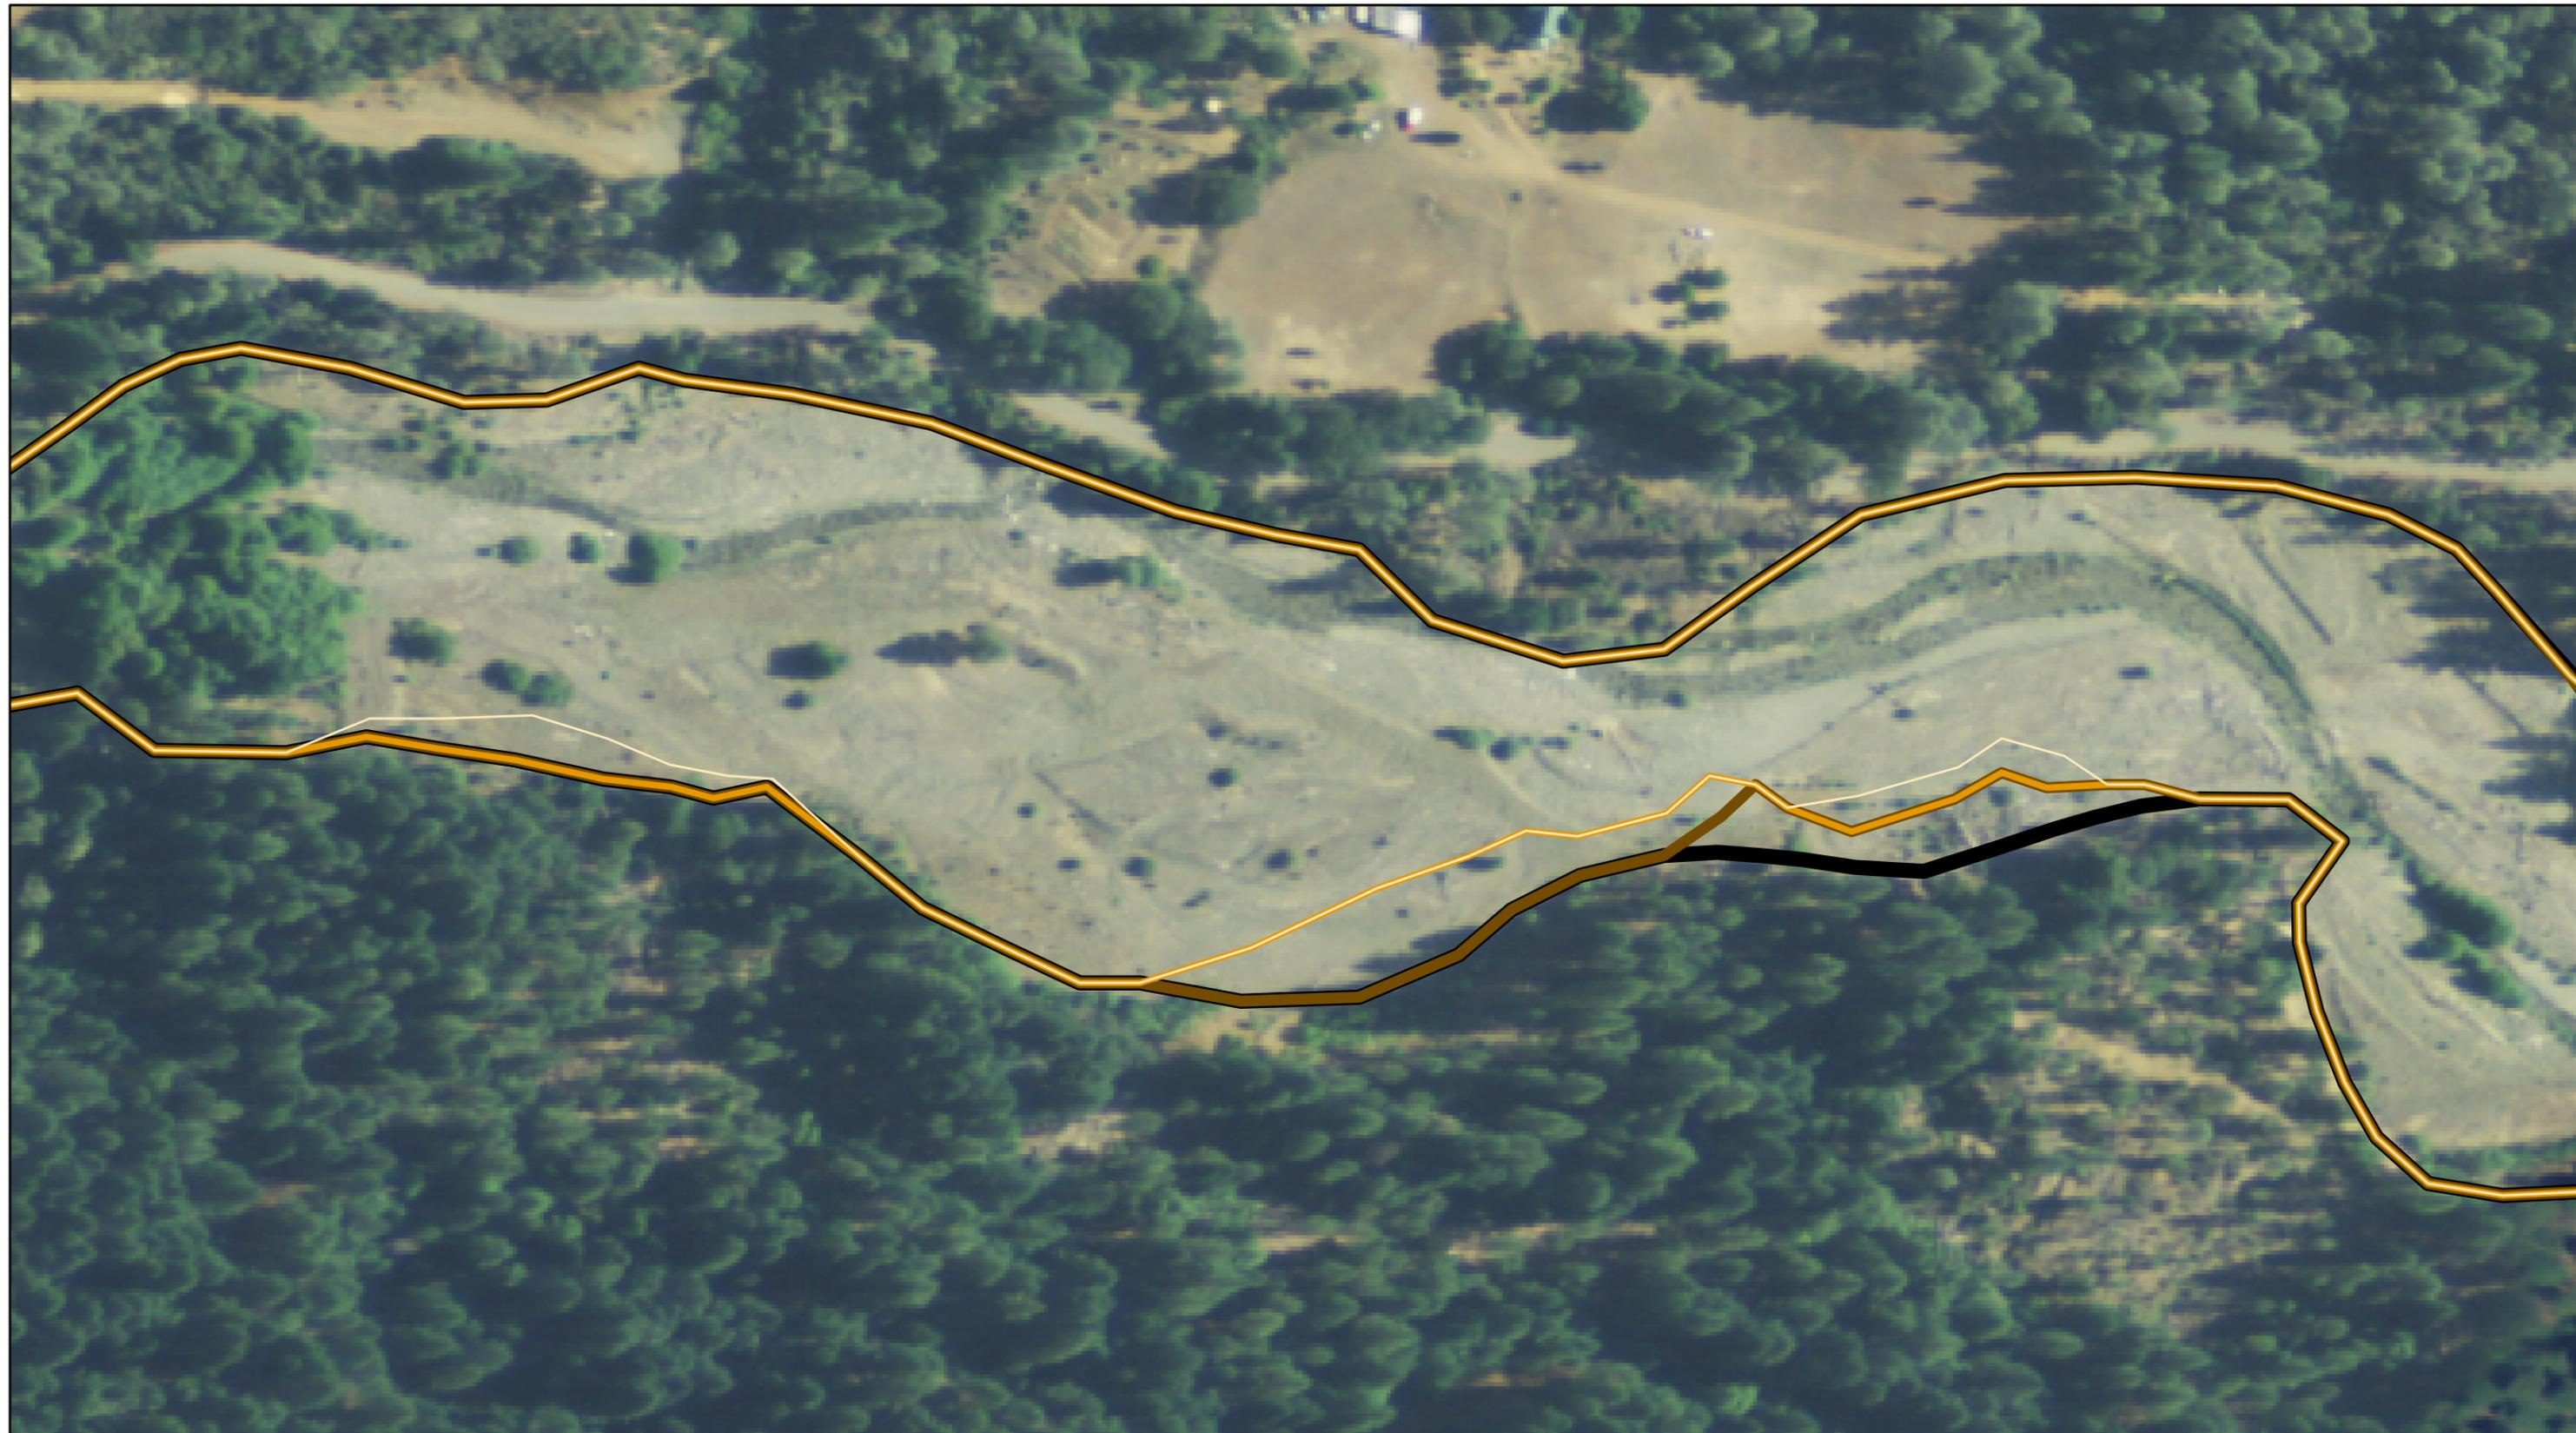
figure 5-4
Indian Creek

- 1944 Channel Meander Zone
- 1969 Channel Meander Zone
- 1993 Channel Meander Zone
- 2009 Channel Meander Zone

Channel Migration Zone Evolution: 1944 through 2009

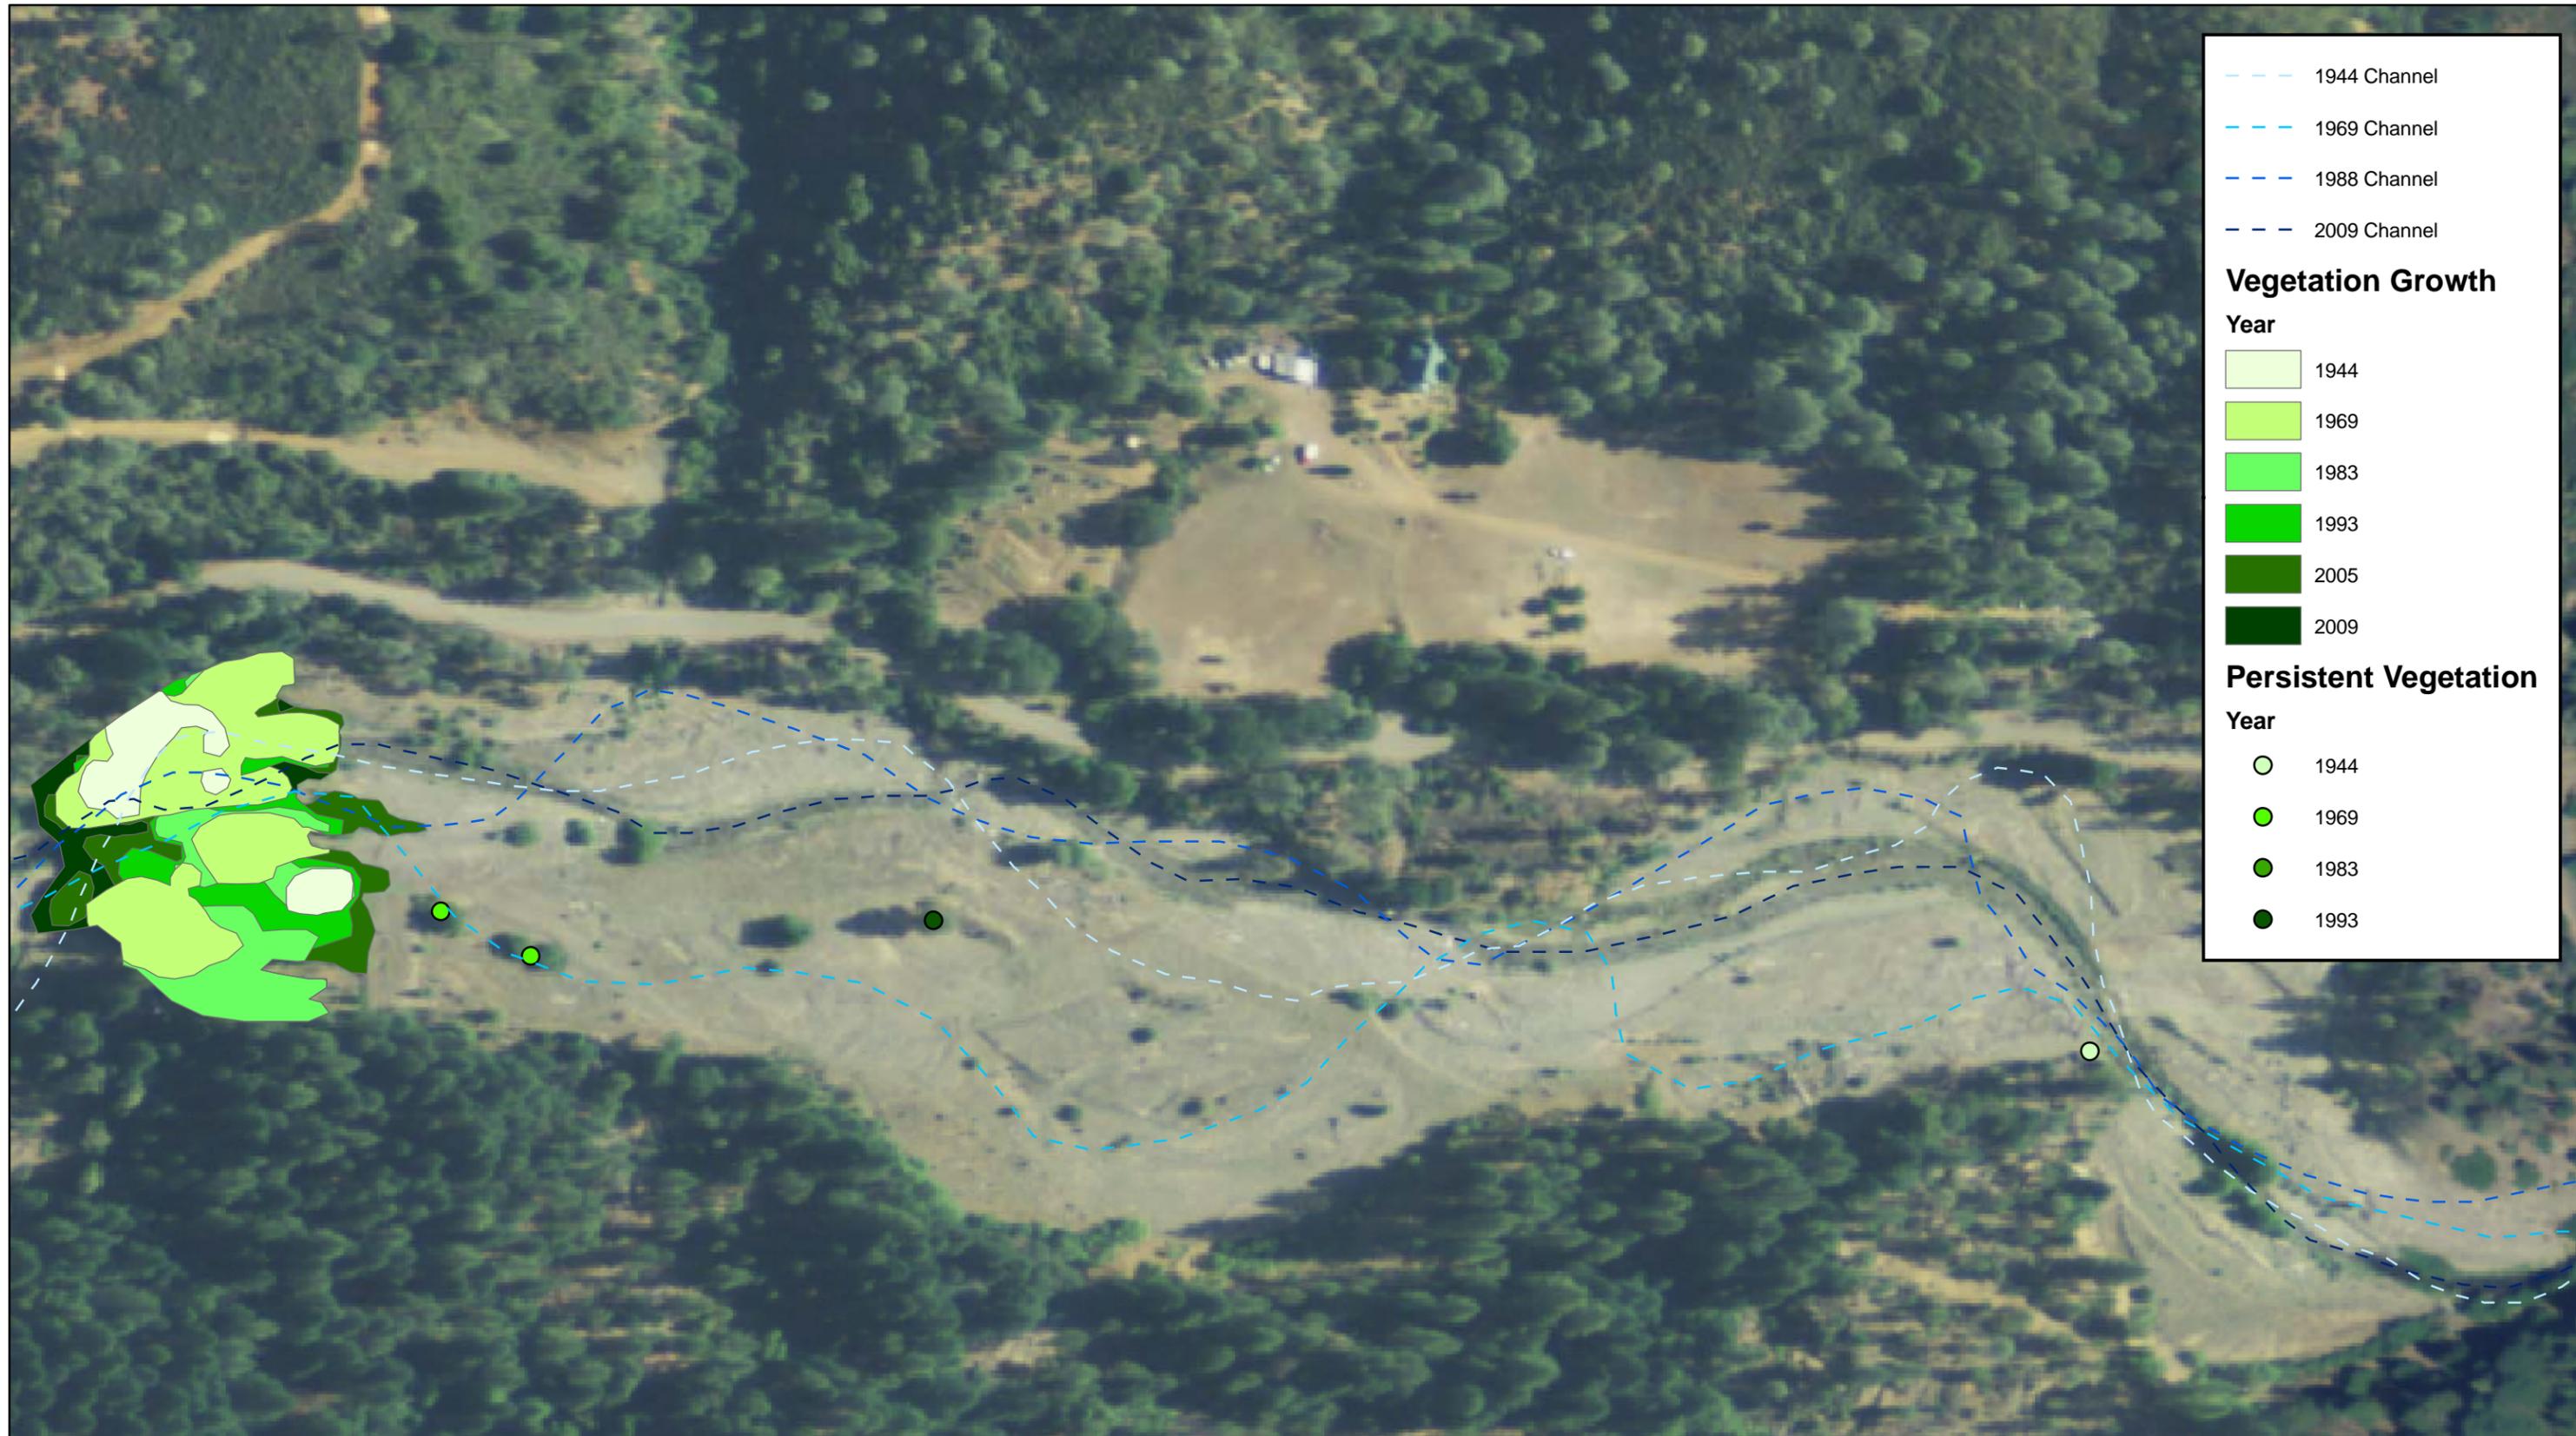
figure 5-5
Indian Creek

Vegetation Evolution: 1944 through 2009

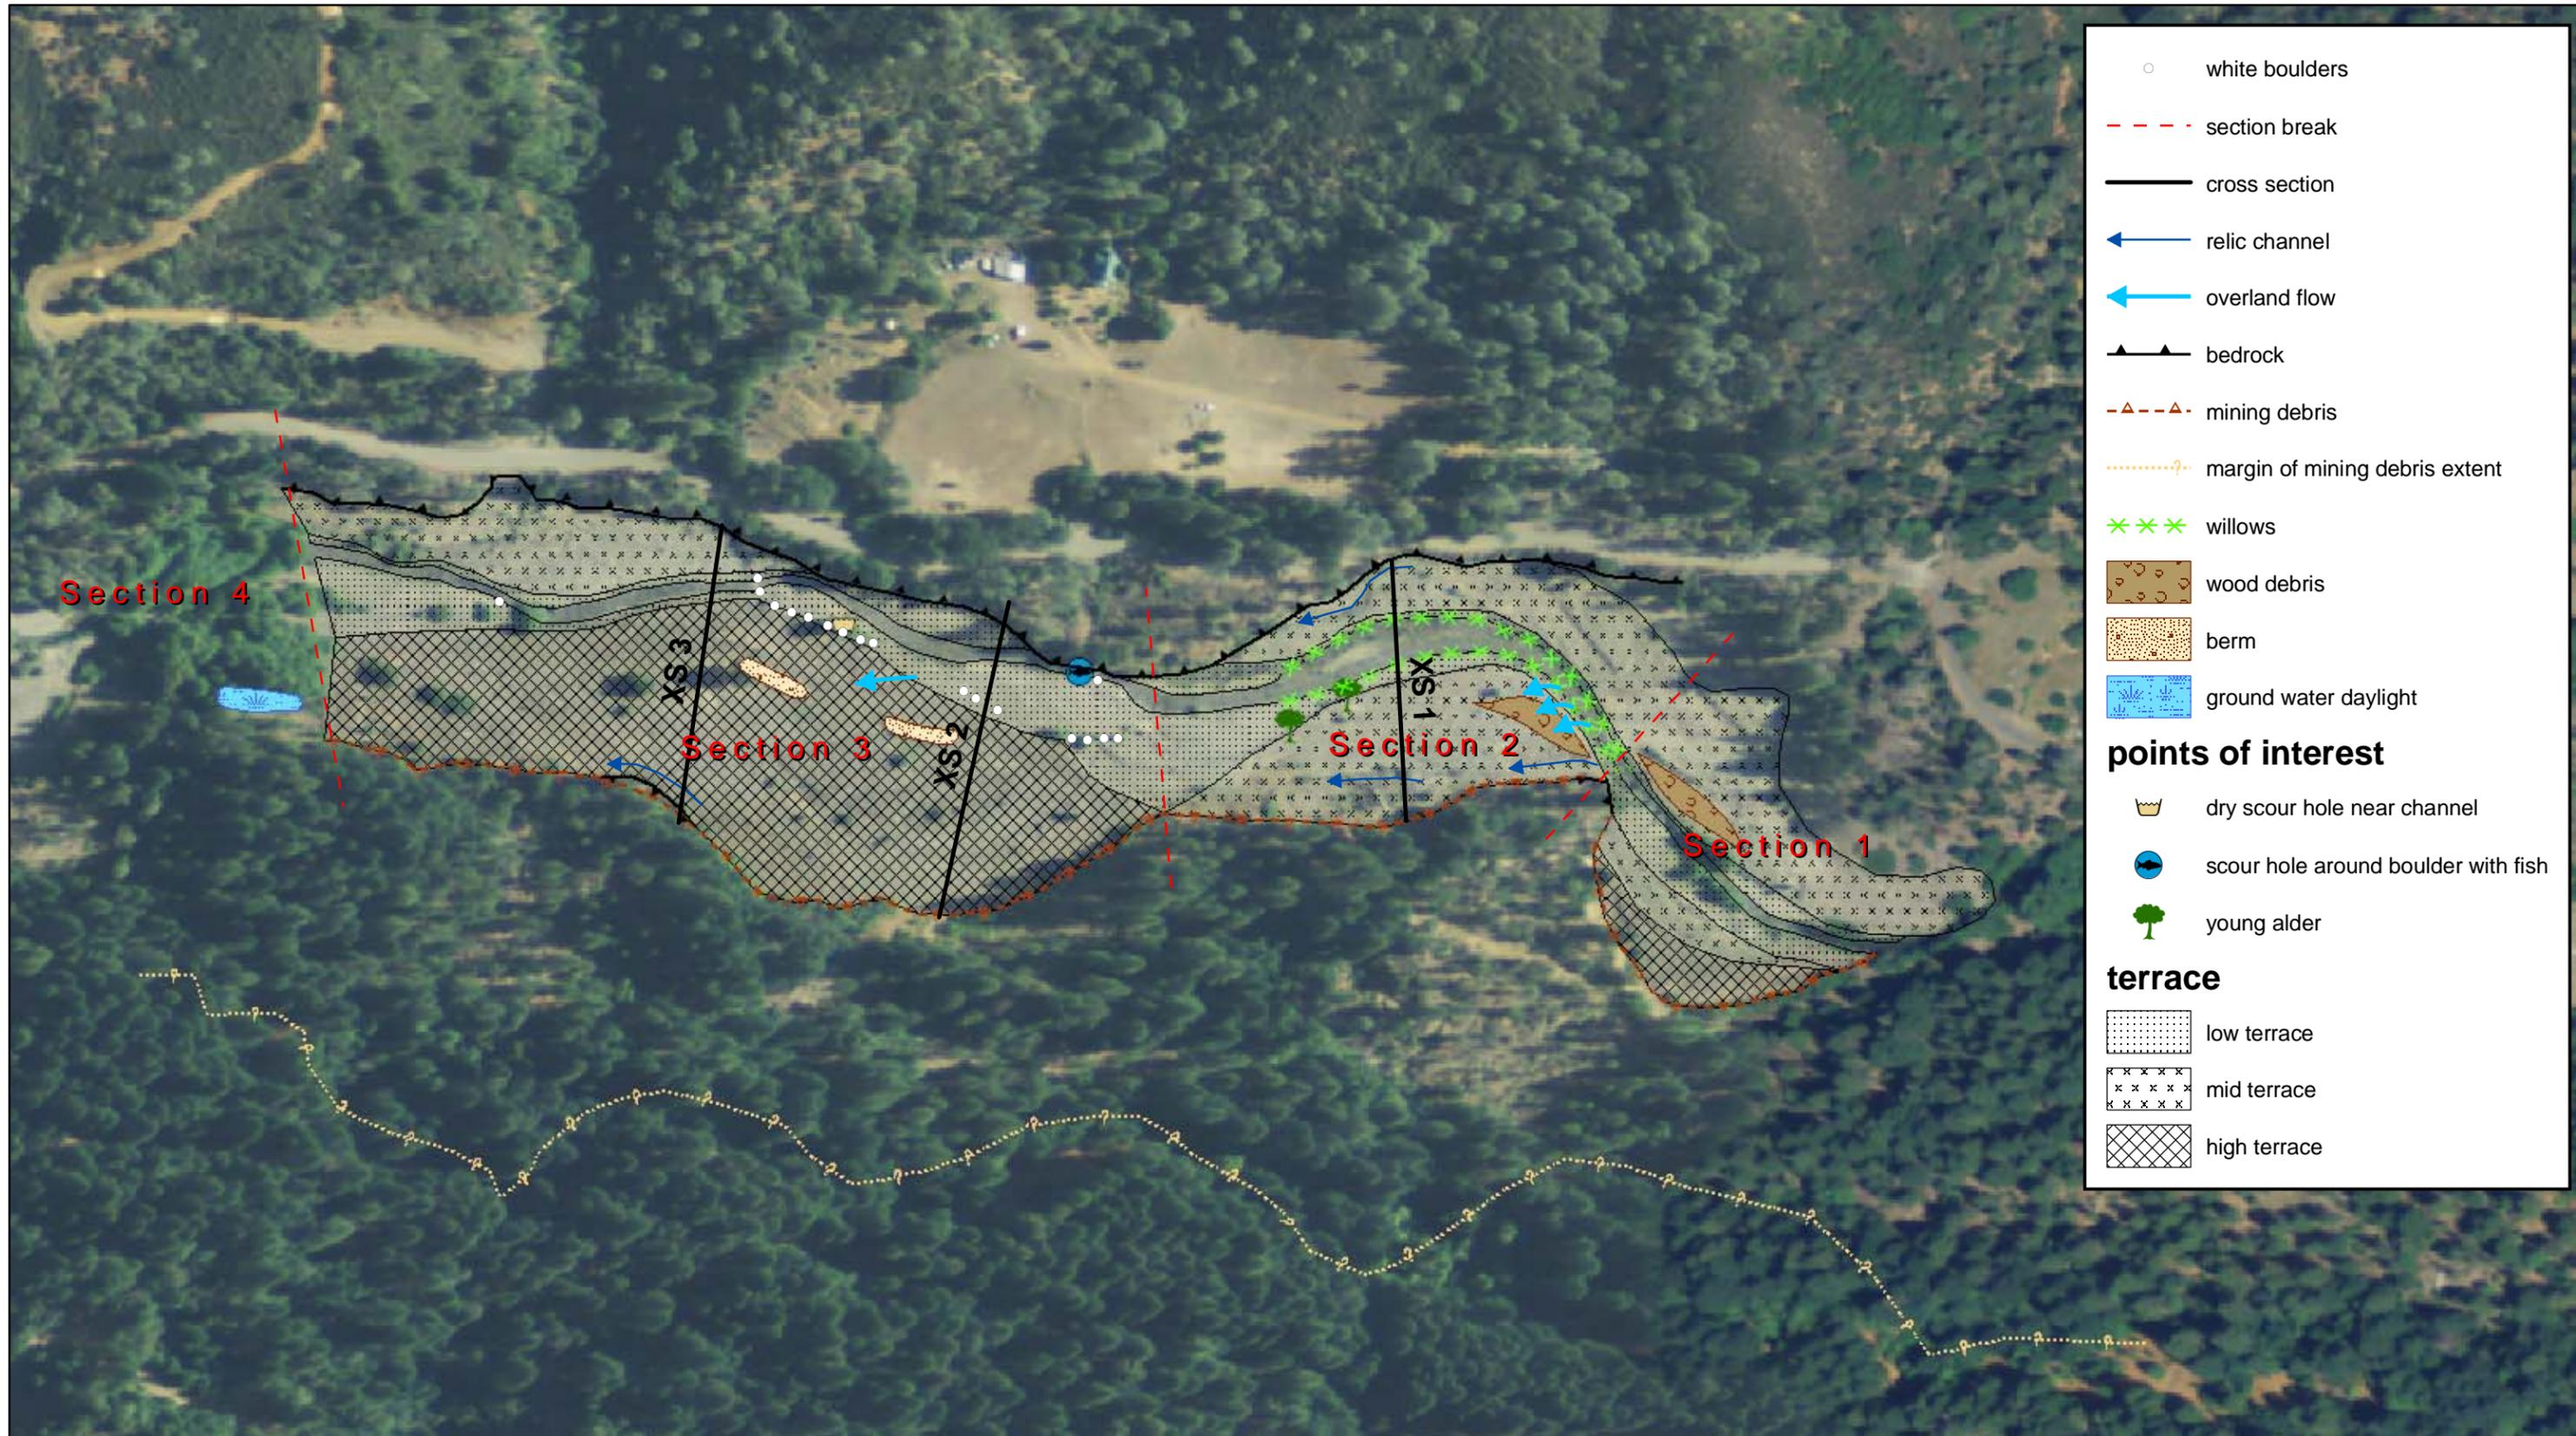
figure 7-1
Indian Creek

GIS Rendering of Field Reconnaissance Notes

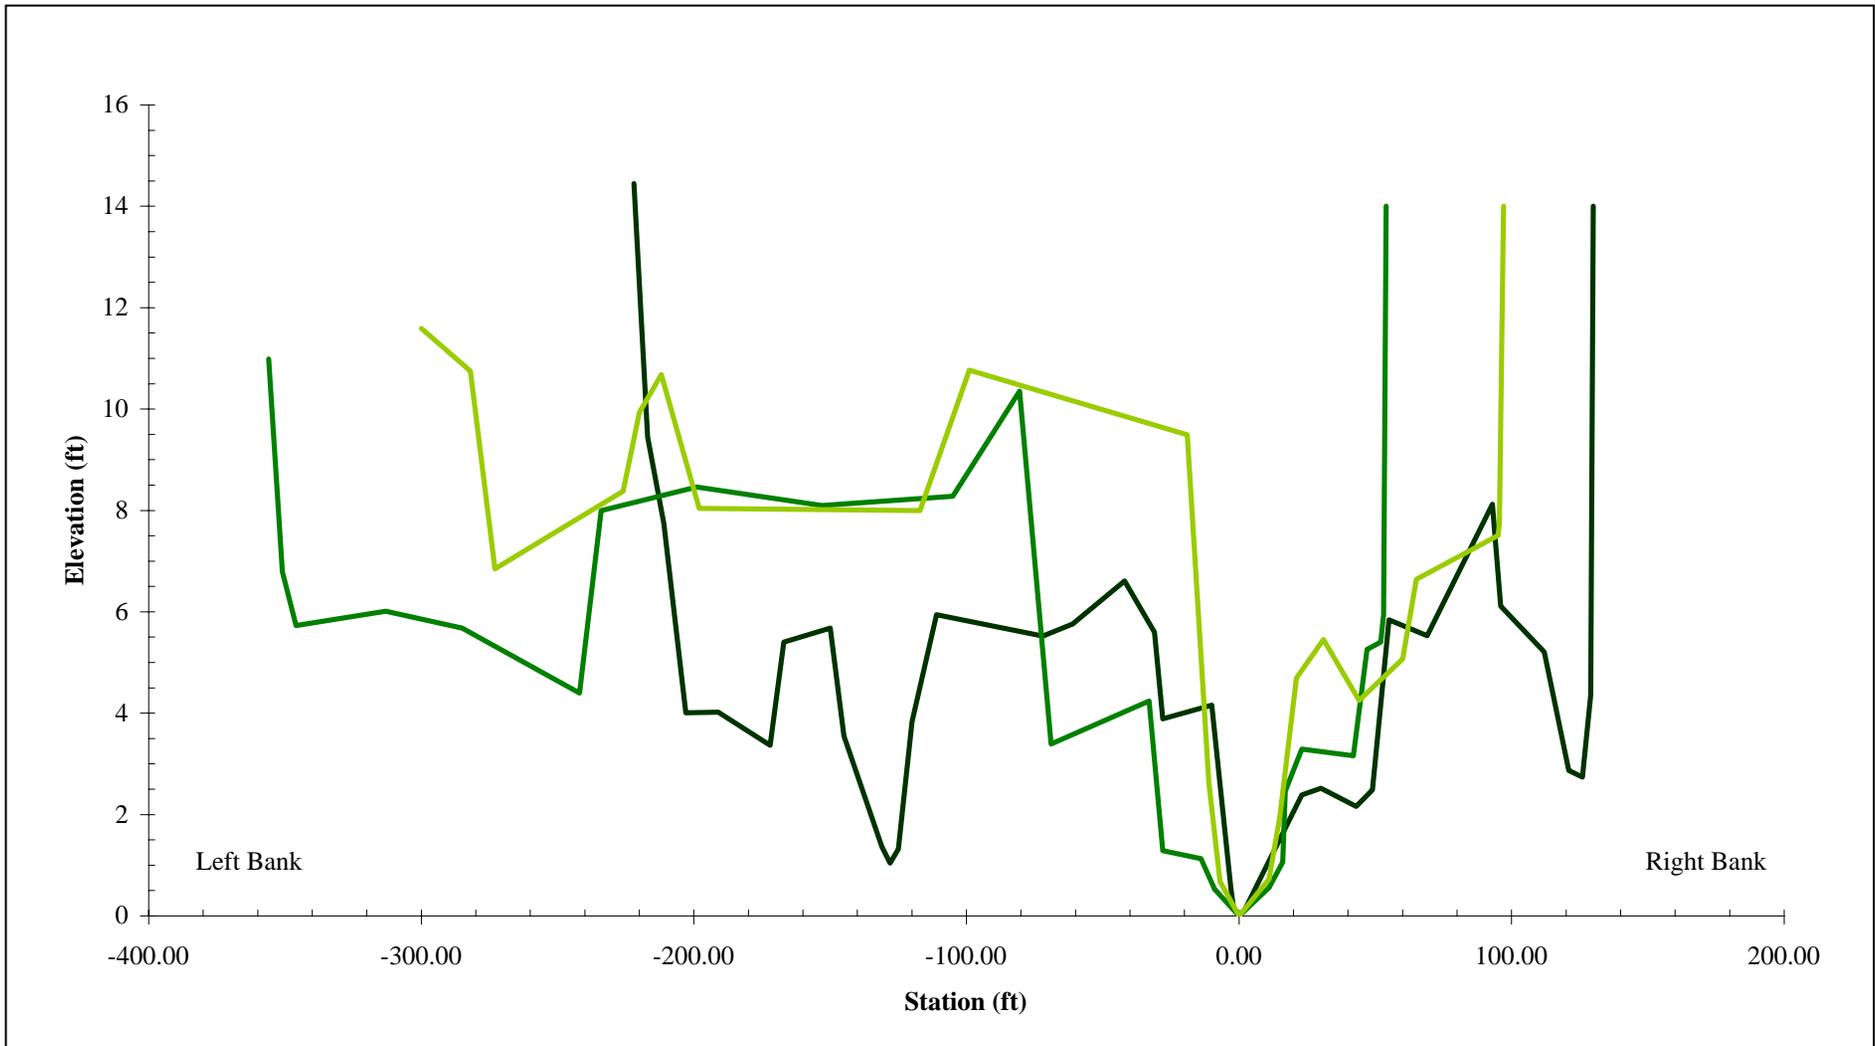
figure 7-2
Indian Creek

Surveyed Cross Sections

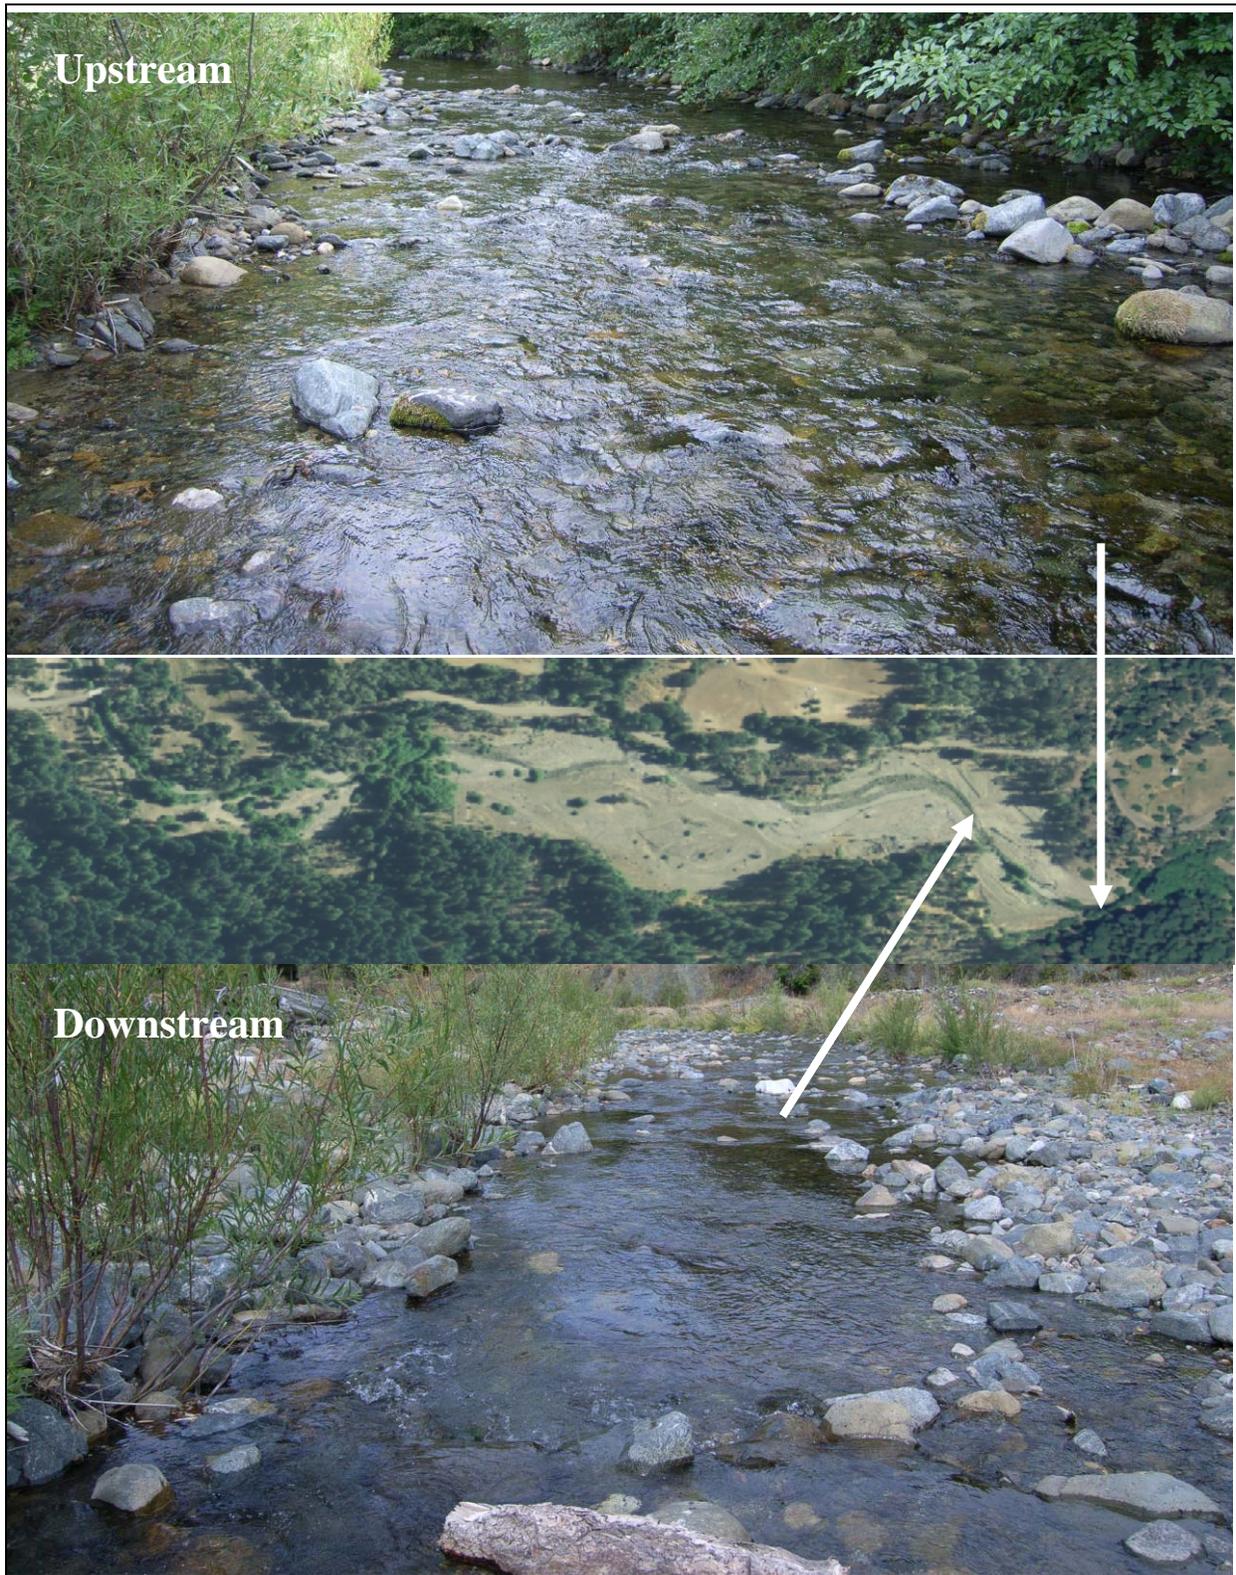
figure 7.3
Indian Creek

Channel Flow Change at Upstream Section

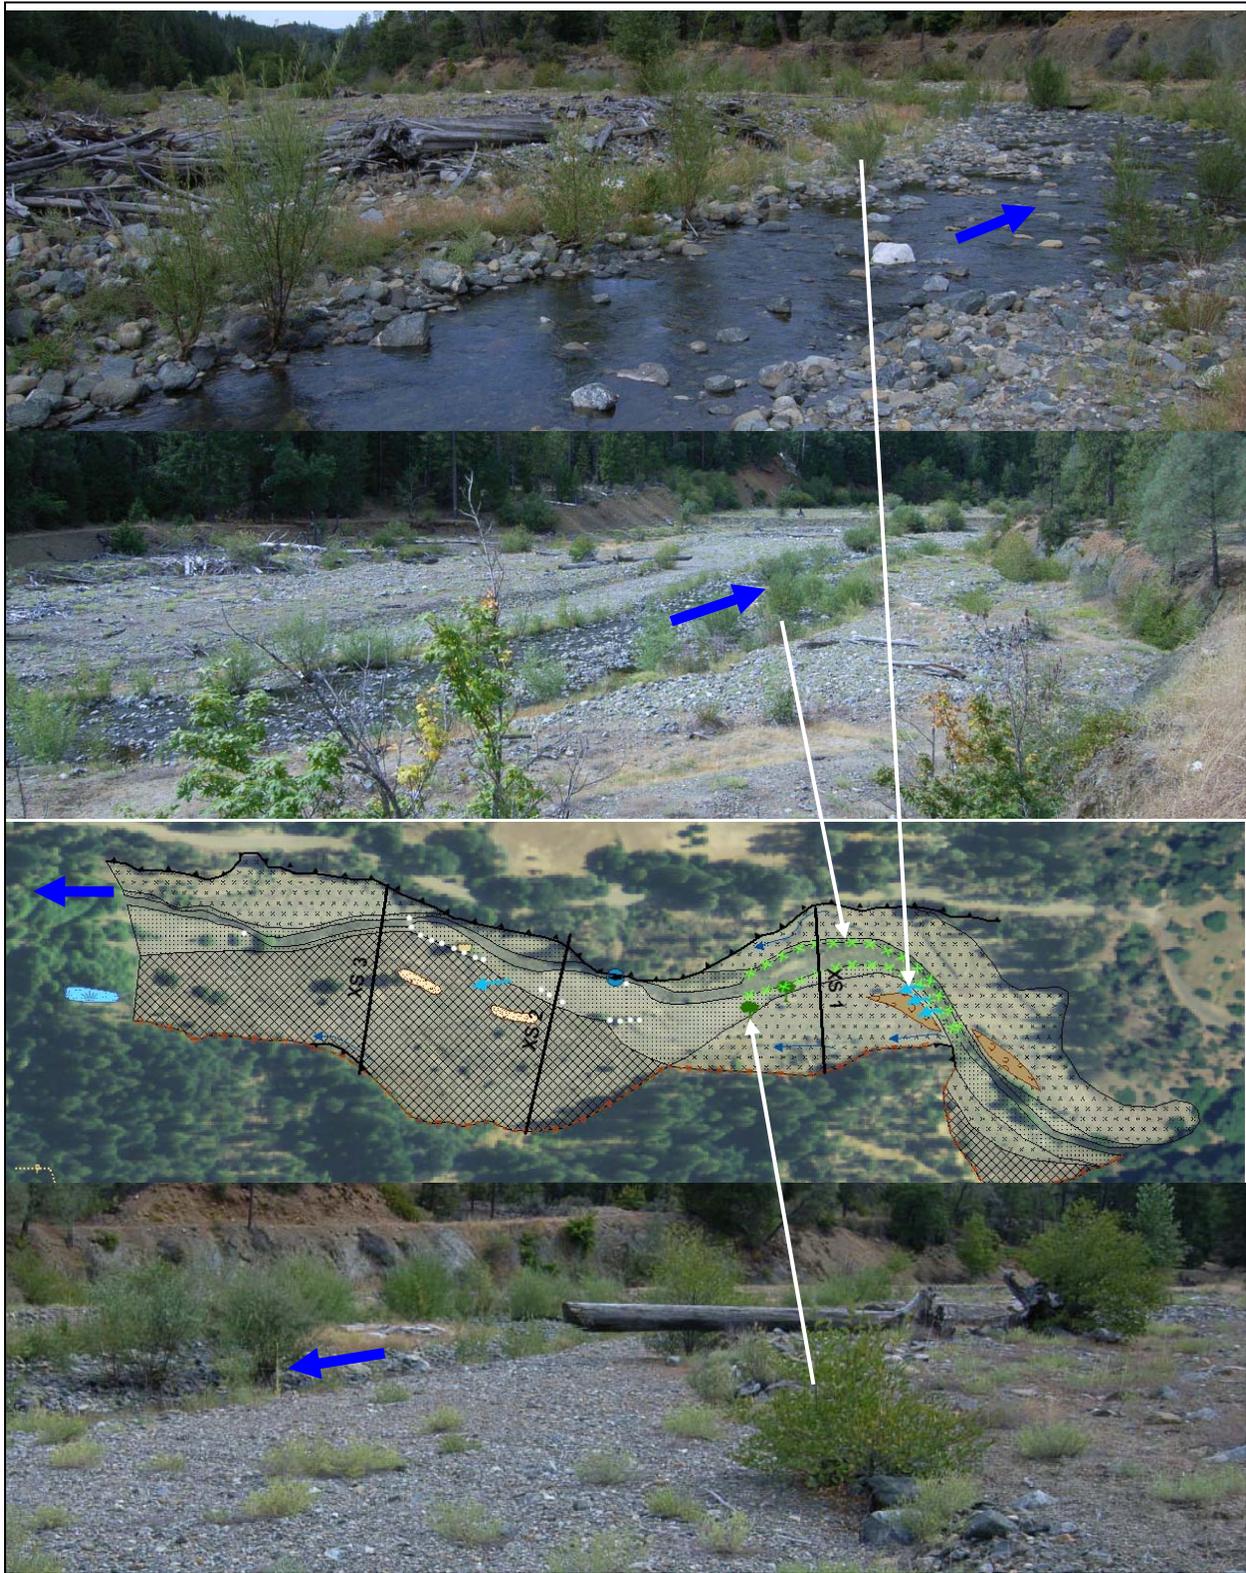
figure 7.4
Indian Creek

Established Vegetation at Upstream Section

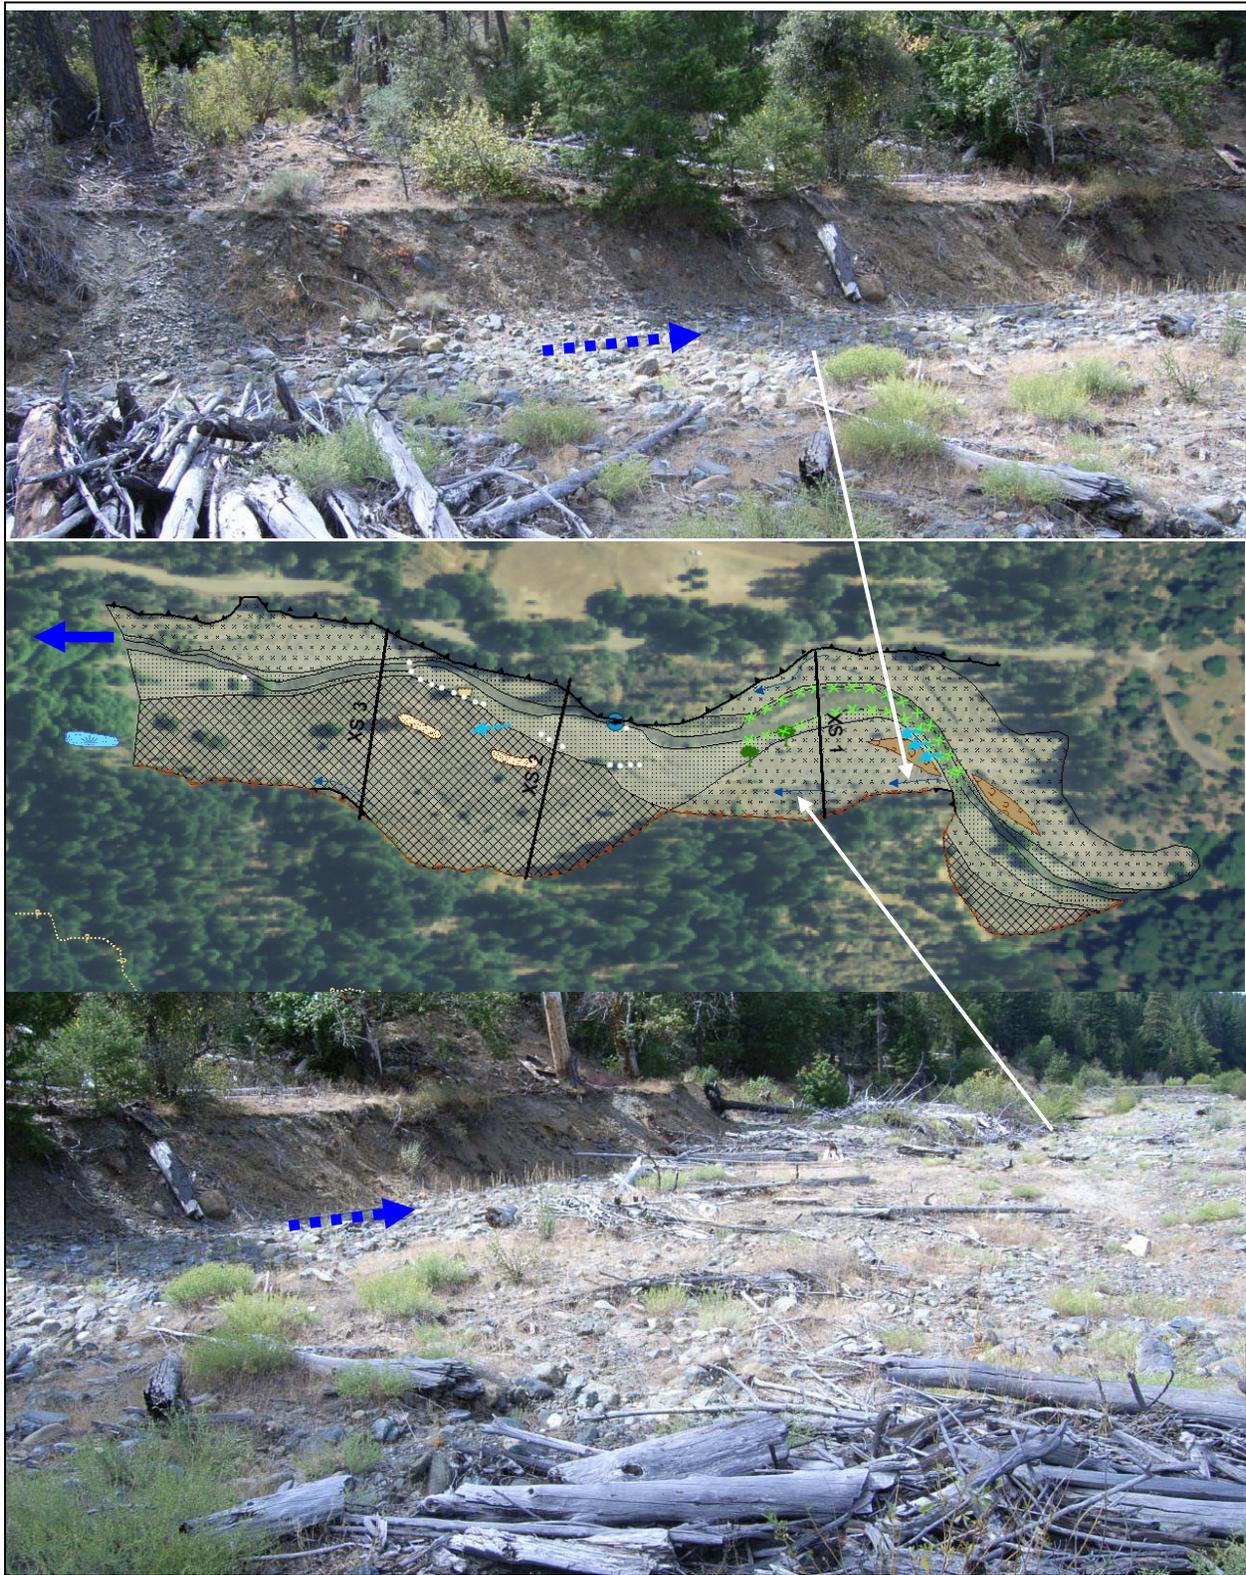
figure 7.5
Indian Creek

Relic/Overflow Channel at Upstream Section

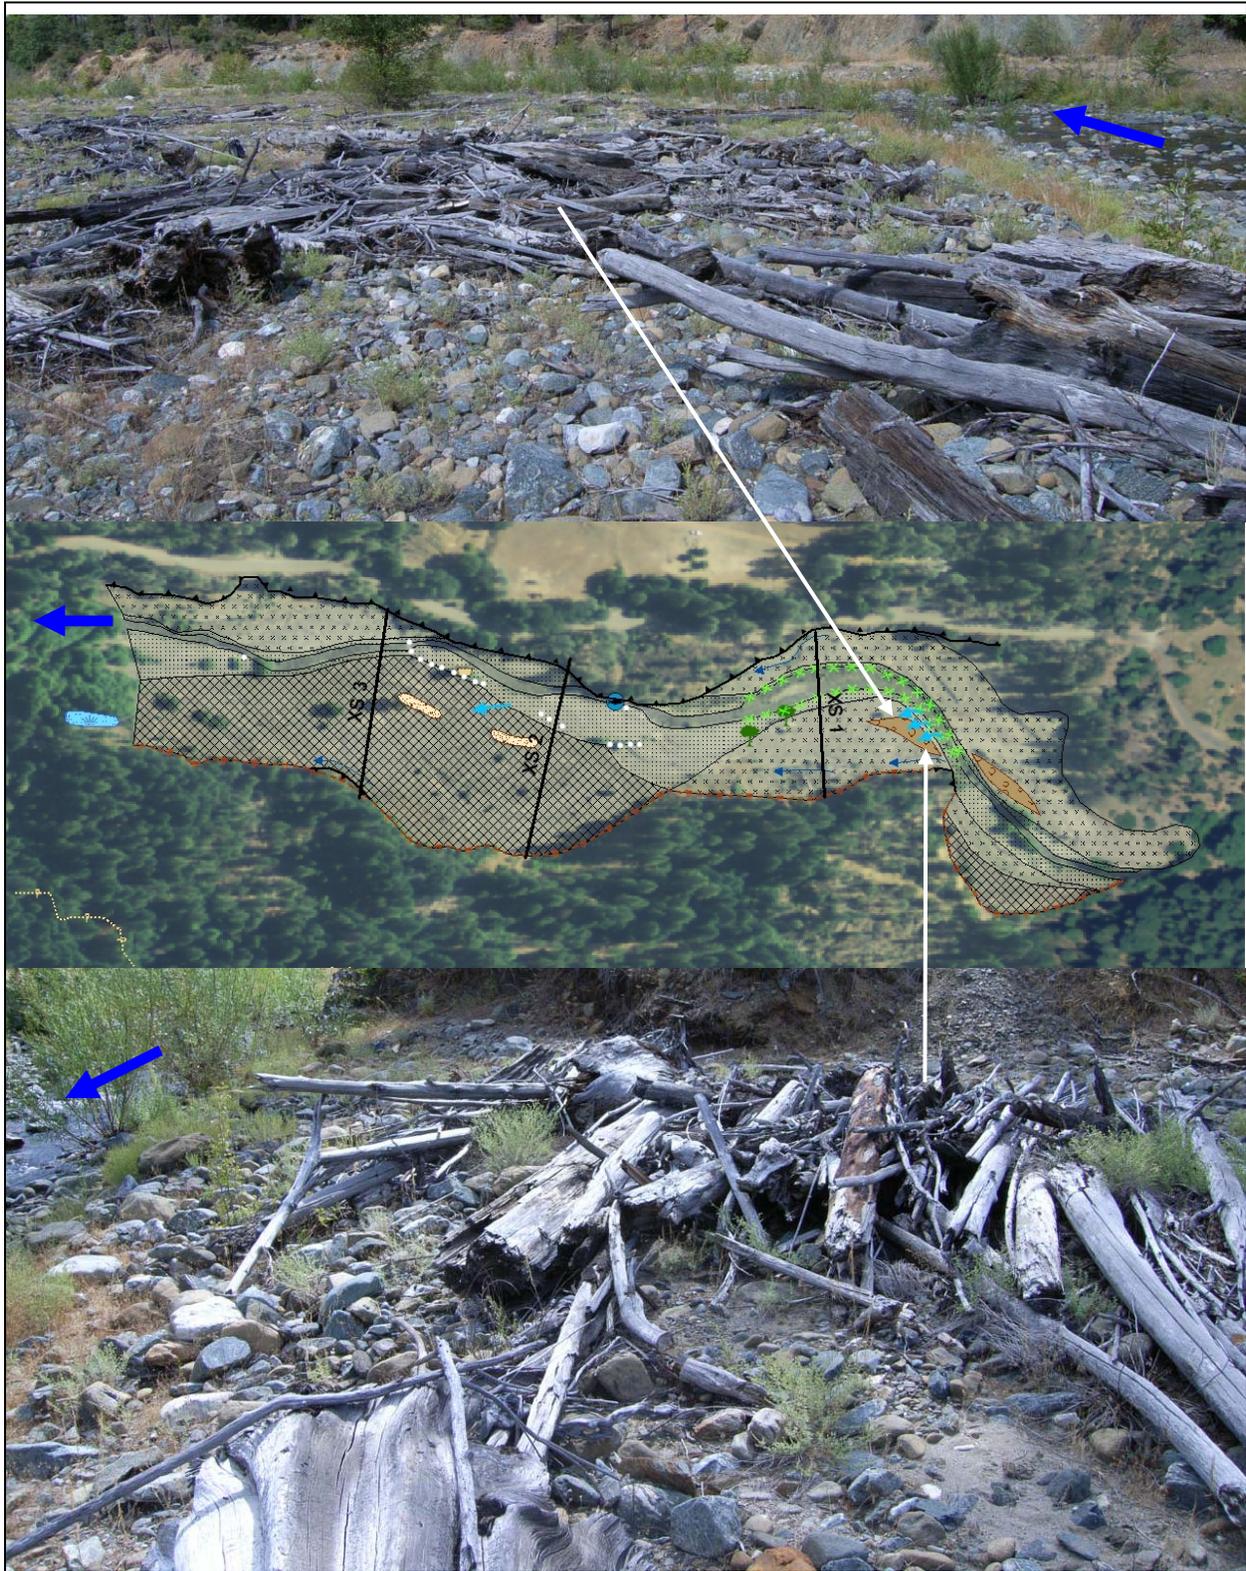
figure 7.6
Indian Creek

Large Wood Debris at Upstream Section
