Coastal Conservancy Proposition 1 Proposal - Section 8 Project Maps and Graphics
Indian Creek Habitat Connectivity and Restoration Project - Yurok Tribe

INDEX OF FIGURES

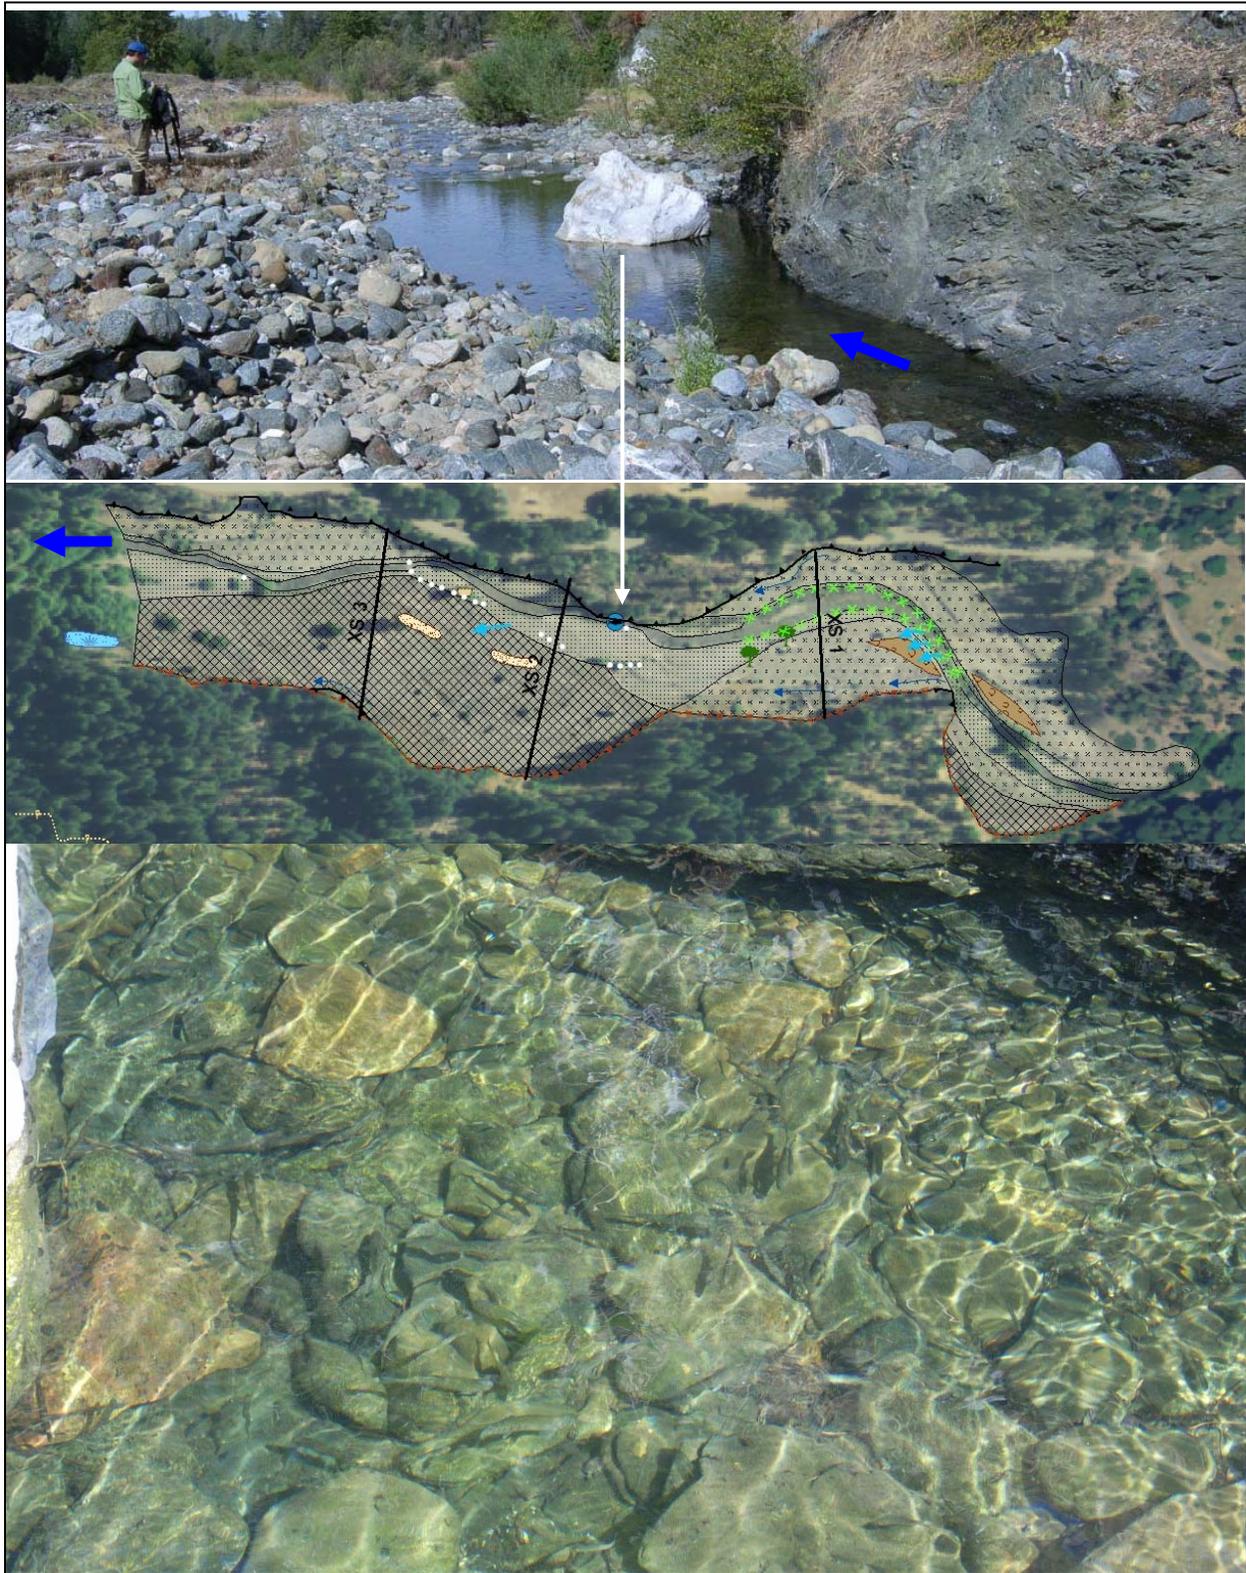
figure 7.9
Indian Creek

Scoured Rearing Hole With Juveniles

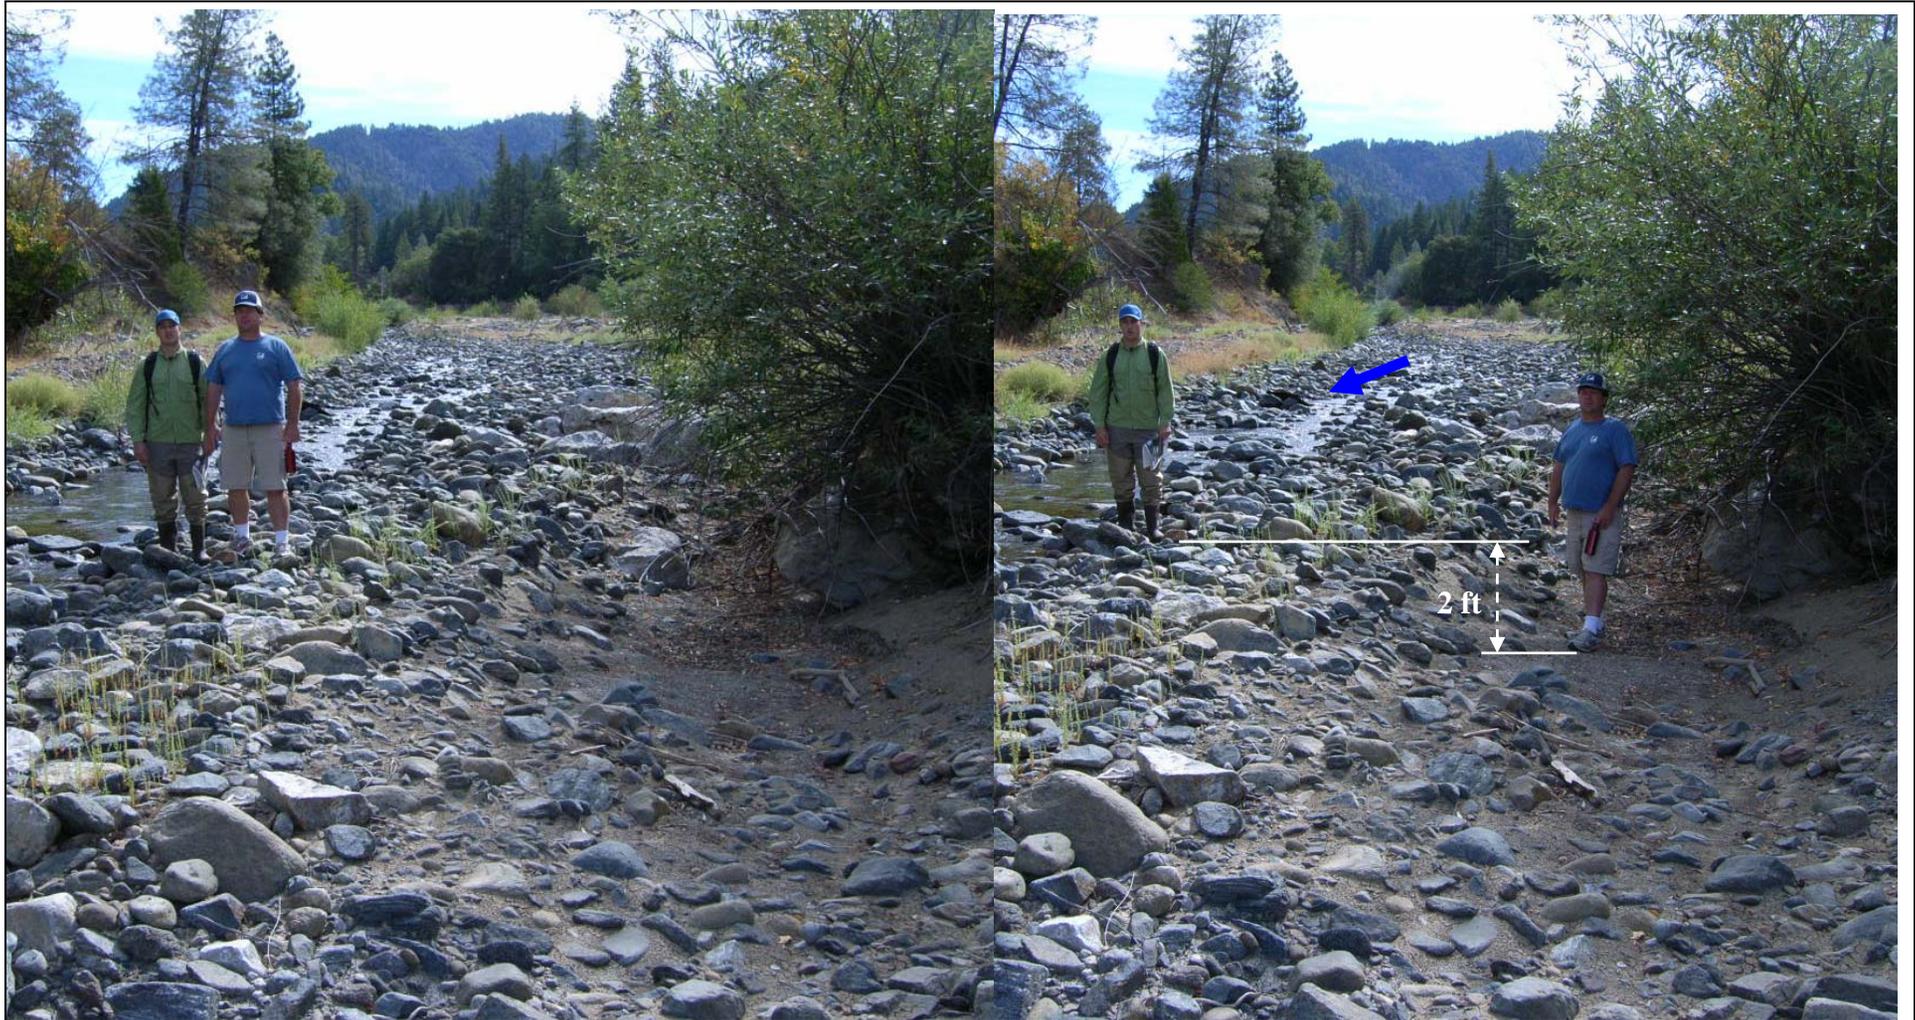
figure 7.10
Indian Creek

Photos illustrates possible perched nature of channel.

Dry Scour Hole Near Channel

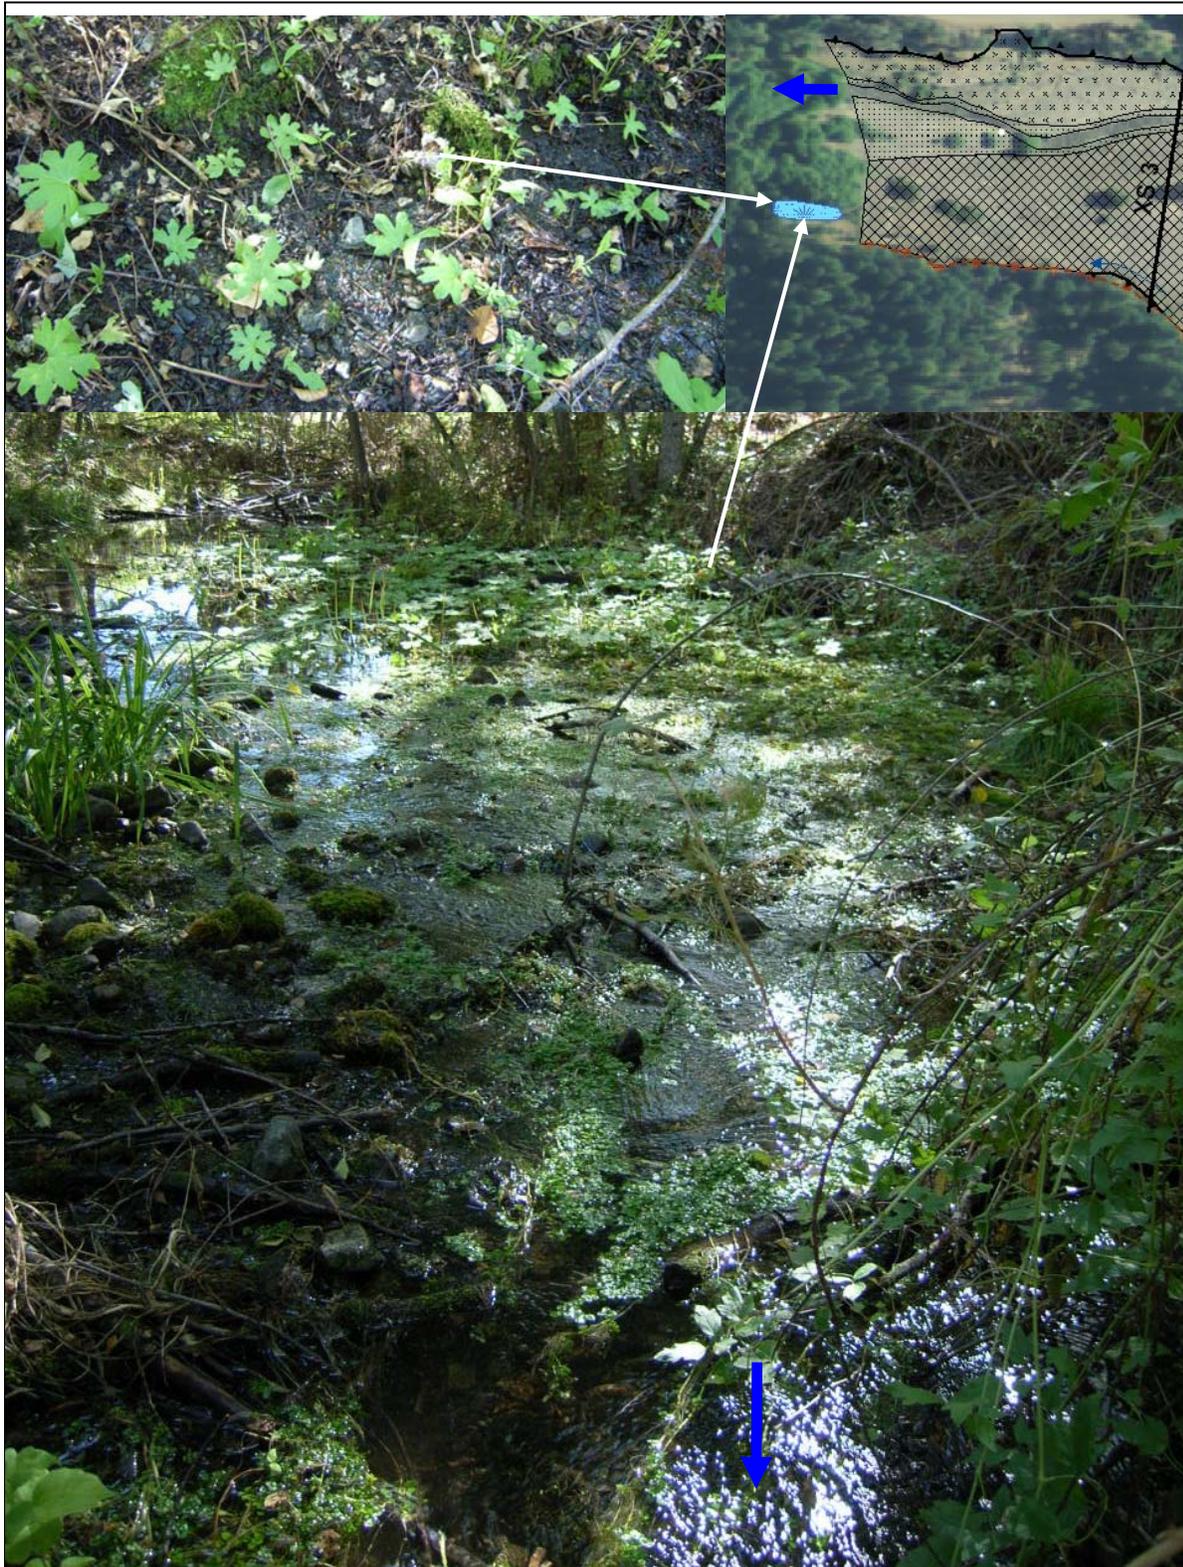
figure 7.11
Indian Creek

Ground Water Daylighting at Downstream Section

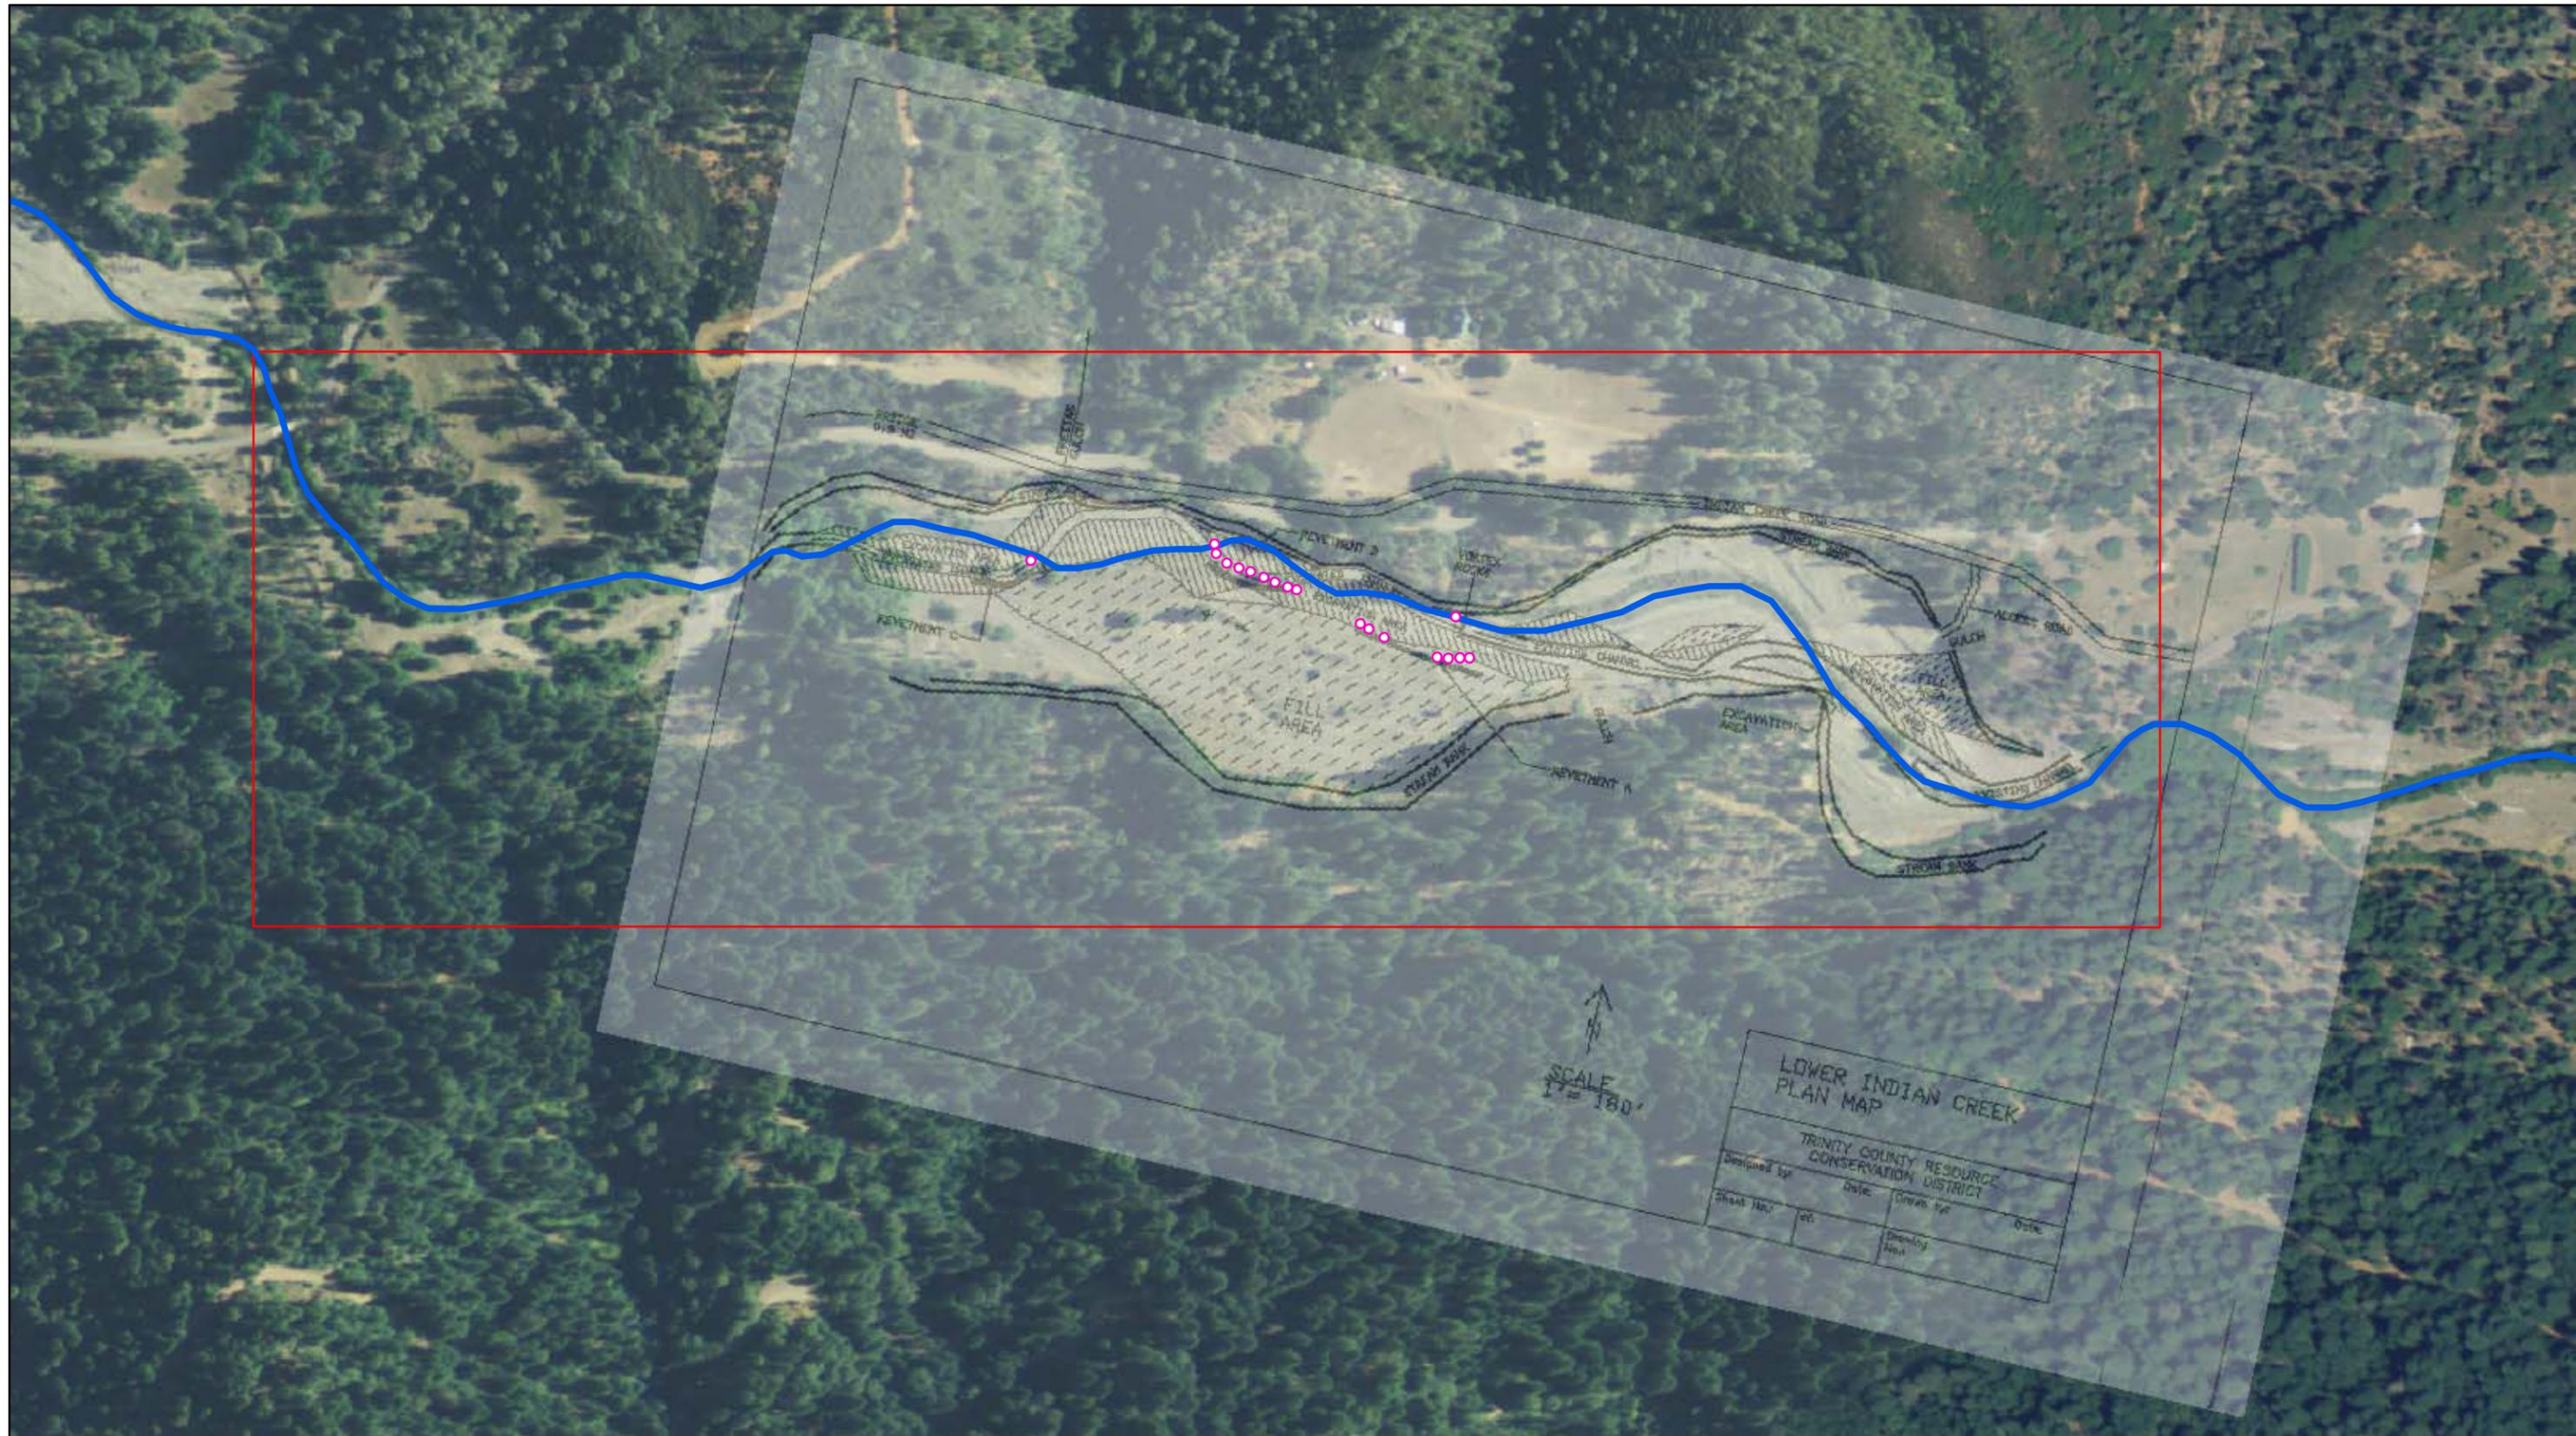
figure 8-1
Indian Creek

LOWER INDIAN CREEK
PLAN MAP

1996 BLM Restoration Design Plan with Assessment Notes

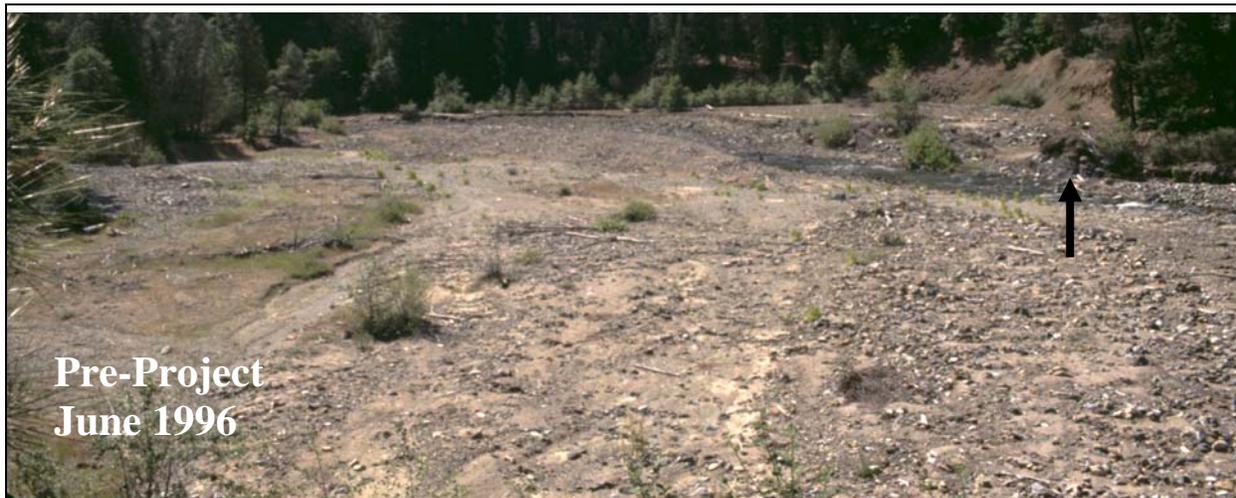
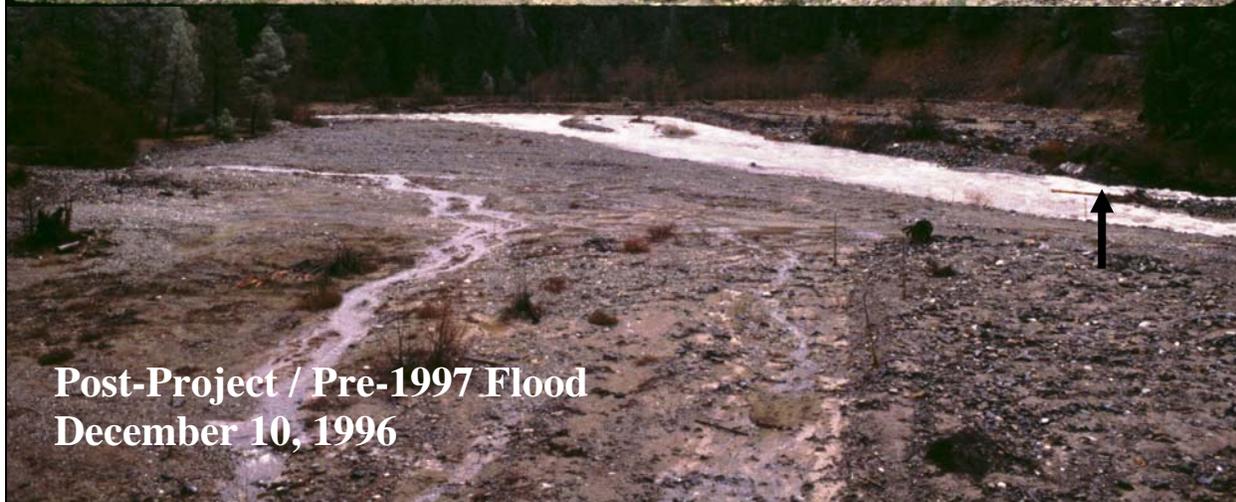
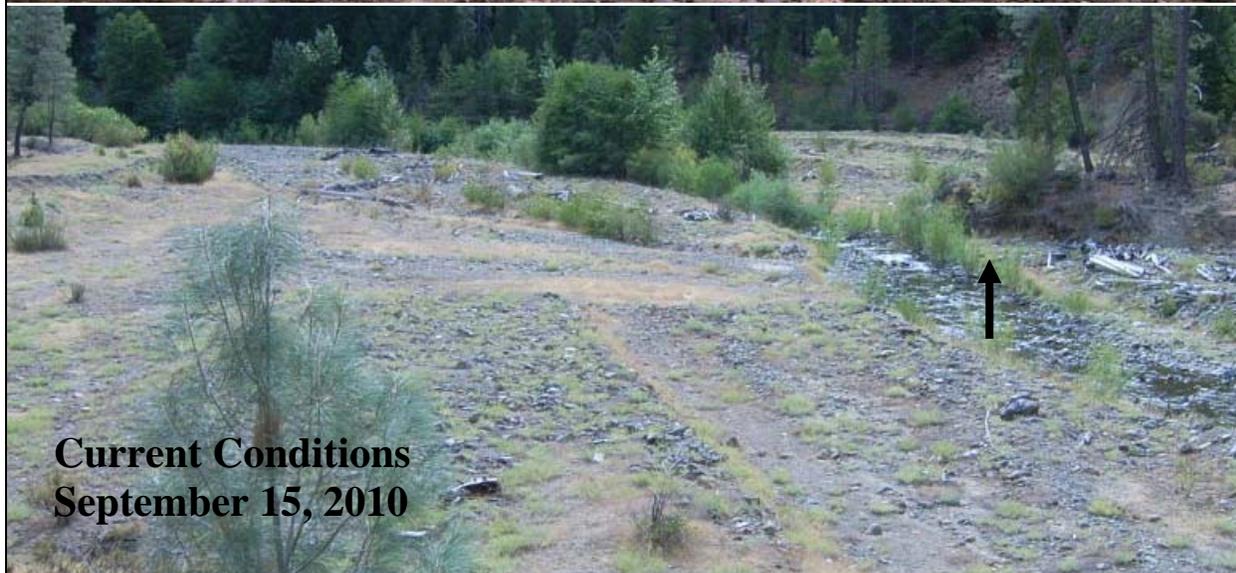
*figure 8-2
Indian Creek*

1996 BLM Restoration: Section 1

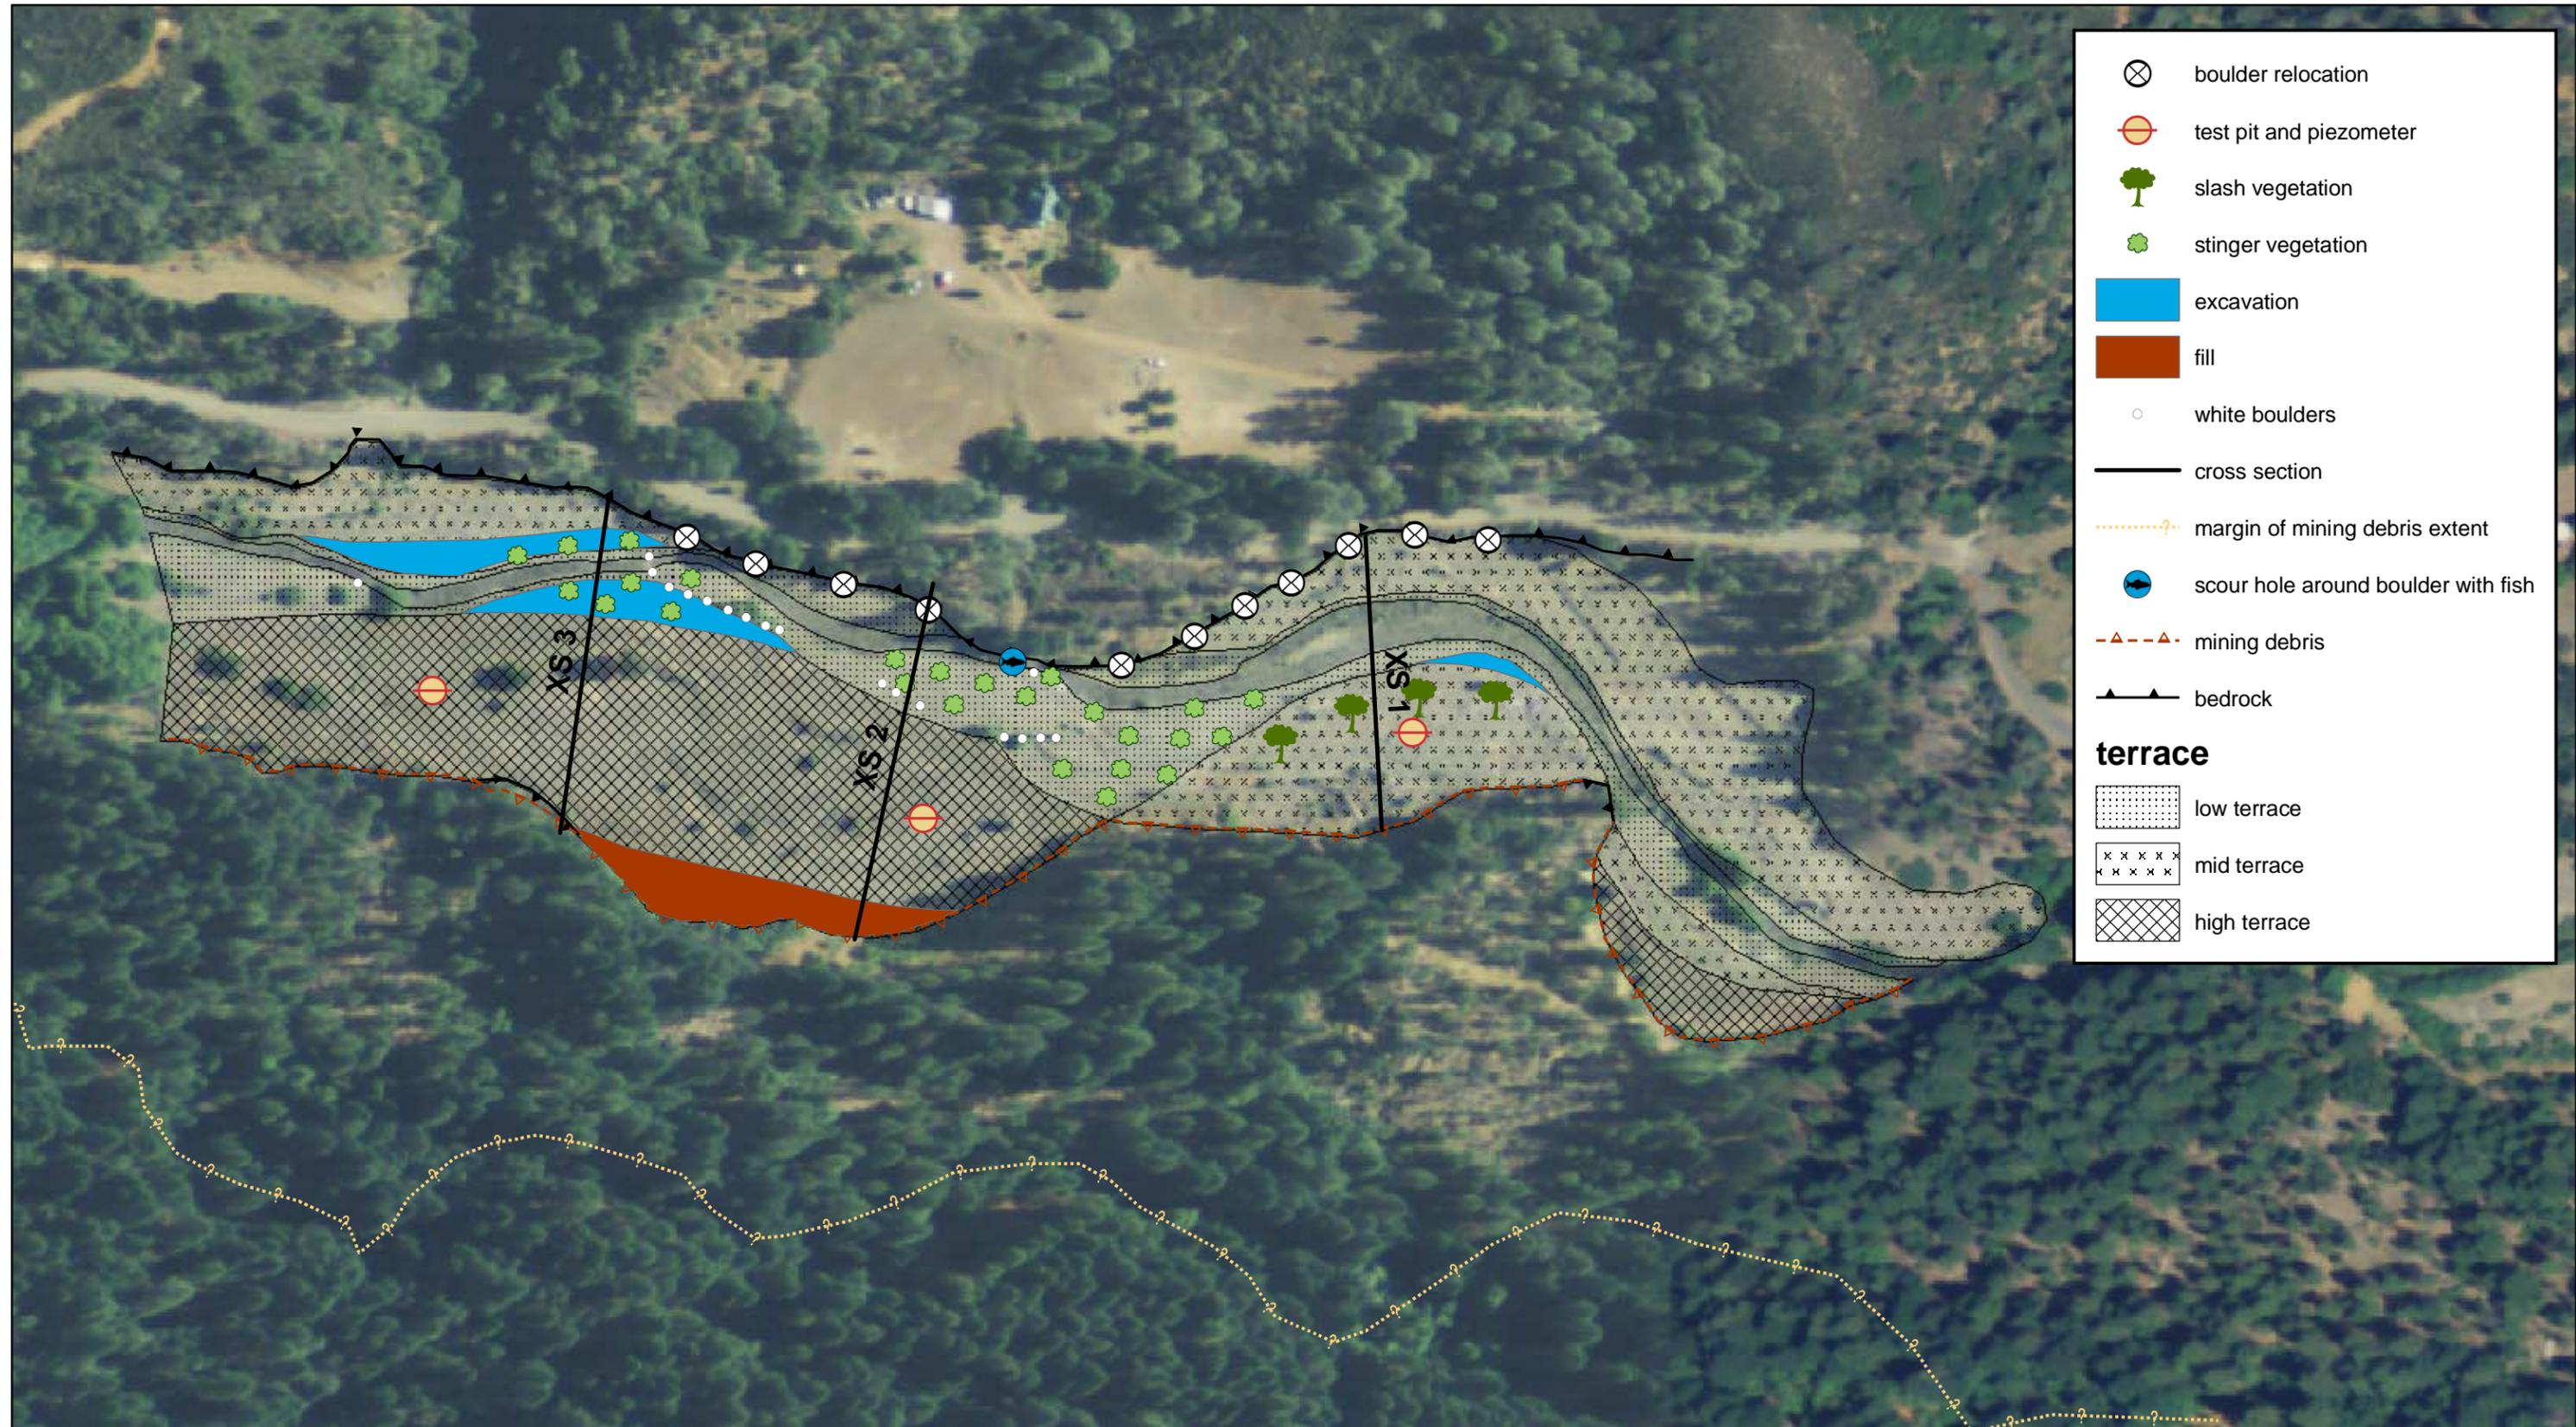
figure 12-1
Indian Creek

Recommended Restoration Actions

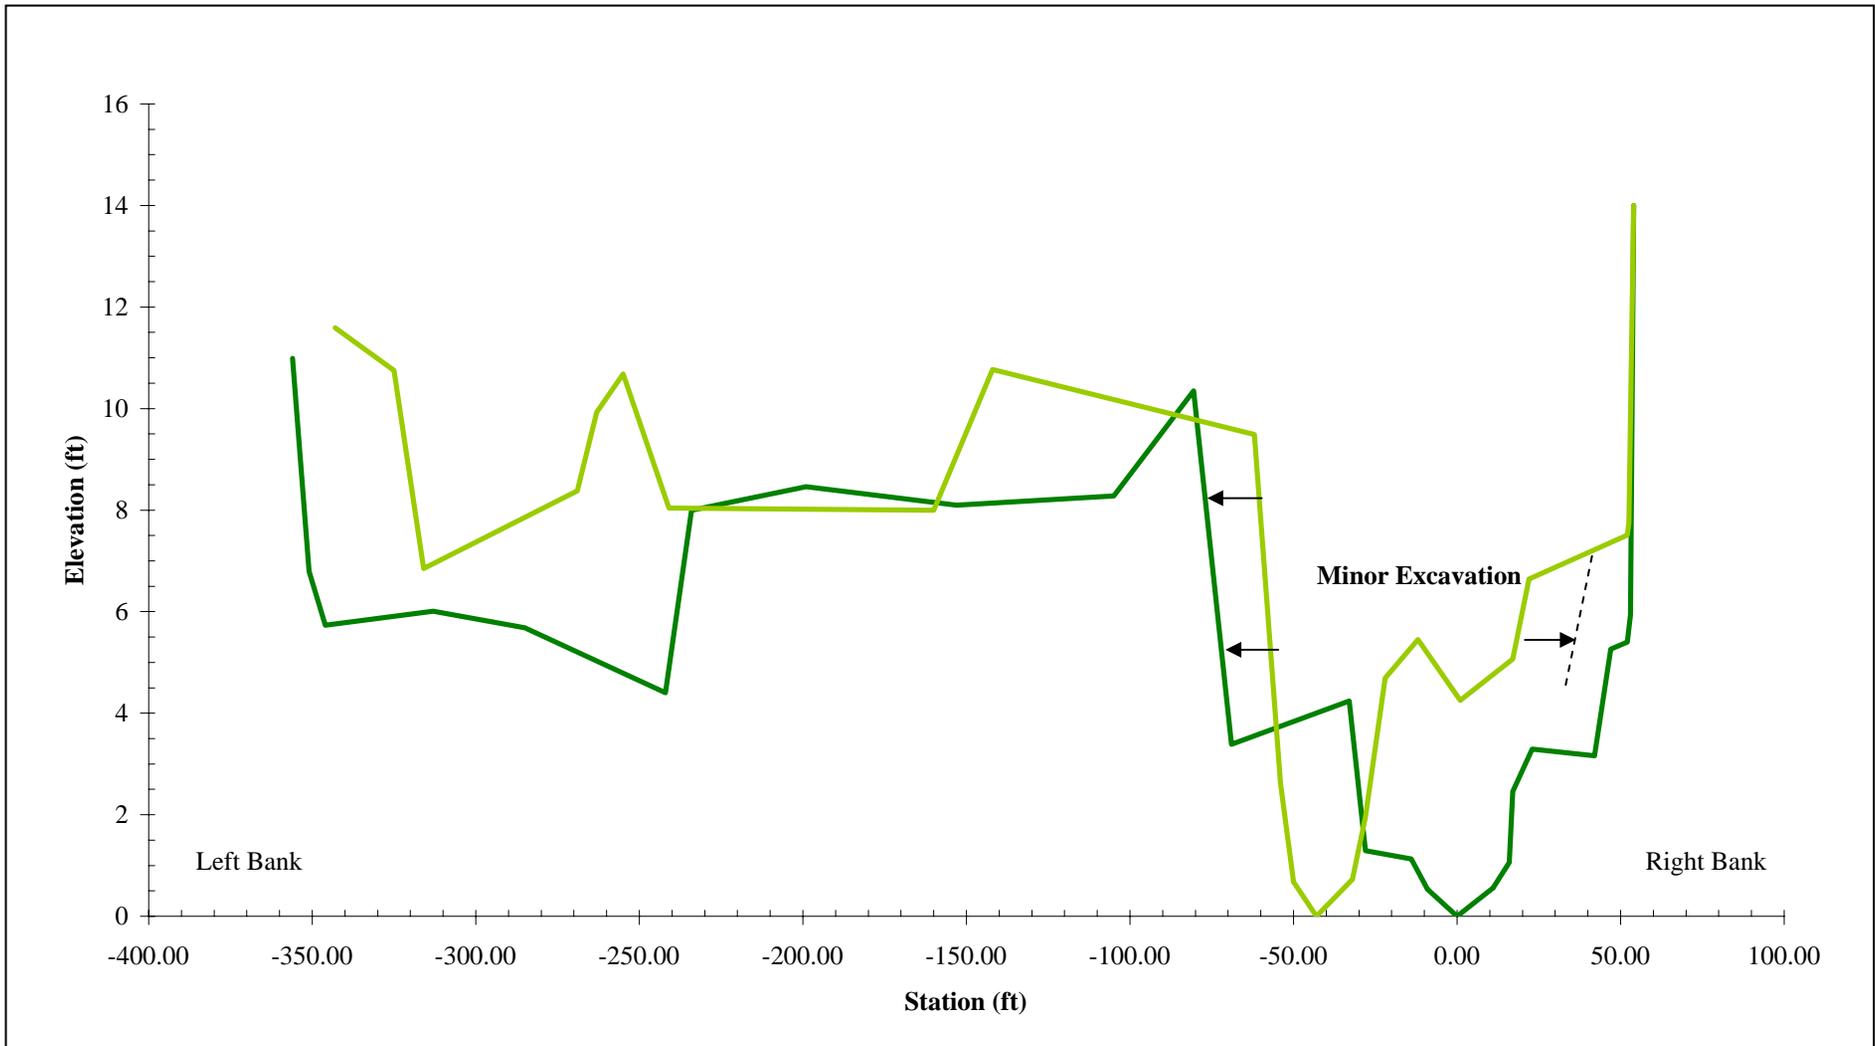
figure 12-2
Indian Creek

Cross Sectional View of Minor Excavation
