# *Salmon Creek Estuary: Study Results and Enhancement Recommendations*

*Prepared by:*  
***Prunuske Chatham, Inc.***  
***P.O. Box 828***  
***Occidental, California 95465***  
***(707) 874-0100***

*June 2006*

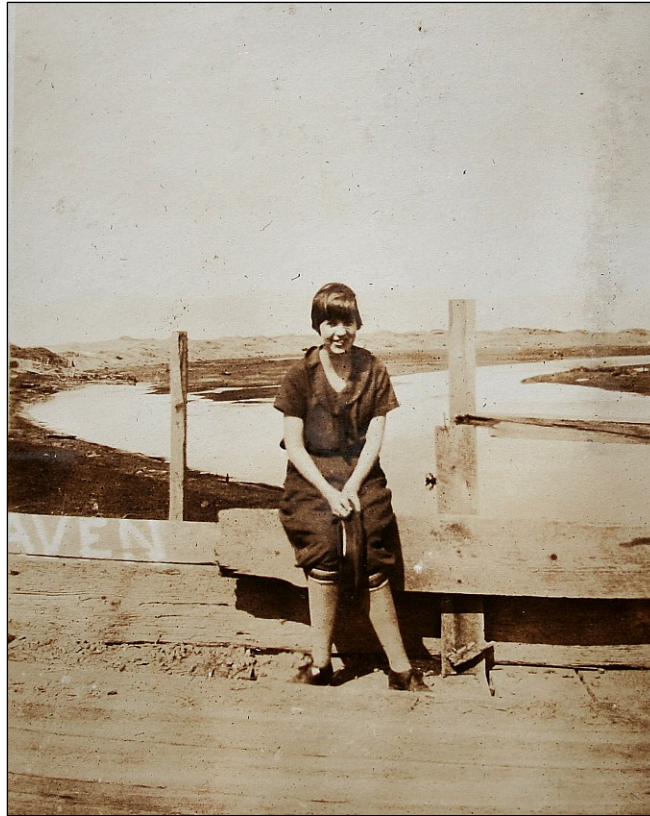
*Figure 3.1.2 1920s photo taken from the first Highway 1 Bridge looking downstream at the lower estuary. Note the extensive tidal wetlands (dark area) covering much of the area in front of the high dunes. This diverse, productive habitat was quickly disappearing by the 1940s and completely gone from the system by the 1960s. (Photo provided by Charles Beck)*

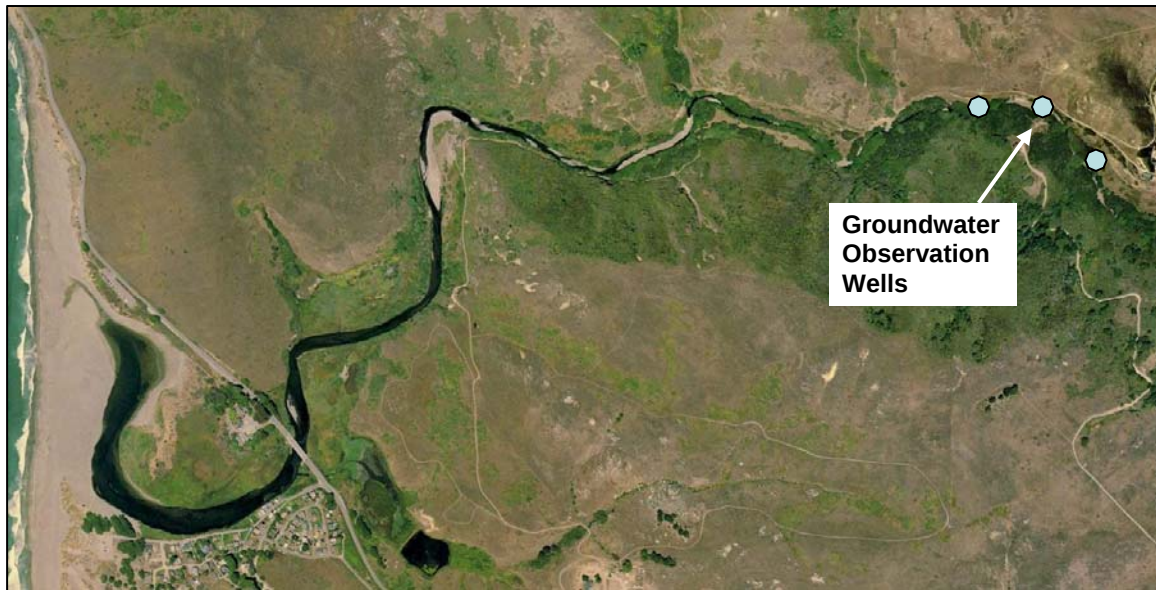
*Figure 3.2.1 Location of observation wells in relationship to the Salmon Creek estuary.*

Additional observation wells were installed 350 ft upstream and 450 ft downstream of the PUD water supply well (Figure 3.2.1). In 2004 the water table decline pattern was consistent in all three observation wells, with maximum water surface lowering over the study period of 2.5 ft at the upstream and middle wells and 2.0 ft at the downstream well. In 2005 the shallow water table remained relatively stable at the three observation wells over the measurement period, similar to what is seen in Figure 3.2.3.

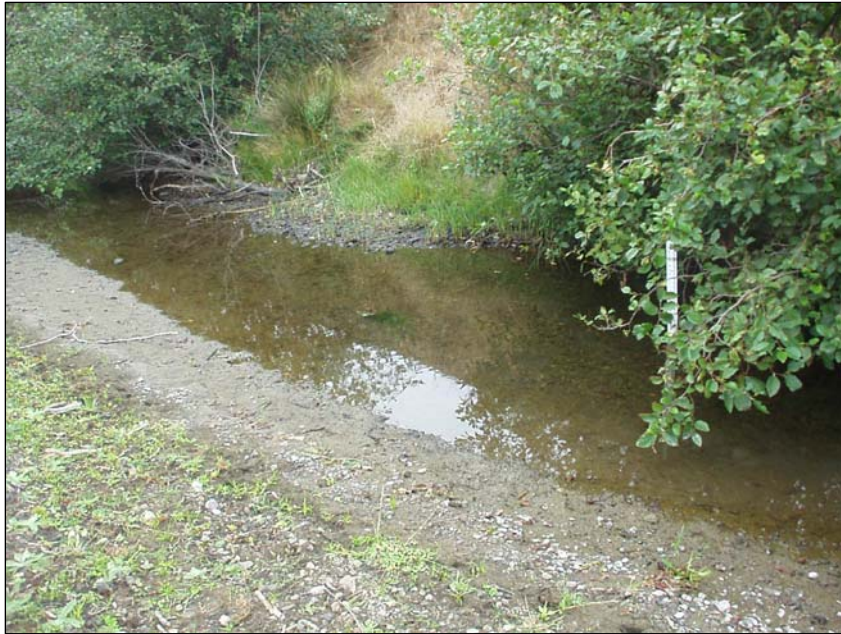
**Figure 3.4.3** Unit 10 near well site, 12 August 2004 – considerable dewatering had already occurred since 2 July survey.

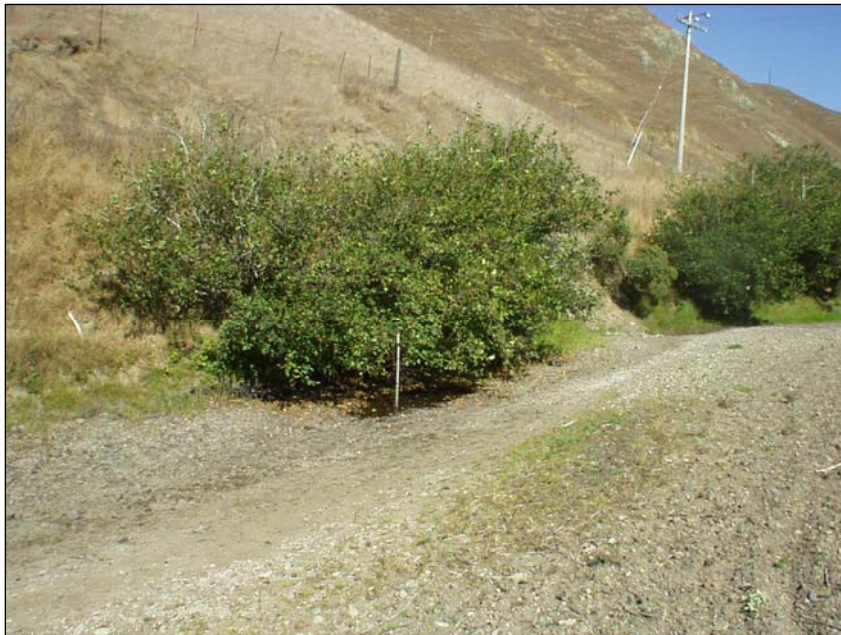
**Figure 3.4.4** Unit 10 near well site, 31 Aug 04 – remaining pool only 4.4 cm. deep, no vertebrates left in the pool.
