## **GARRAPATA STATE PARK**

# **Coastal Habitat Restoration and Coastal Trail Improvement Management Plan**

State of California  
**DEPARTMENT OF PARKS AND RECREATION**  
Monterey District

December 2013

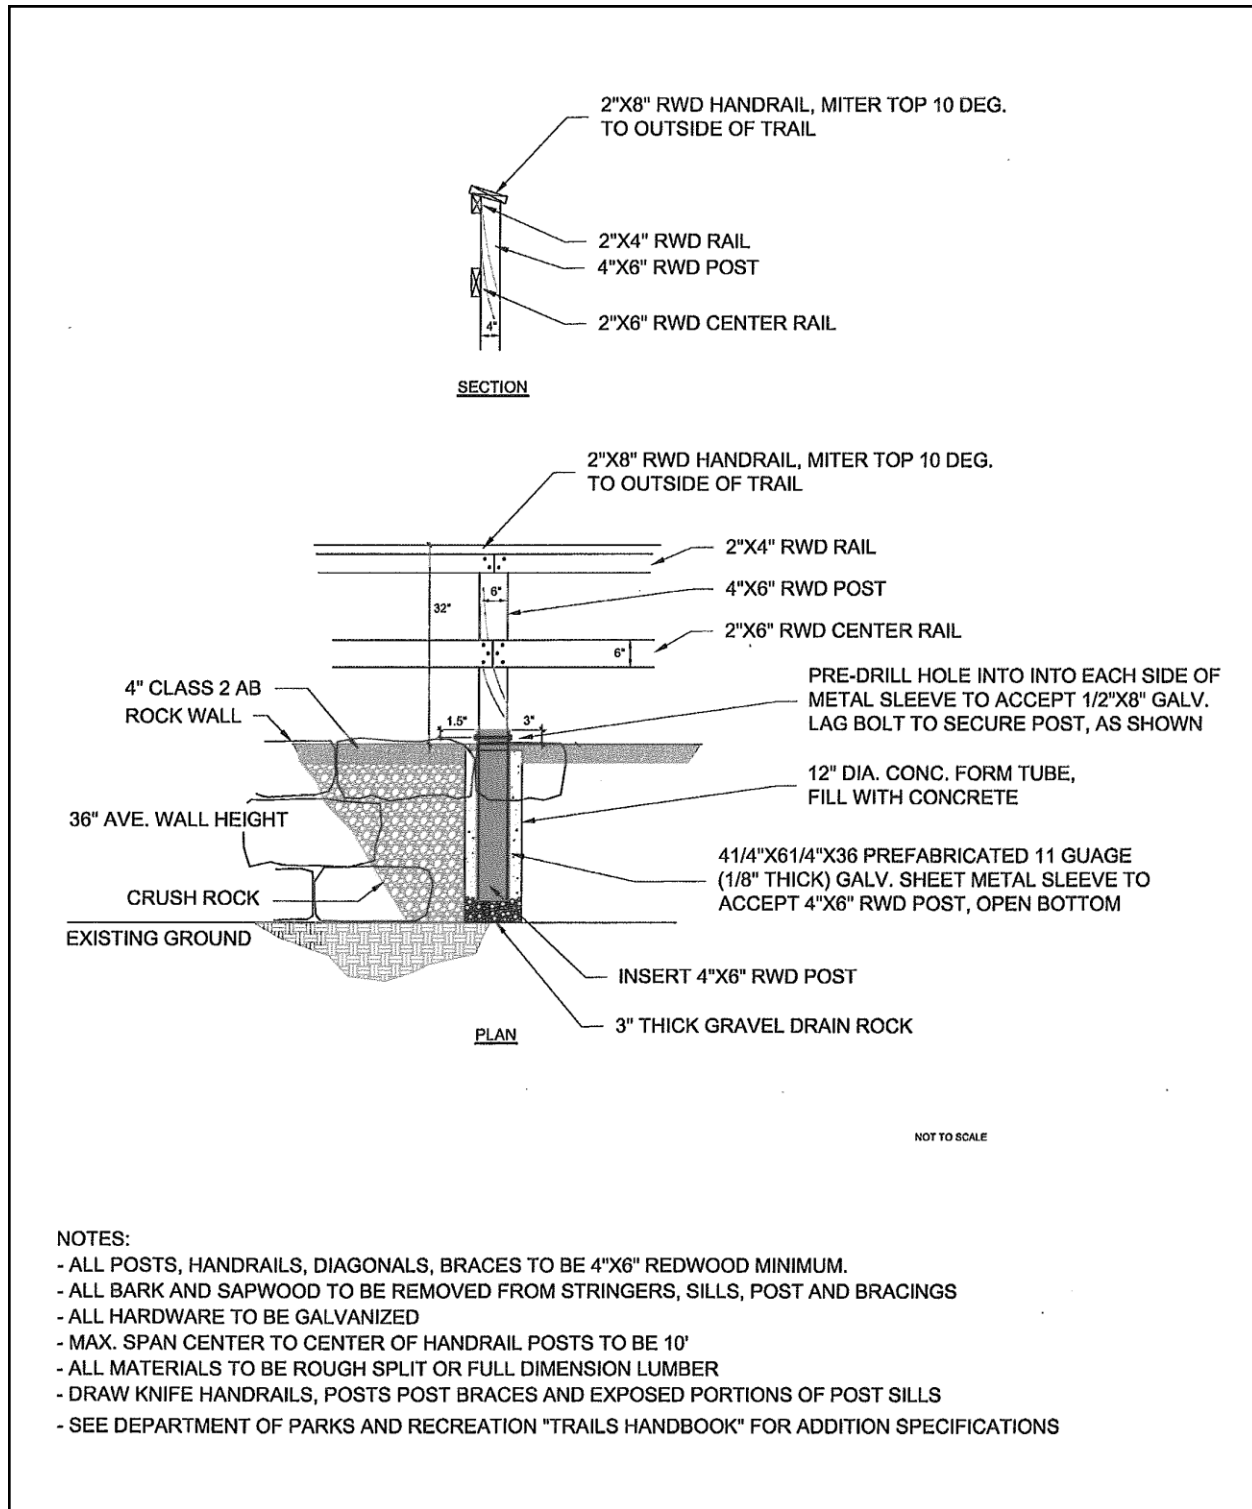
Figure 4-6  
 Overlook Railing Detail

To minimize visual impacts, DPR will only install rock walls and railings at those overlook sites where visitor safety and site stability require it. The height of the rock wall will vary, but will not exceed approximately 3 feet in height above ground surface. Wood railing may be installed at some overlooks as needed depending on the height of the rock wall and potential safety hazards on the downslope side of the wall (see Figure 4-6).

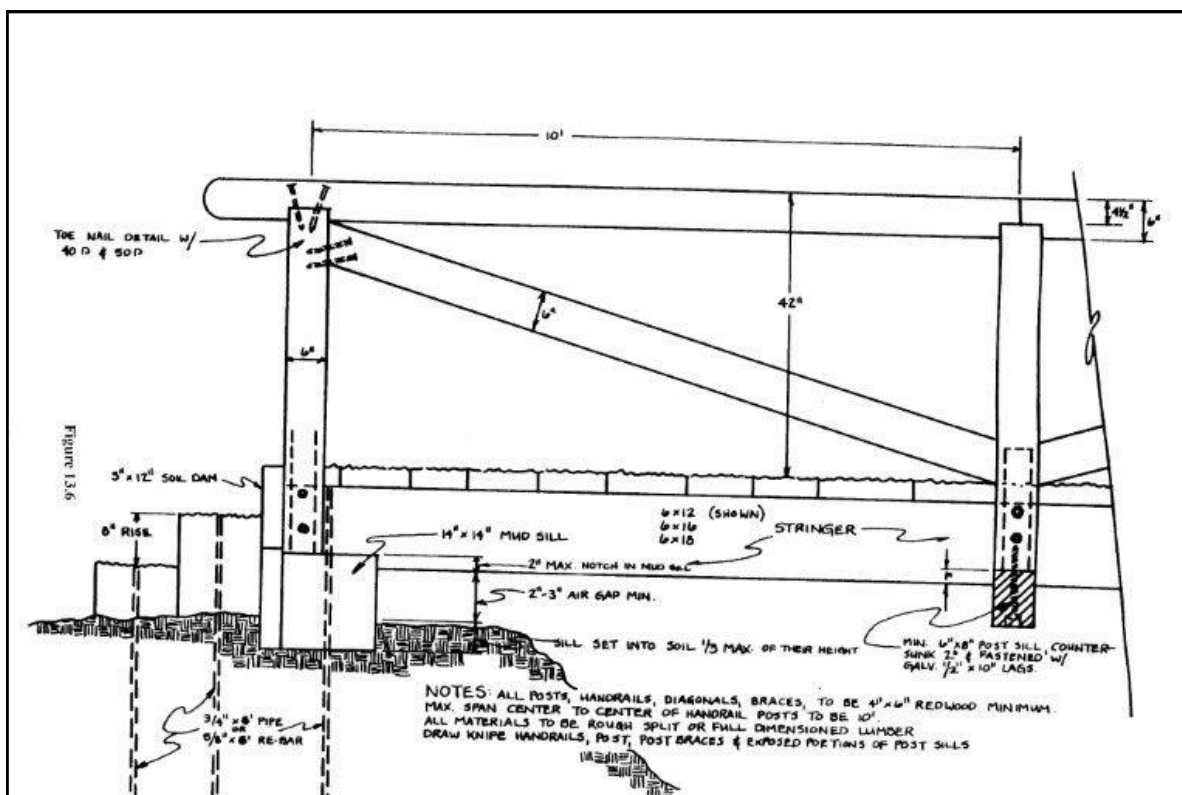
Figure 4-7 Bridge Schematic Design

At Soberanes Creek, there is no existing designated trail crossing and park users have created various pathways down into the creek corridor. The project includes construction of a new pedestrian wood bridge spanning the top of the creek corridor. The main span of the bridge crossing the ravine and Soberanes Creek will be approximately 45 feet long, with an additional shorter span on the coastal bluff connecting to the trail route. The bridge will feature wood railing and decking. The schematic design of the bridge is depicted in Figure 4-7 below.

Existing user created trails cross Soberanes Creek (south of Trail Gate 8) and Doud Creek (between Trail Gates 18 and 19) within the creek channels. No bridges presently exist at these locations. Trampling of riparian vegetation and impacts to California red-legged frog habitat are occurring as a result of visitor use. The Coastal Habitat Restoration and Coastal Trail Improvement project includes construction of pedestrian bridge crossings at Soberanes Creek and Doud creek to benefit riparian vegetation and red-legged frog habitat, and improve visitor safety. The locations of the bridges are shown in Figure 4-1(Trail Gate 7) and in Figure 4-4 (south of Trail Gate 18). Appendix C (Map Sheets 6 and 19) show the locations in greater detail.

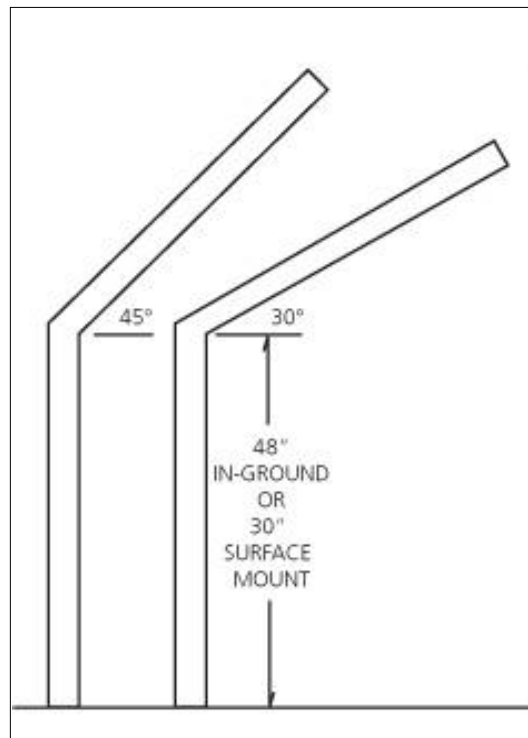
Figure 4-8 Interpretive Sign Mount

New trail markers will be installed which clearly designate the trailhead entrance. Markers will be small metal signs installed on an existing or repaired/replaced wood post at the trail gate entrance. Existing DPR regulatory/warning signs will be repaired or replaced where deteriorated or damaged. New Coastal Trail emblems (4 to 8 square inches) will be installed on an existing or replaced wood post at trail gates where the Class I or II trail segments have been improved and designated as California Coastal Trail segments. An interpretive sign may be installed at one more trail access gates where trail improvements have been made. Any interpretive sign would be located within DPR property near the trail entrance gate such that it is not readily visible from Highway 1.

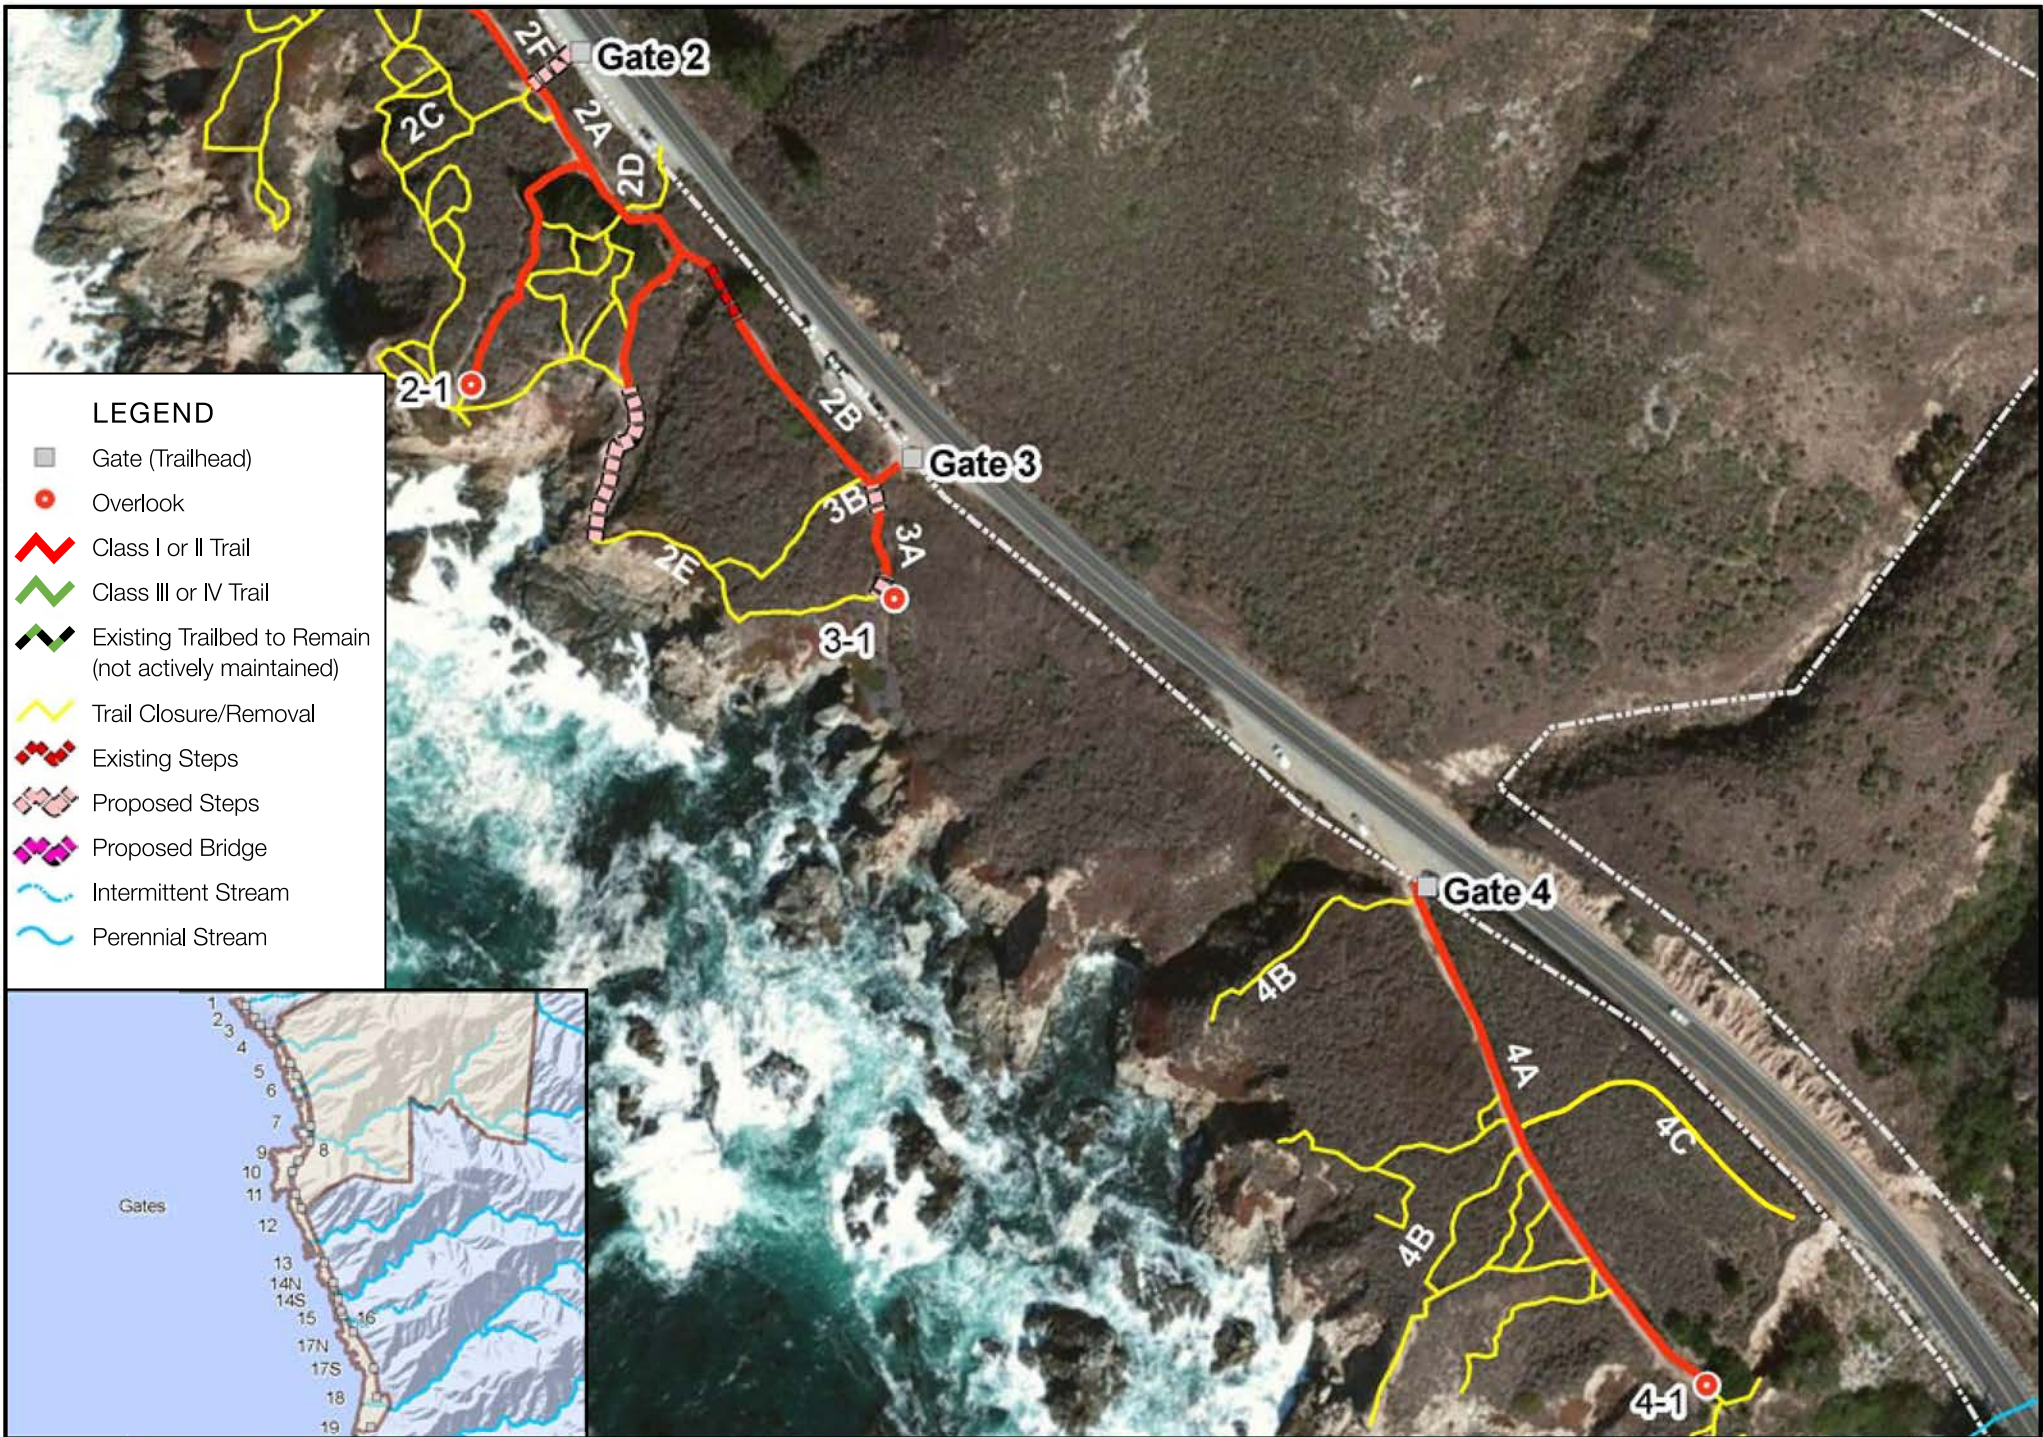
Sheet 2

Improved access down the bluffs to the intertidal zone presently exists at Trail Gates 2 and 5, though the steps have severely deteriorated and all that remains today is exposed rebar. Park users continue to descend the bluffs, creating several pathways down the slope. The project includes installation of new wood steps at Trail Gate 2 and new cable steps at Trail Gate 5. The cable steps will be anchored at the top of the bluff, with no anchoring required down the slope face. Installation of the wood steps and cable steps will provide a designated route and minimize erosion. The location of the steps at Trail Gates 2 and 5 are shown in Figure 4-1 and in greater detail in Appendix C (see Map Sheets 2 and 4).

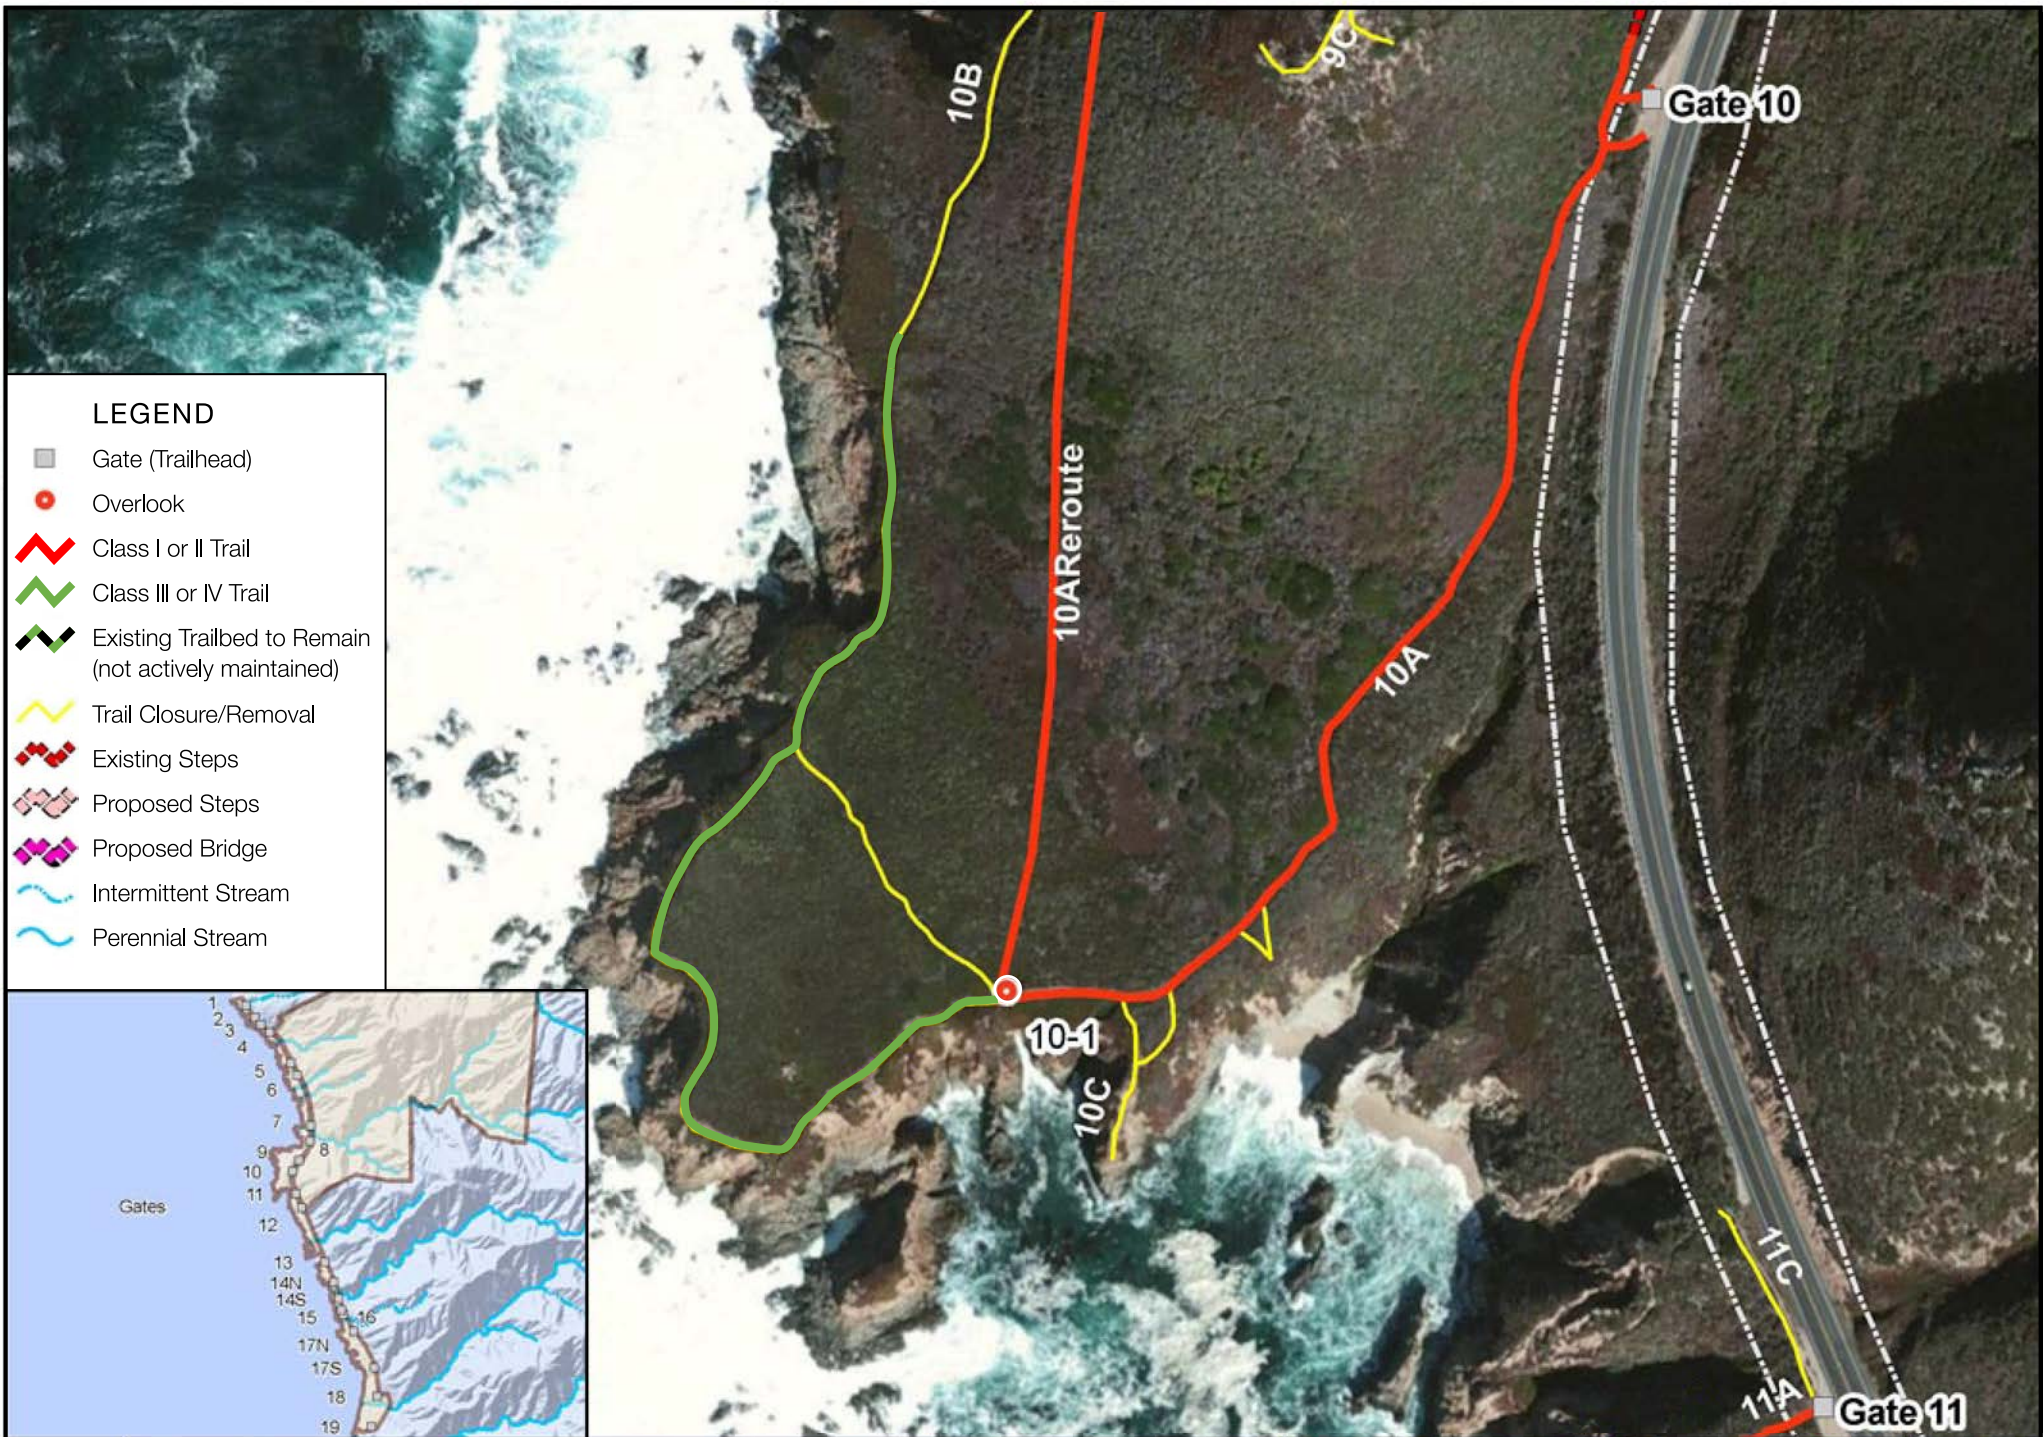
Sheet 9

All of the trails to be improved as Class I or Class II trails presently exist as natural surface trails except for a new trail alignment at Soberanes Point (shown on maps as 10A). This reroute is required due to gully erosion and resulting damage to an existing wood walkway and retaining wall. The reroute is approximately 750 feet in length, and avoids sensitive archaeological sites and areas of known sea cliff buckwheat. The location of the trail reroute is between trail gates 8 and 10. The reroute alignment is shown in detail in Appendix C (Sheets 8 and 9).
