Exhibit 2: Photographs

Pigeon Point Lighthouse Rehabilitation Plan
Architectural Resources Group

Pescadero, California
December 2008

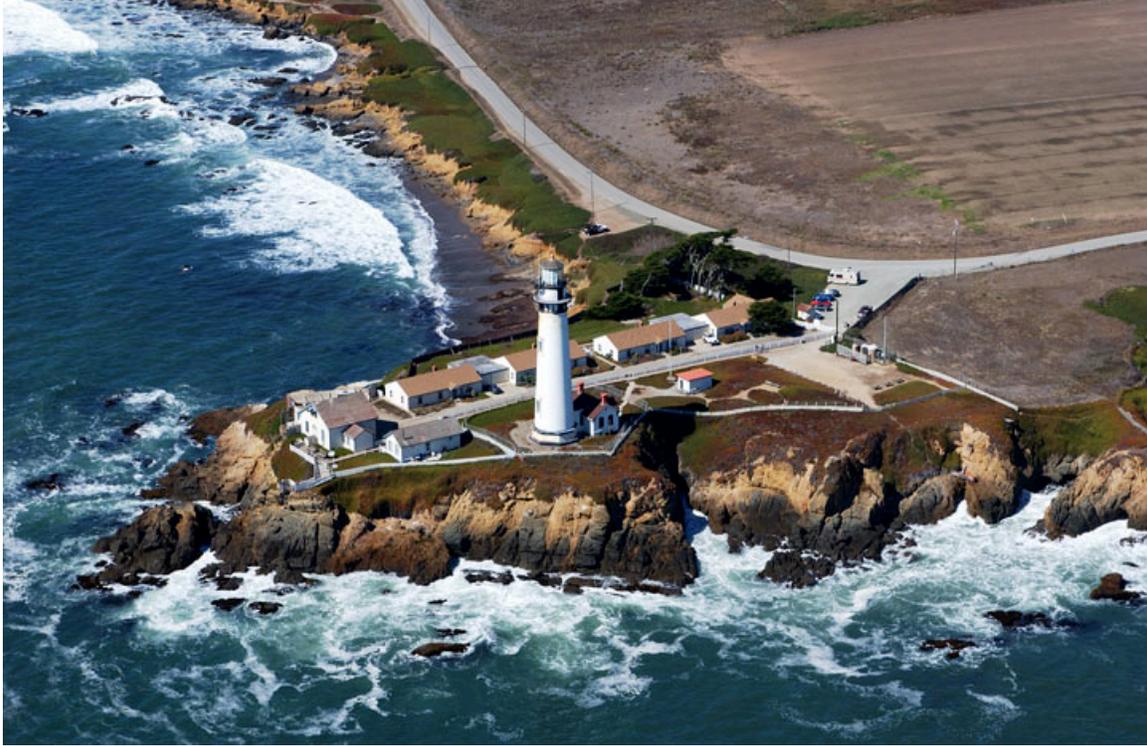
The chain-link fence that blocks public access to the lighthouse tower is visible in this 2008 aerial photo of the Pigeon Point Light Station (California Coastal Records Project).

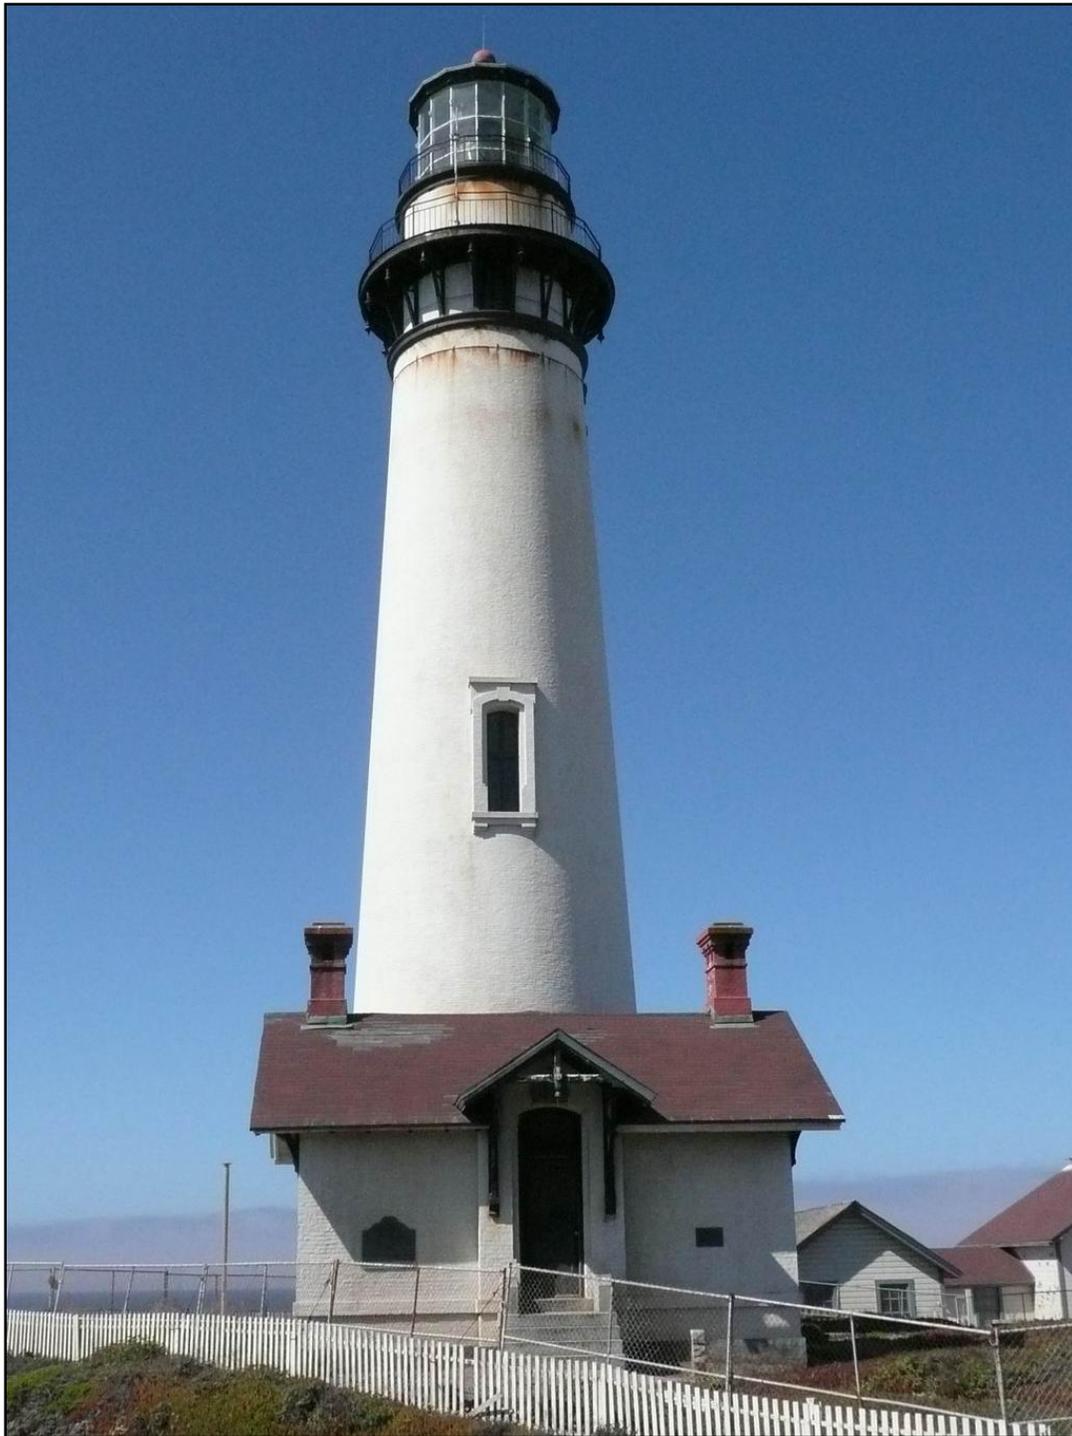
Pigeon Point Lighthouse east elevation, with Oil House in front.
