**Investigating suitability for eelgrass at Pier 94 (San Francisco) with test plantings**  
Final Report to Golden Gate Audubon Society  
December 2021

Margot Buchbinder, Melissa Patten and Katharyn Boyer  
Estuary & Ocean Science Center, San Francisco State University

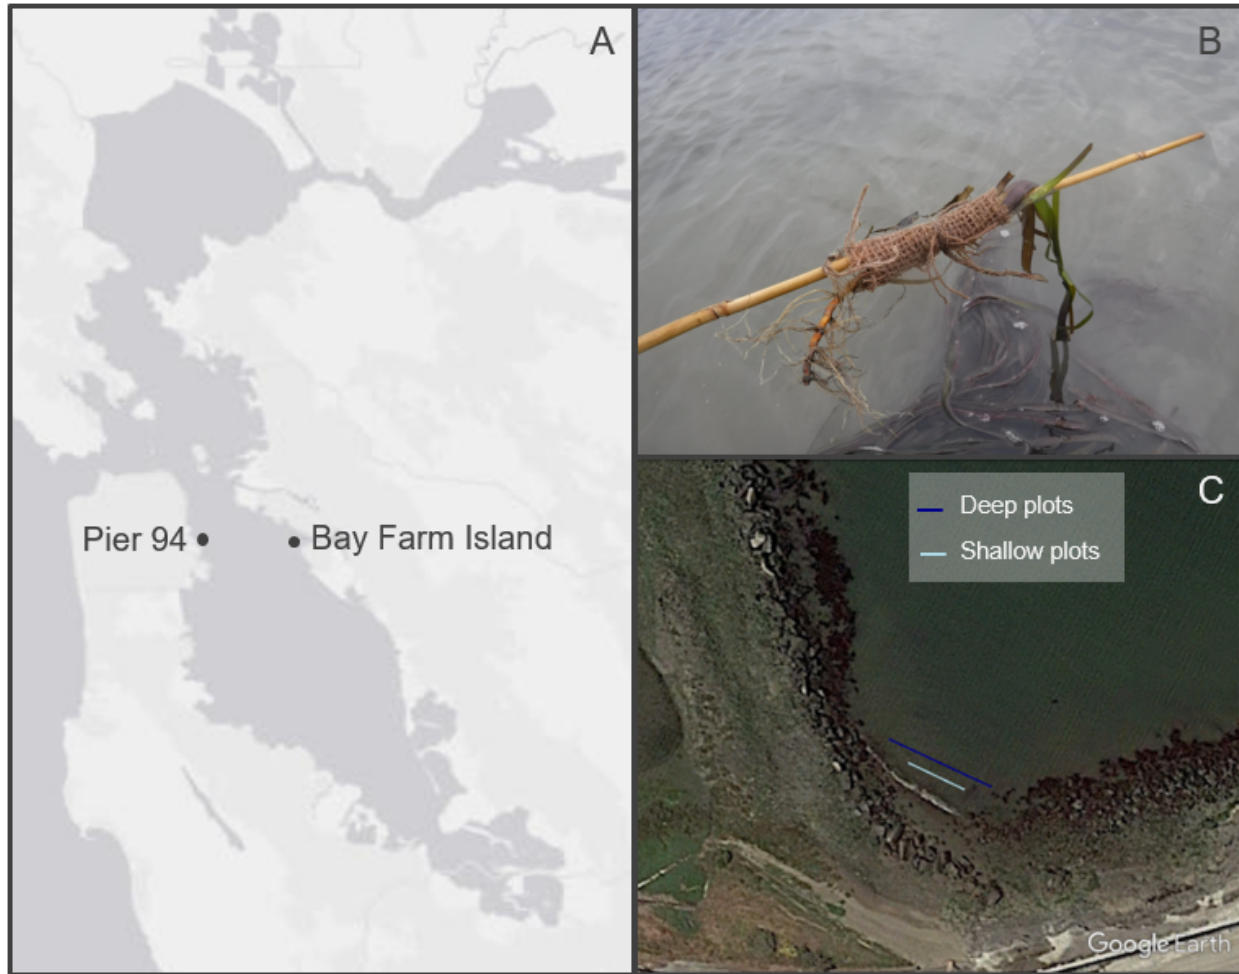
Figure 1. A) Map of Pier 94 (study site) and Bay Farm Island (eelgrass donor site) in San Francisco Bay; B) eelgrass transplanting unit; C) Satellite image showing locations of the shallow (-1.5 ft MLLW) and deep (-2 ft MLLW) plots at Pier 94.
